HISTORIC STRUCTURES REPORT

the RICHARDSON OLMSTED COMPLEX *Buffalo, NY*

July 2008

GOODY
CLANCY

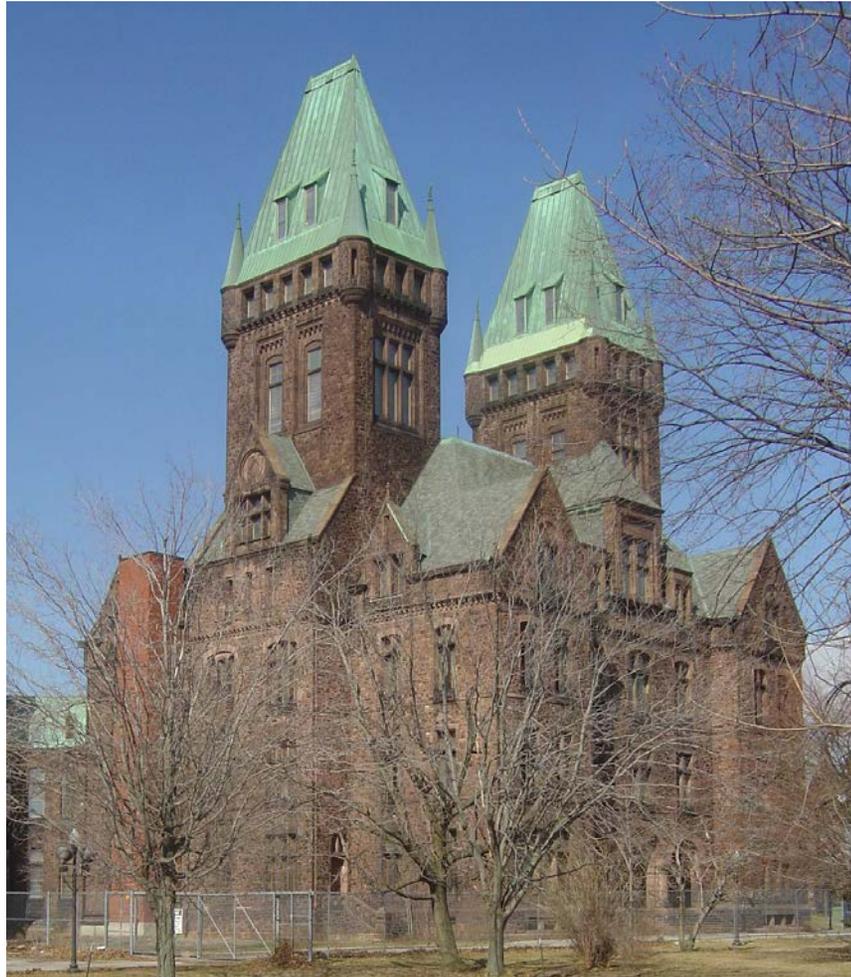
Overall, the exterior of the building is in fair condition, with some deterioration and damage. A description of the building elements (roof, masonry, windows, etc.) follows, with a description of the material, the existing condition of the element, and the treatment recommendations for each. The conditions are described below and shown on the building elevations (Sheets AB 2.1-2.4).

Fig. AB.1 Southwest elevation with towers
Image courtesy GCA

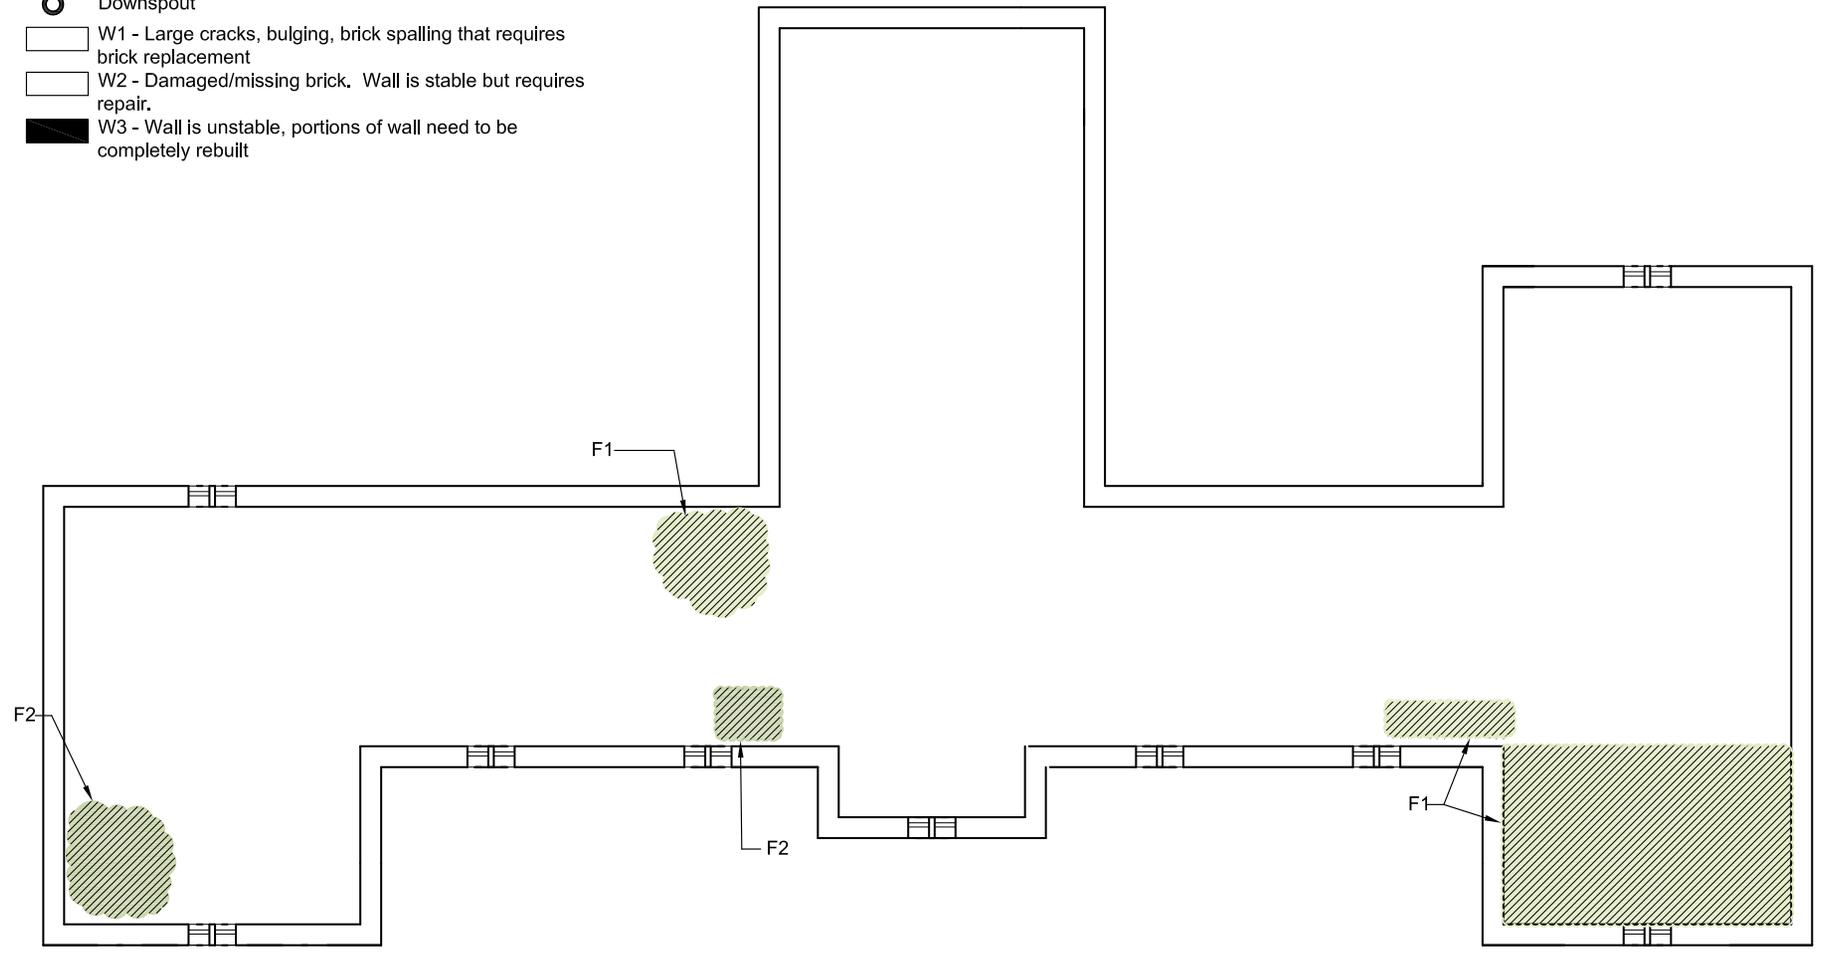
A
1.4 **Attic Plan** MALE WARD A
These drawings show estimated existing conditions.

W3 - Wall is unstable, portions of wall need to be completely rebuilt

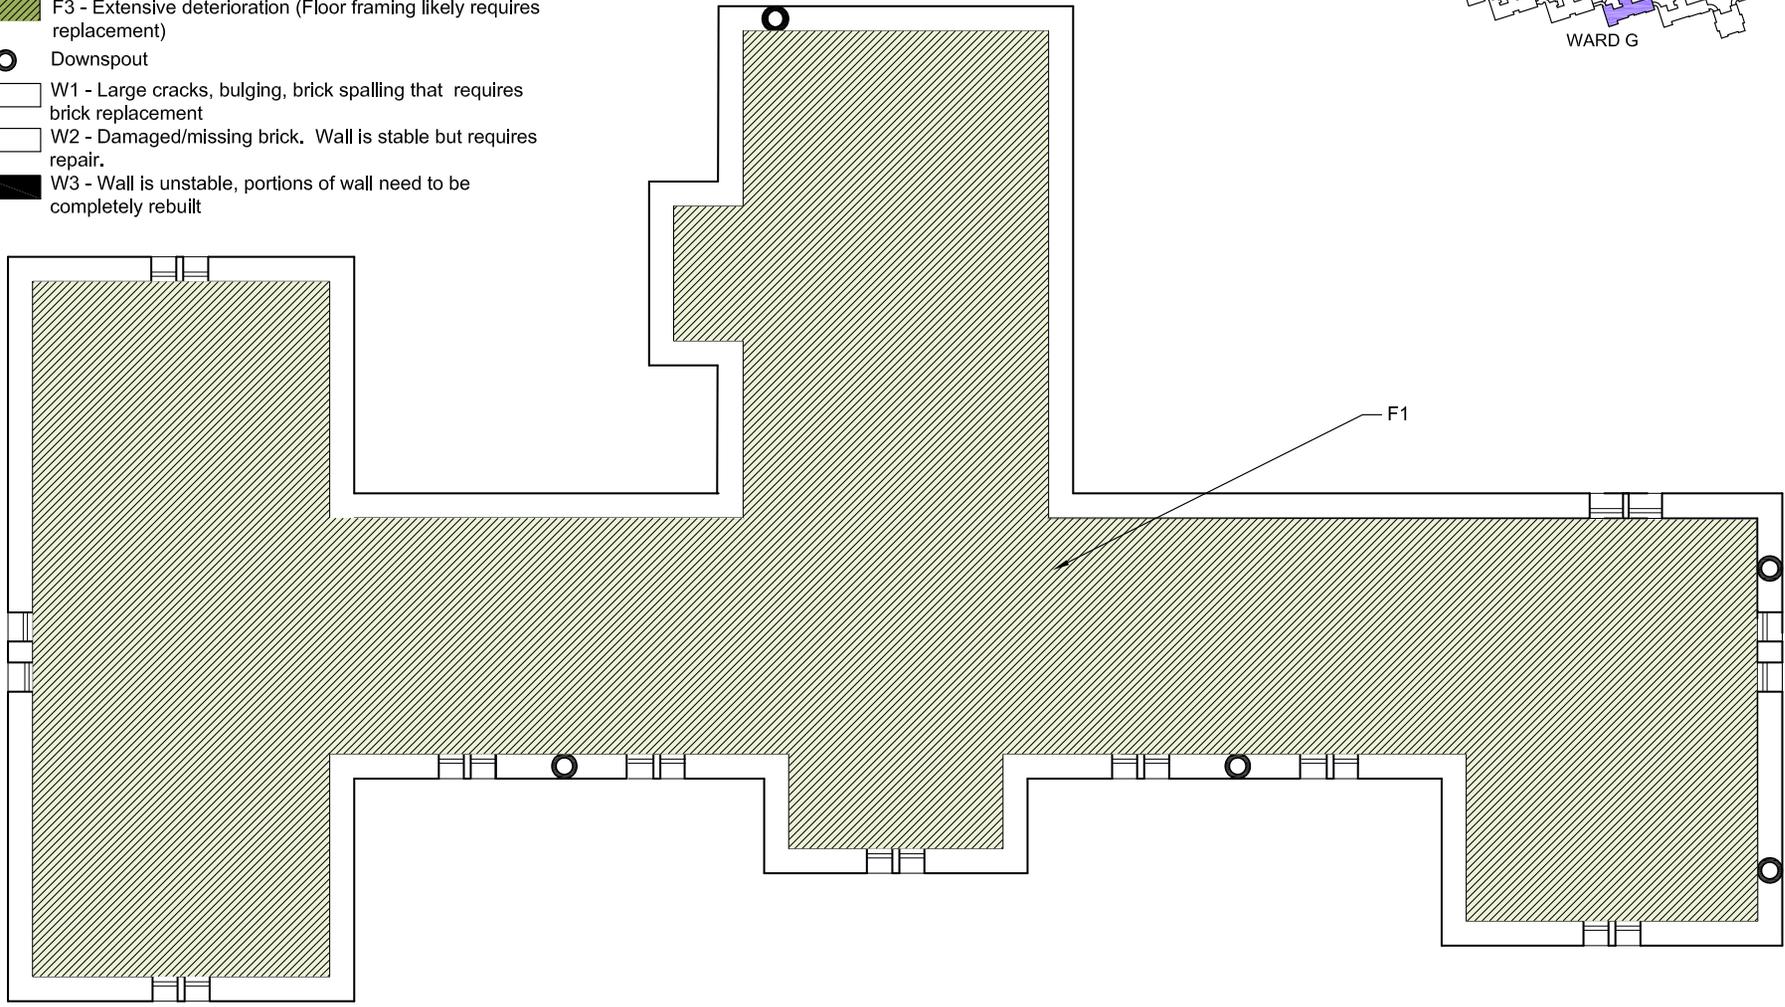
G
1.4 **Attic Plan** FEMALE WARD G
These drawings show estimated existing conditions.

W3 - Wall is unstable, portions of wall need to be completely rebuilt

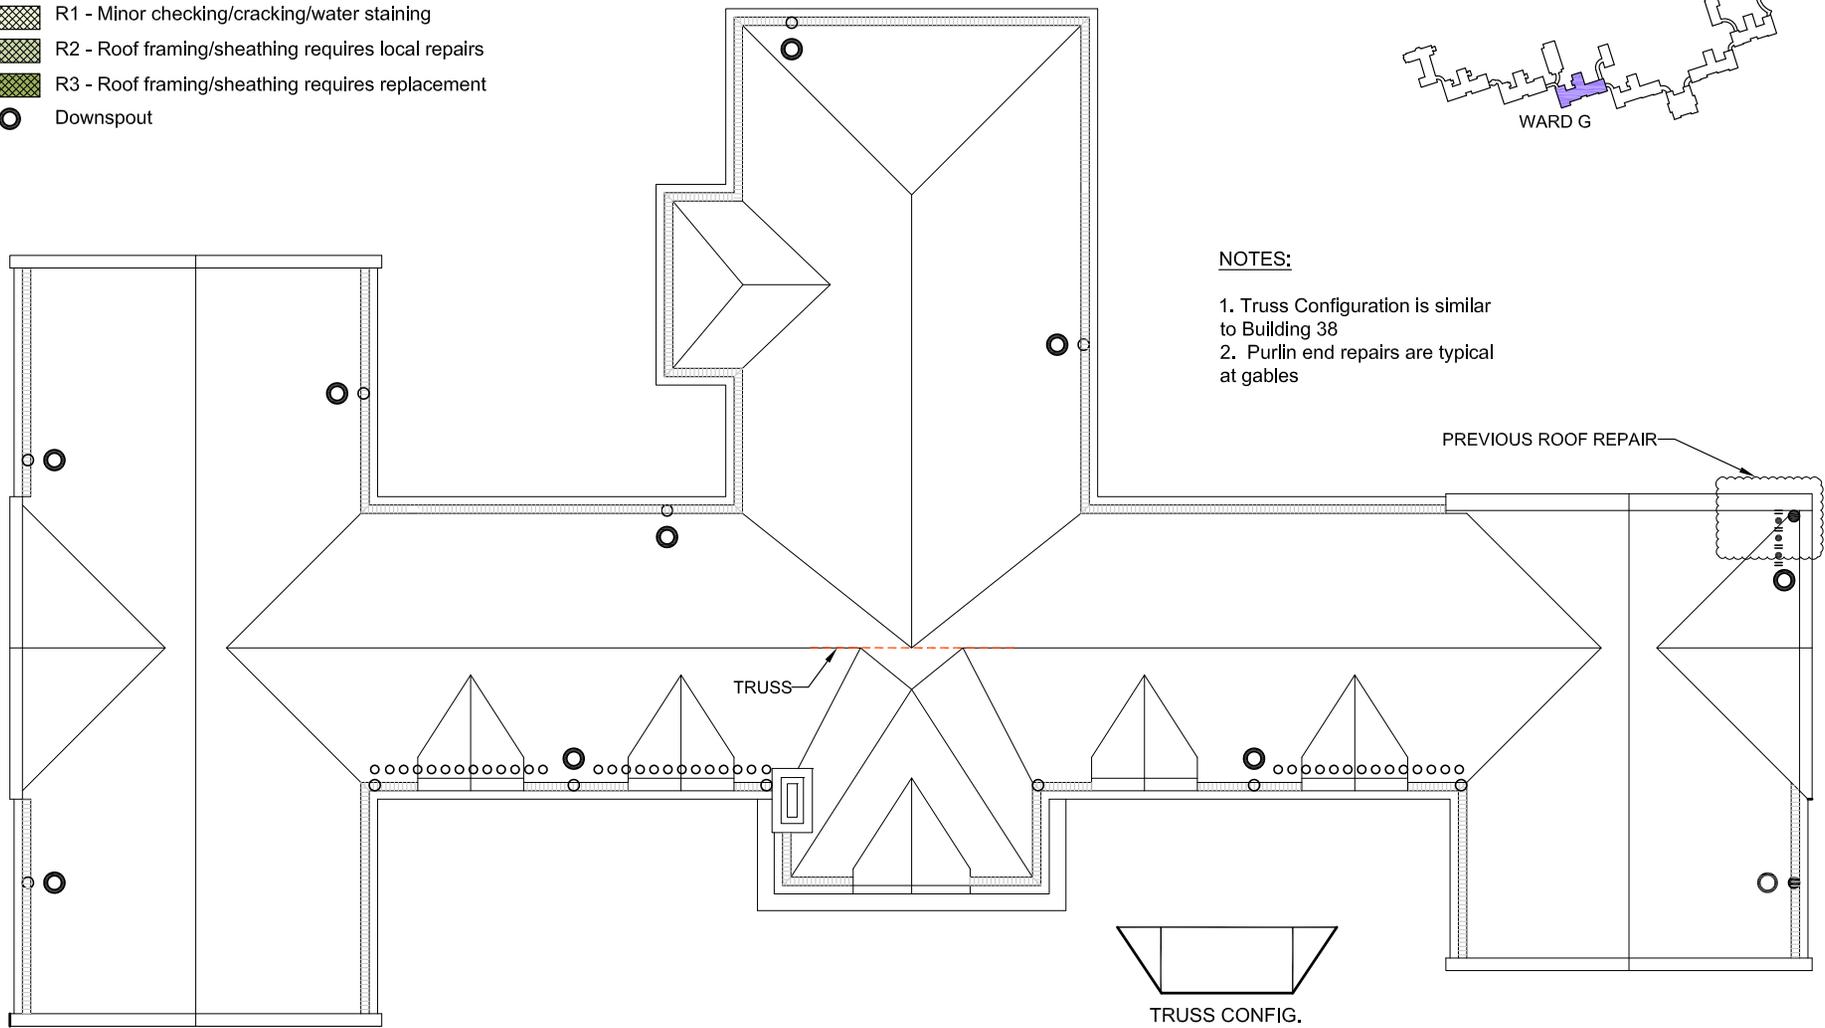
G
1.5

1. Truss Configuration is similar to Building 38
2. Purlin end repairs are typical at gables

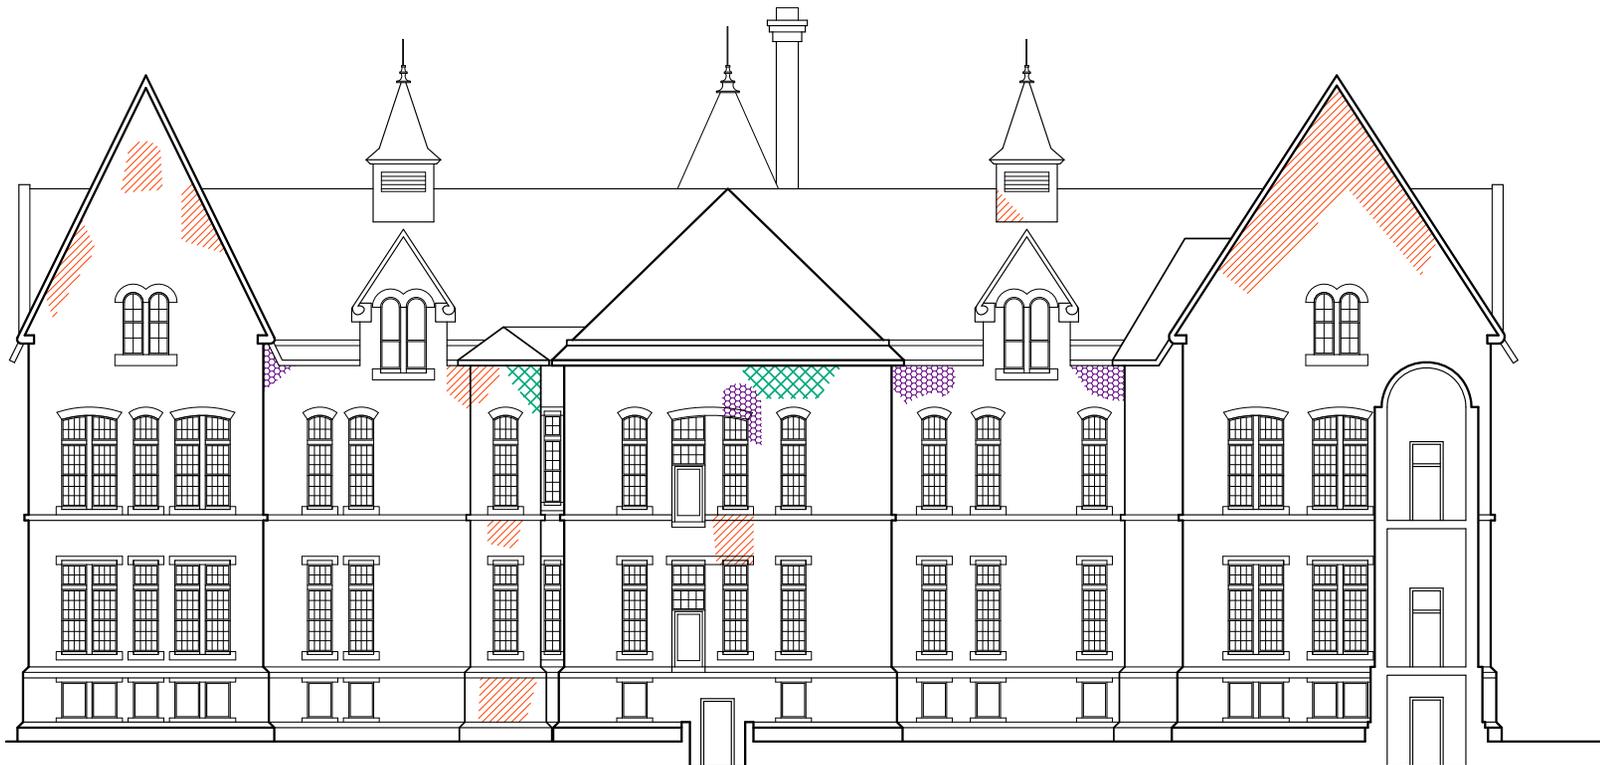
I
2.1 **North Elevation** FEMALE WARD I
These drawings show estimated existing conditions.

Crack through Stone
	18% Spalling
	46% Staining
	32% Mortar Erosion

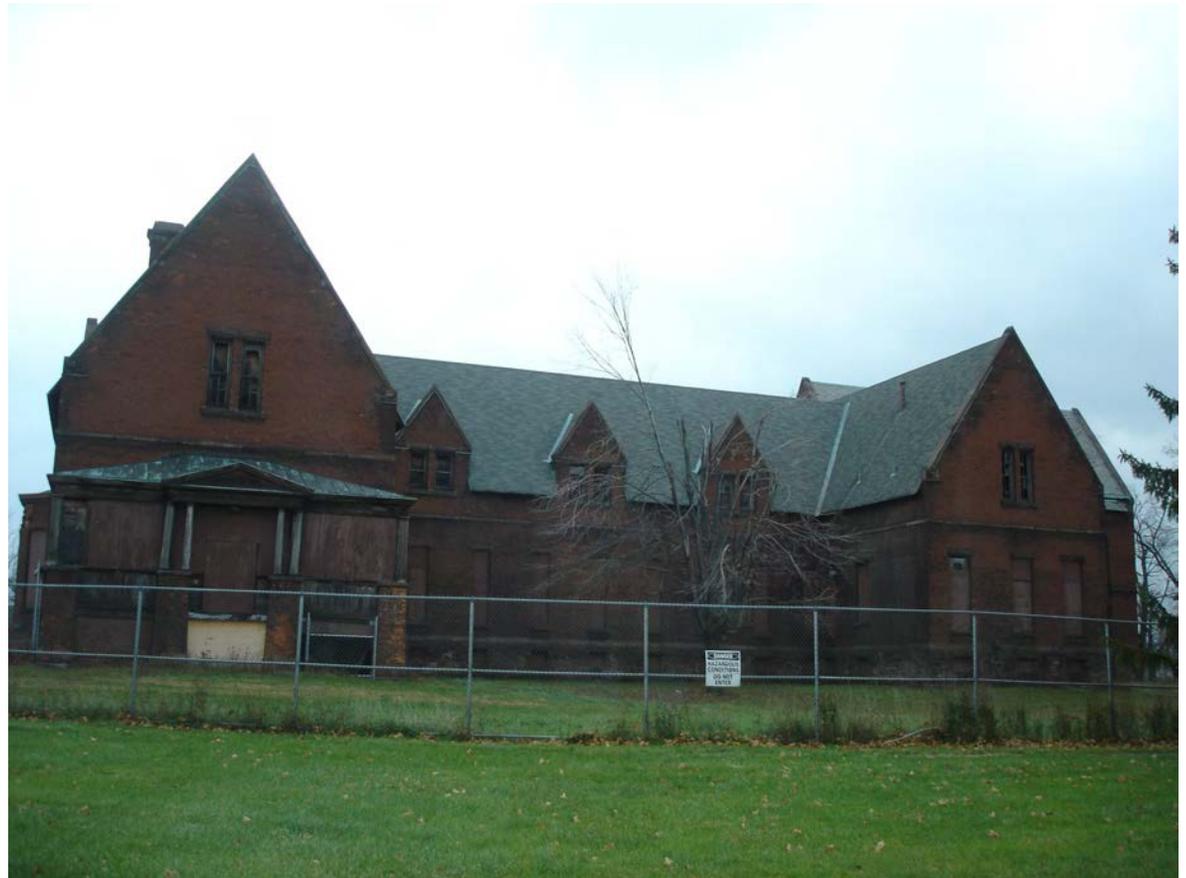
In general, the stone trim elements are in good condition. The surface of the stone contains minor spalling, soiling and some algae growth at the foundation walls on the north elevation.

Fig. J.1 **West elevation of Female Ward J**
Image courtesy GCA
