**RICHARDSON OLMSTED CAMPUS
BUILDING CONDITIONS ASSESSMENT**

BUFFALO, NY

PREPARED FOR: RICHARDSON CENTER CORPORATION

JANUARY 2023

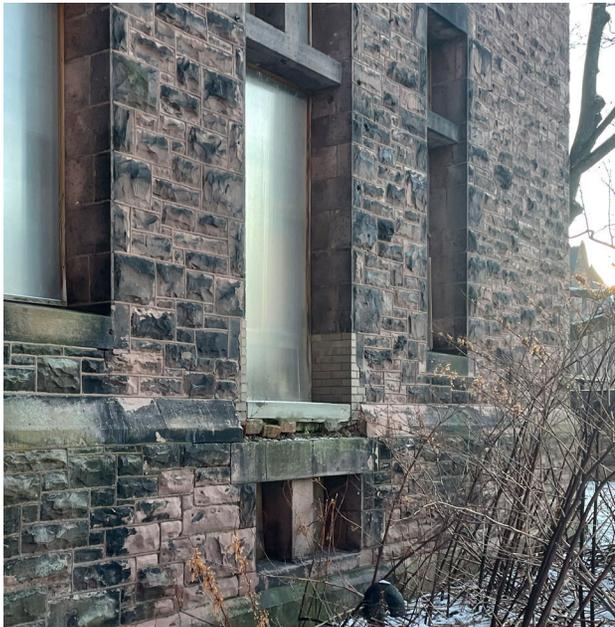
Detail of Deterioration of Mortar Joints

The mortar joints are generally sound. Deterioration is noted in locations where ongoing water infiltration and saturation is occurring. Buff colored and red mortar were evident, indicative of several repointing campaigns.

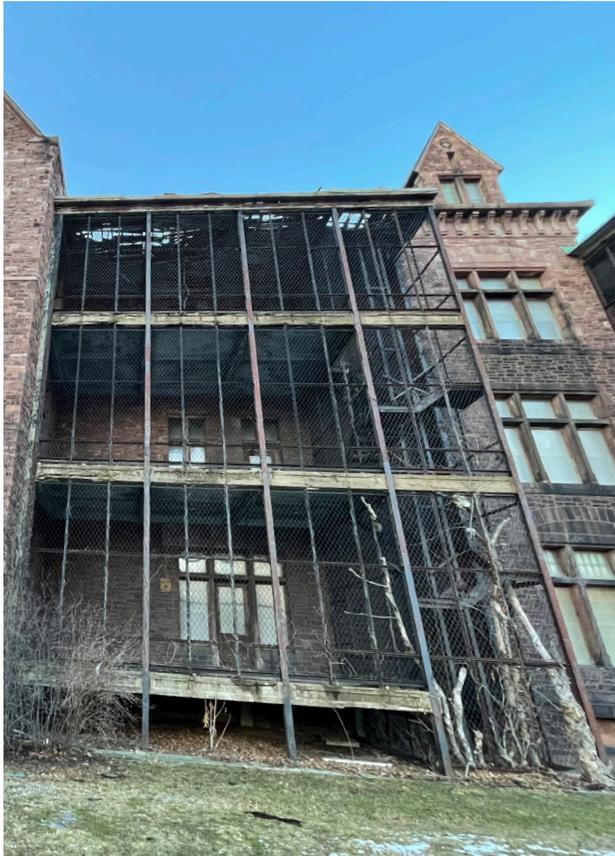
The porches on the east and west sides of the south elevation are in poor condition. The concrete is spalling, and the steel is rusting. The roof of the porches have deteriorated, and water is infiltrating the building at the flashing.

Porches on the West Side of the South Elevation

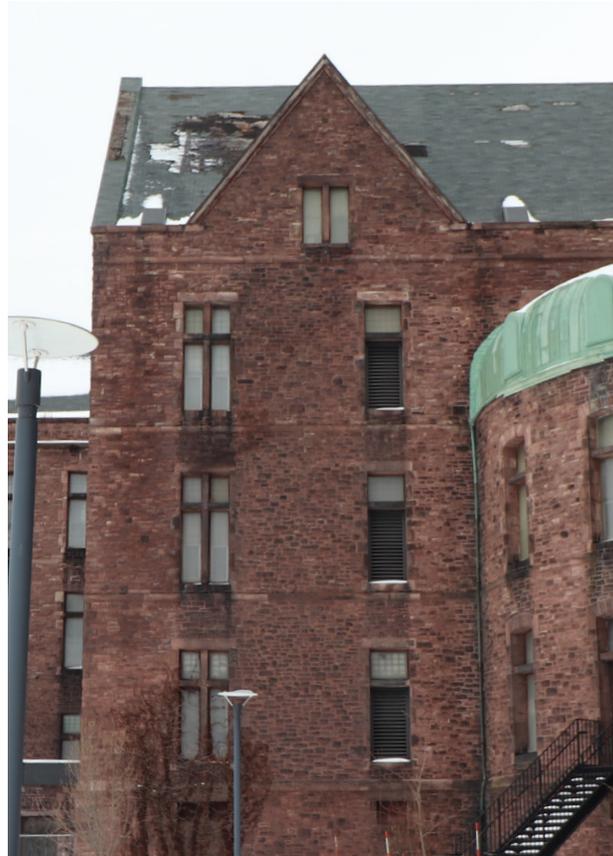
The roof is covered in asphalt 3 tab shingles. The roof is deteriorated with open holes and missing shingles at east, west, and center wings. The main portion of the roof was installed after 2002. The gutters are built into the stone parapet wall. The gable rake is covered with asphalt shingles. The gable rake has a wood trim on the face.

Roof Damage on West Elevation

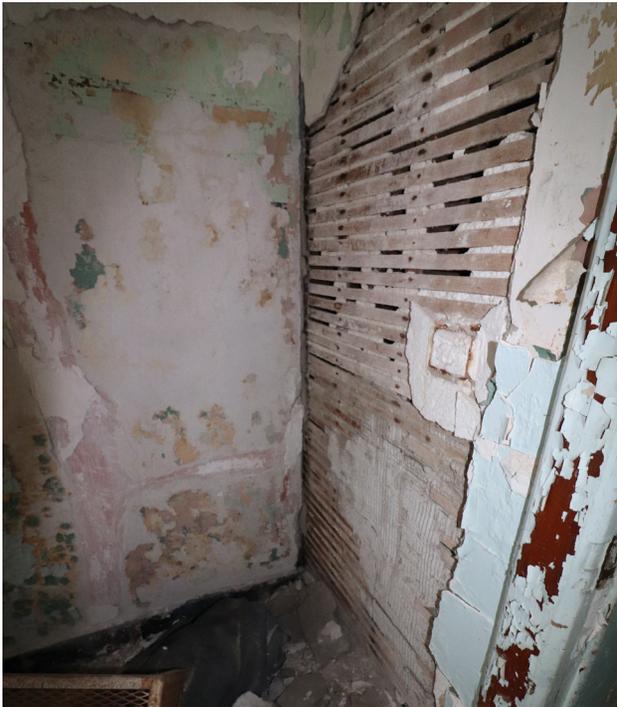
Deteriorated Plaster on Third Floor Wall

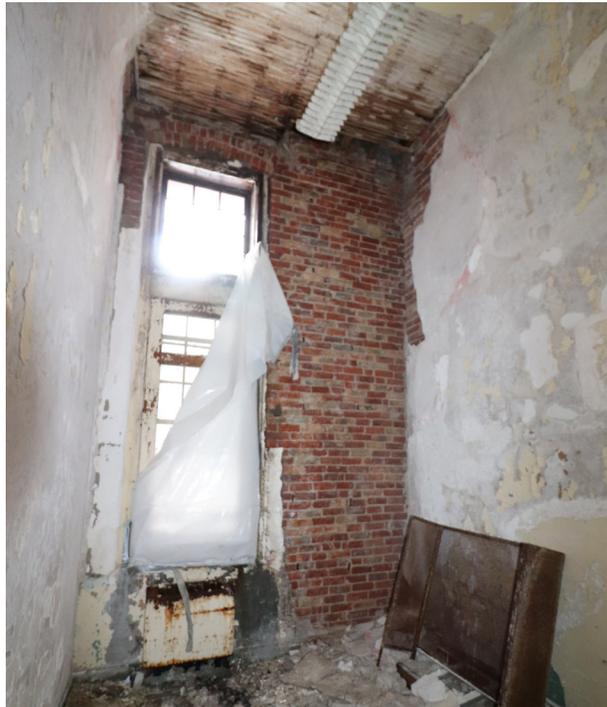
Deteriorated Plaster on Third Floor Wall

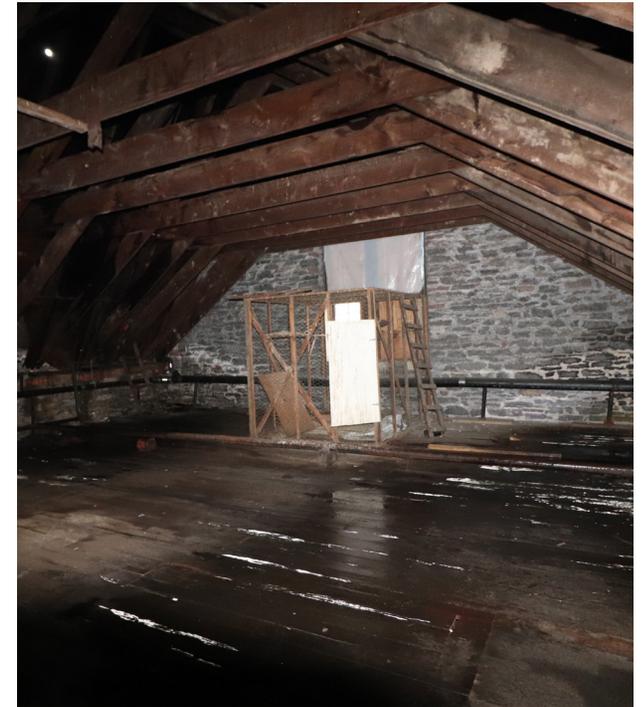
Water Infiltration Inside Attic

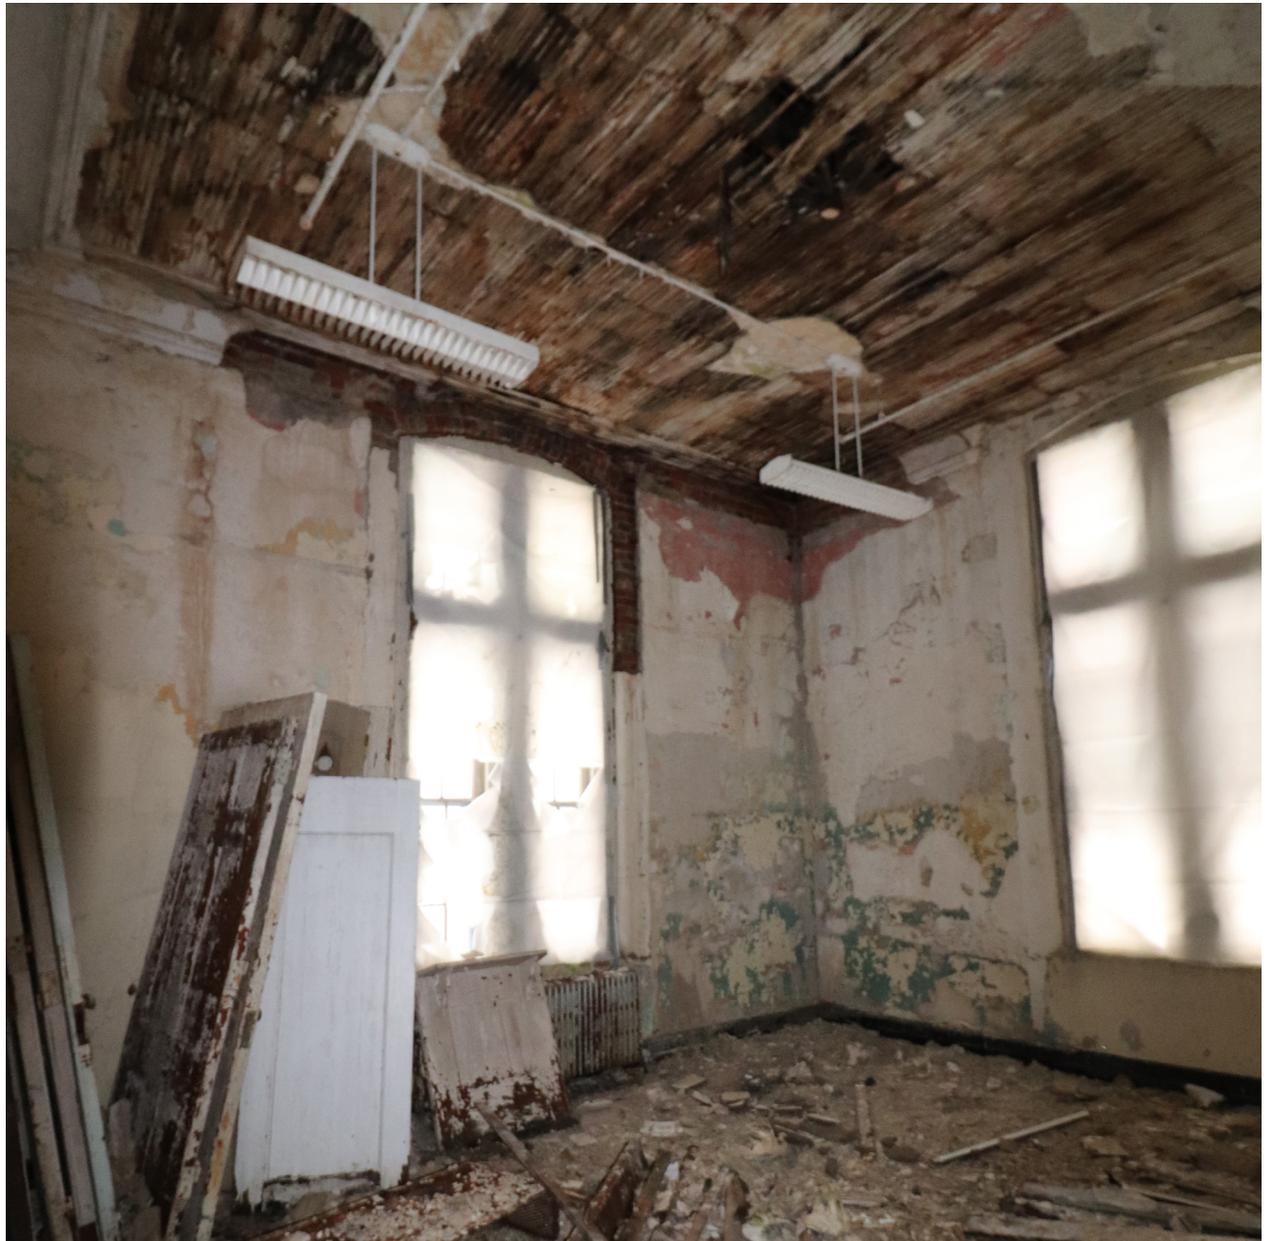
In general the structure of the building is in fair condition. The exterior and interior bearing walls appear to be in good condition. The floor structure and ceiling structure have failed in locations where there is significant water infiltration due to holes in the roof and failing internal downspouts. The roof framing in the main block was repaired in early 2000s as noted in the 2008 HSR. Several holes were observed in the roof decking at the east, west, and central wings. Water continues to infiltrate the building at these locations. Infiltration was observed in the east, west, and central wings. Water damage was observed on the attic floors, and where the purlins bear in pockets, and at sheathing abutting gable end walls.

Deteriorated Ceiling Plaster on Third Floor

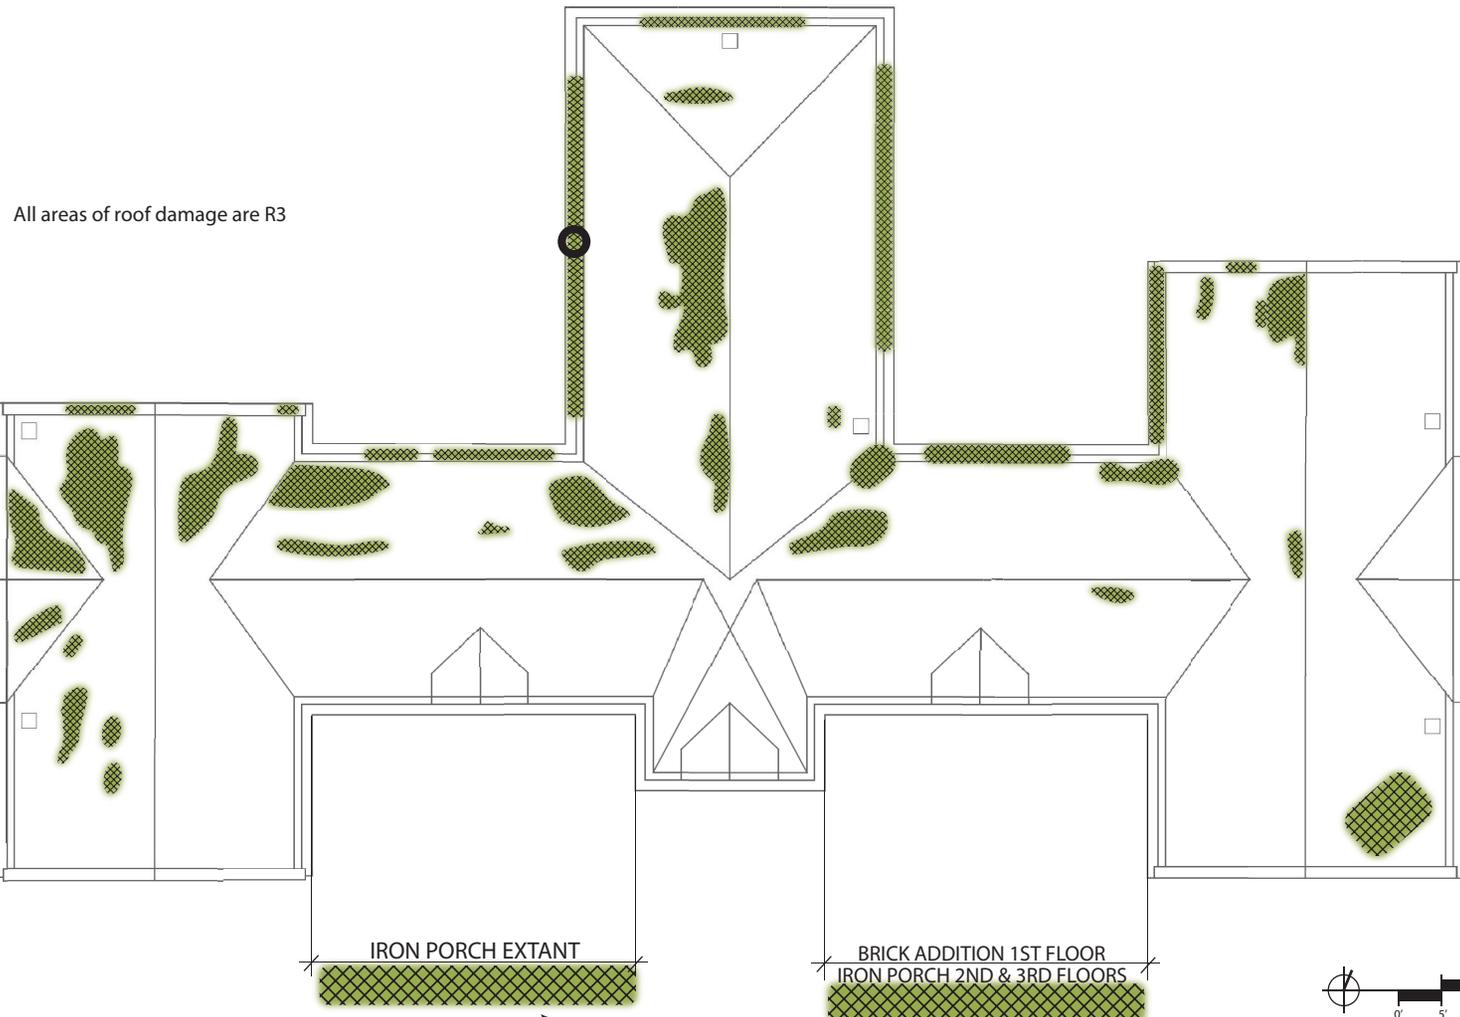
All areas of roof damage are R3

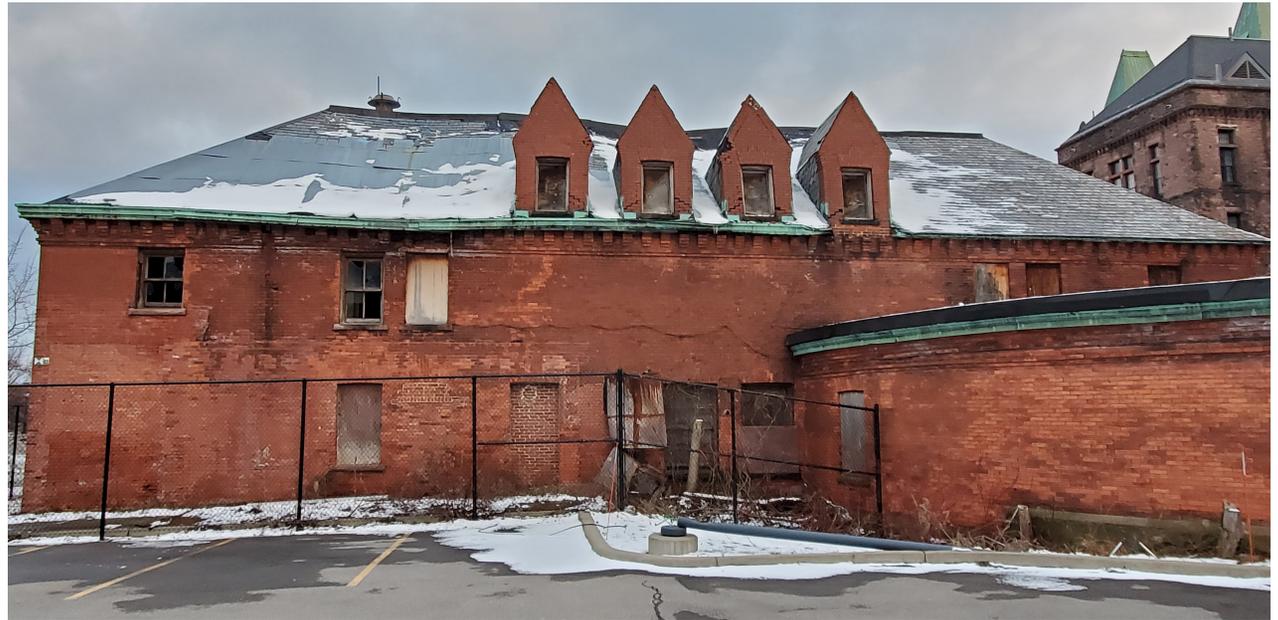
The building is severely deteriorated, with failures noted at the roof, which is on the verge of collapse, and at the masonry walls. The interior of the building was not accessible due to the building's structural instability.

West Elevation of Female Kitchen (Building 43)

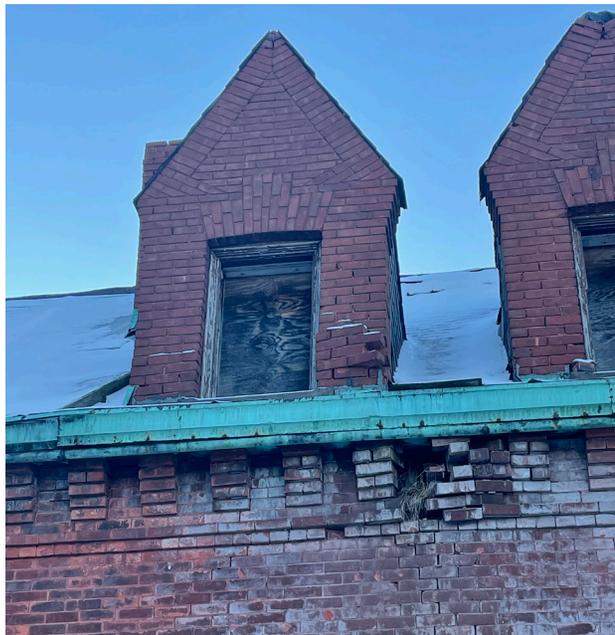
The brick masonry is in poor condition due to the continual water saturation through holes in the roof and failing gutters and missing downspouts. The brick is displaced in a number of locations, step cracking at brick joints, and areas where the wall is bulging were observed. There has been no maintenance or stabilization work at Building 43. Extensive spalling is noted and the majority of the mortar joints are deteriorated. Efflorescence is visible in areas of continued water infiltration.

East Elevation Dormer Failing Masonry Detail

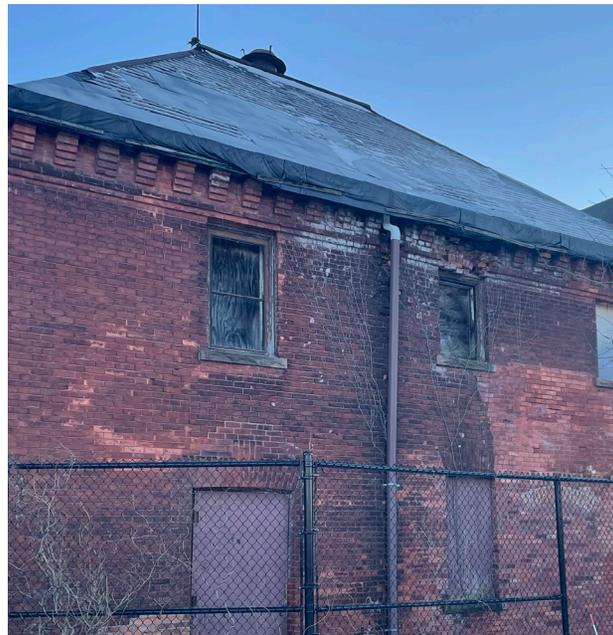
The original slate roof and, copper gutter and flashing are failing. The slate is missing in a number of areas and holes are observed in numerous locations at the roof. The roof is sagging and failing due to compromised structural members. The dormers are in danger of imminent collapse. There are holes, cracks, and missing sections at the copper gutters. The downspouts are missing resulting in water falling directly on the masonry surface.

North Elevation Roof Damage and Deteriorated and Failing Masonry

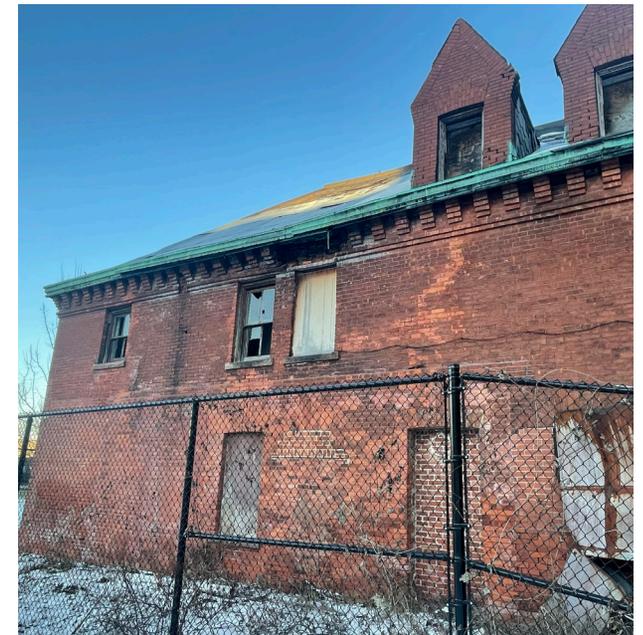
West Elevation Roof Damage and Deteriorated and Failing Masonry

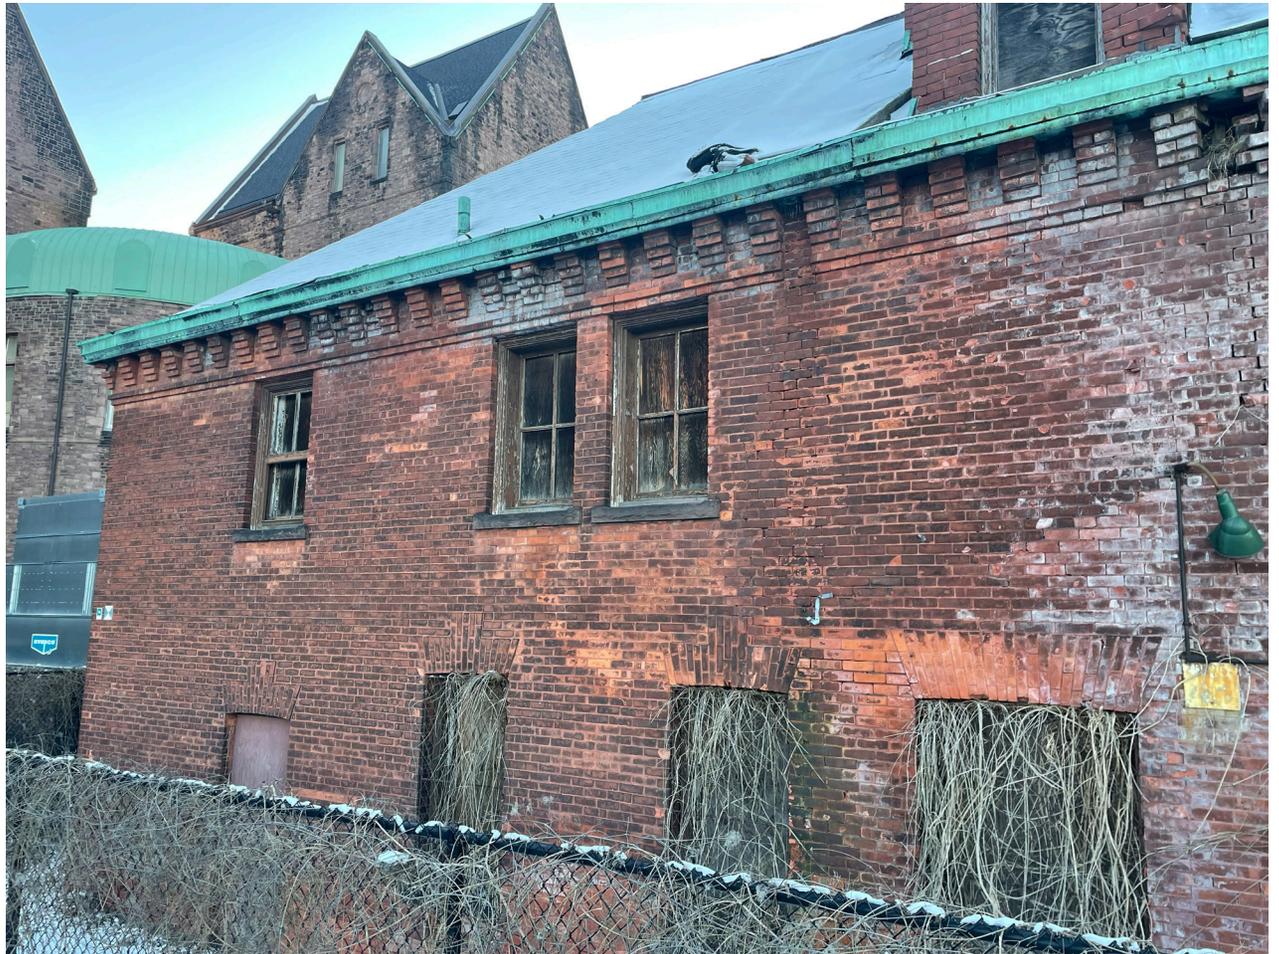
The structure of Building 43 is severely compromised. The roof and attic framing members are deteriorated and failing. Although not accessible, given the condition of the roof and continuous water infiltration it can be assumed that interior framing and structural members are also failing. Without immediate stabilization, including shoring/bracing to support the masonry walls and roof it is probable that the building will fail and collapse.

East Elevation Roof Damage and Deteriorated and Failing Masonry. Note Extant Four-Light Wood Sash.

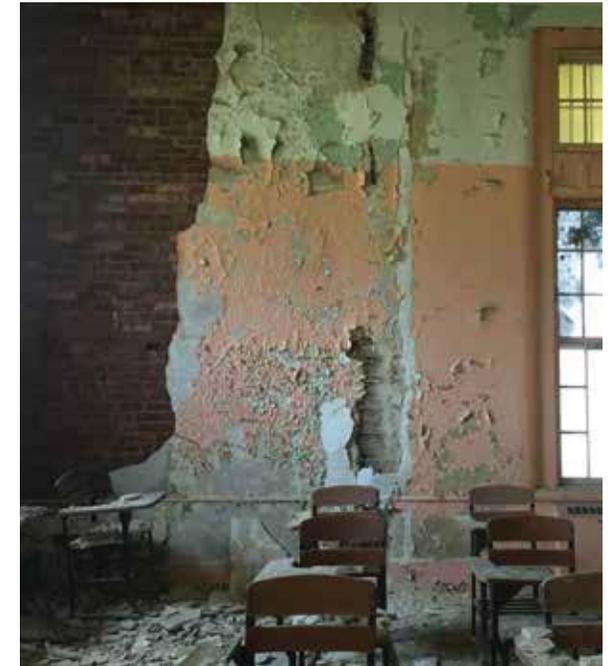
The majority of visible interior finish damage is limited to the paint or the finish plaster coat. The significant damage occurs around broken internal downspouts and areas of previous water infiltration.

Fig. 3-12: Room 28, First Floor. Typical interior damage from broken downspout (CJSA 2019)

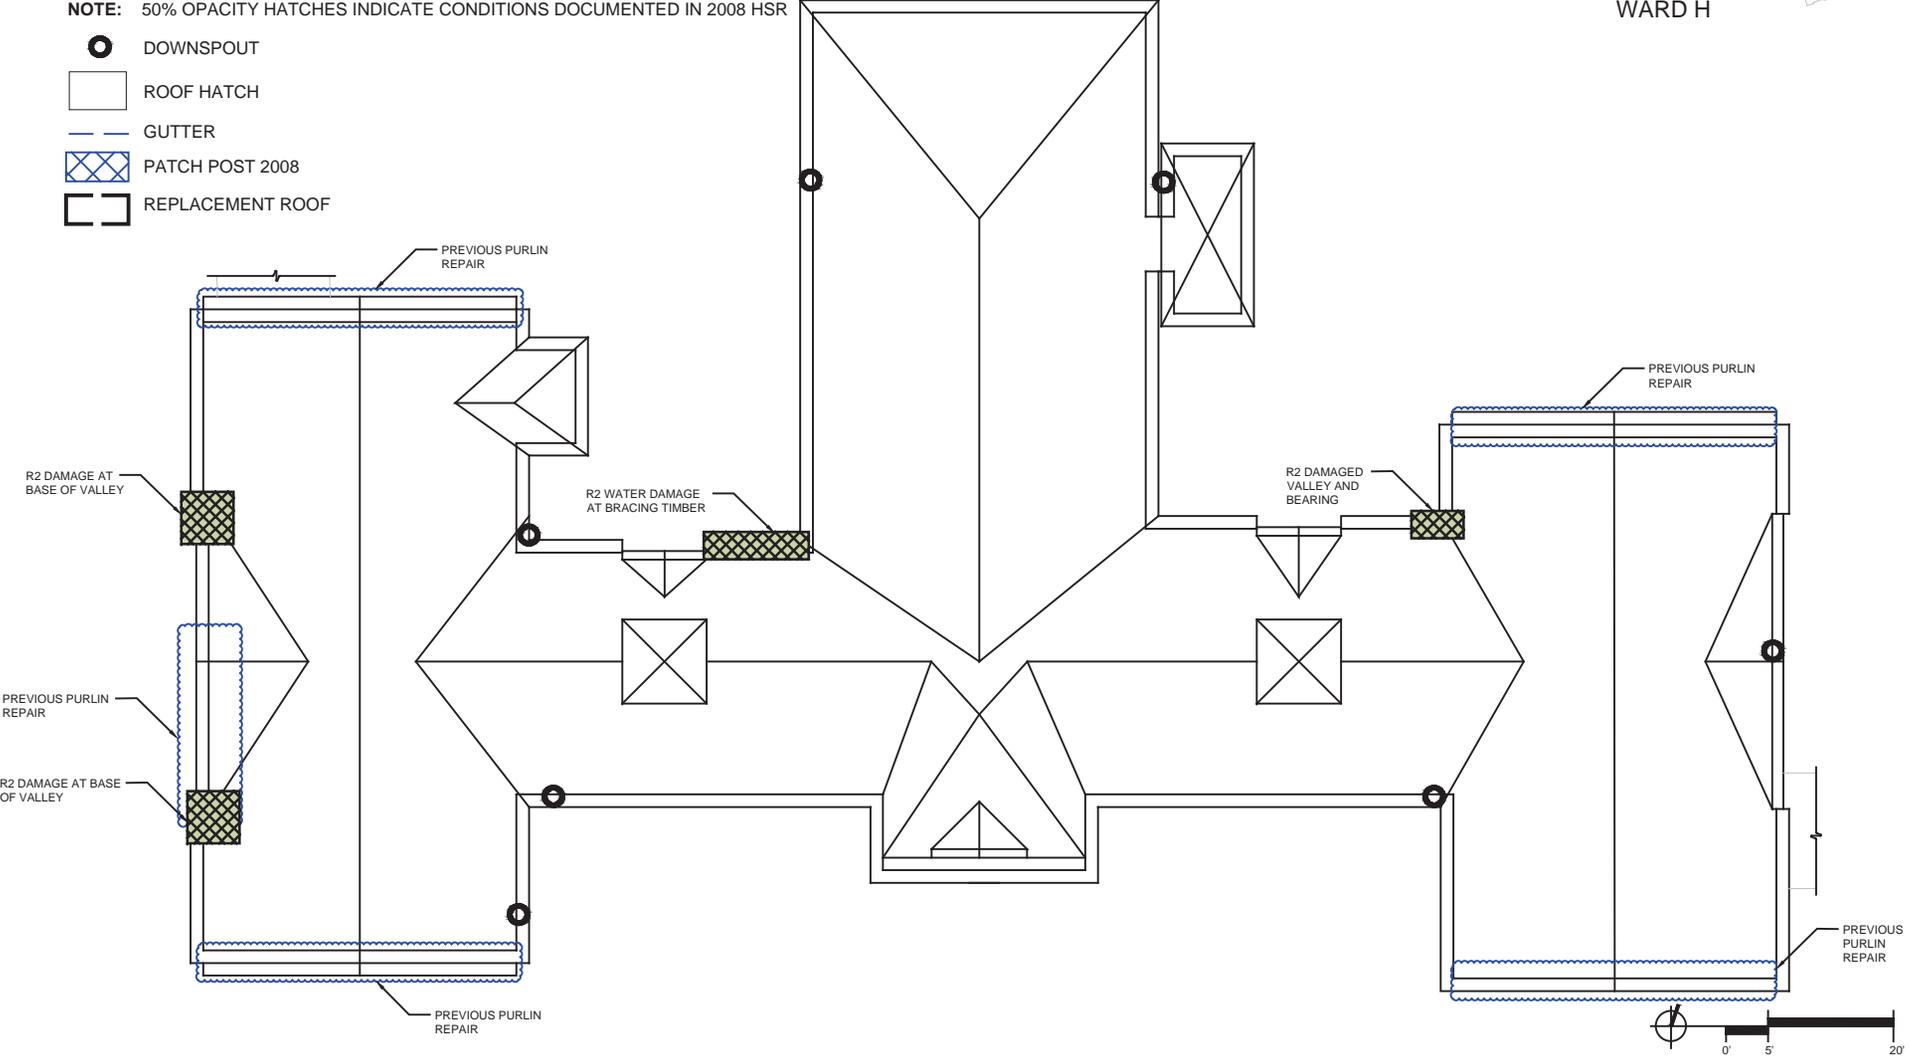
BUILDING 40 (FEMALE WARD H)
 ROOF PLAN

NOTE: CONDITION OF SHINGLES AND GUTTERS NOT SURVEYED AS PART OF THIS PROJECT. REFER TO CONTRACTOR'S REPORT.
 LAYOUT AND TRUSS CONFIGURATION IS SIMILAR TO FEMALE WARD I.
 ENTIRE SLATE ROOF WAS REPLACED WITH ASPHALT PRE-2019.

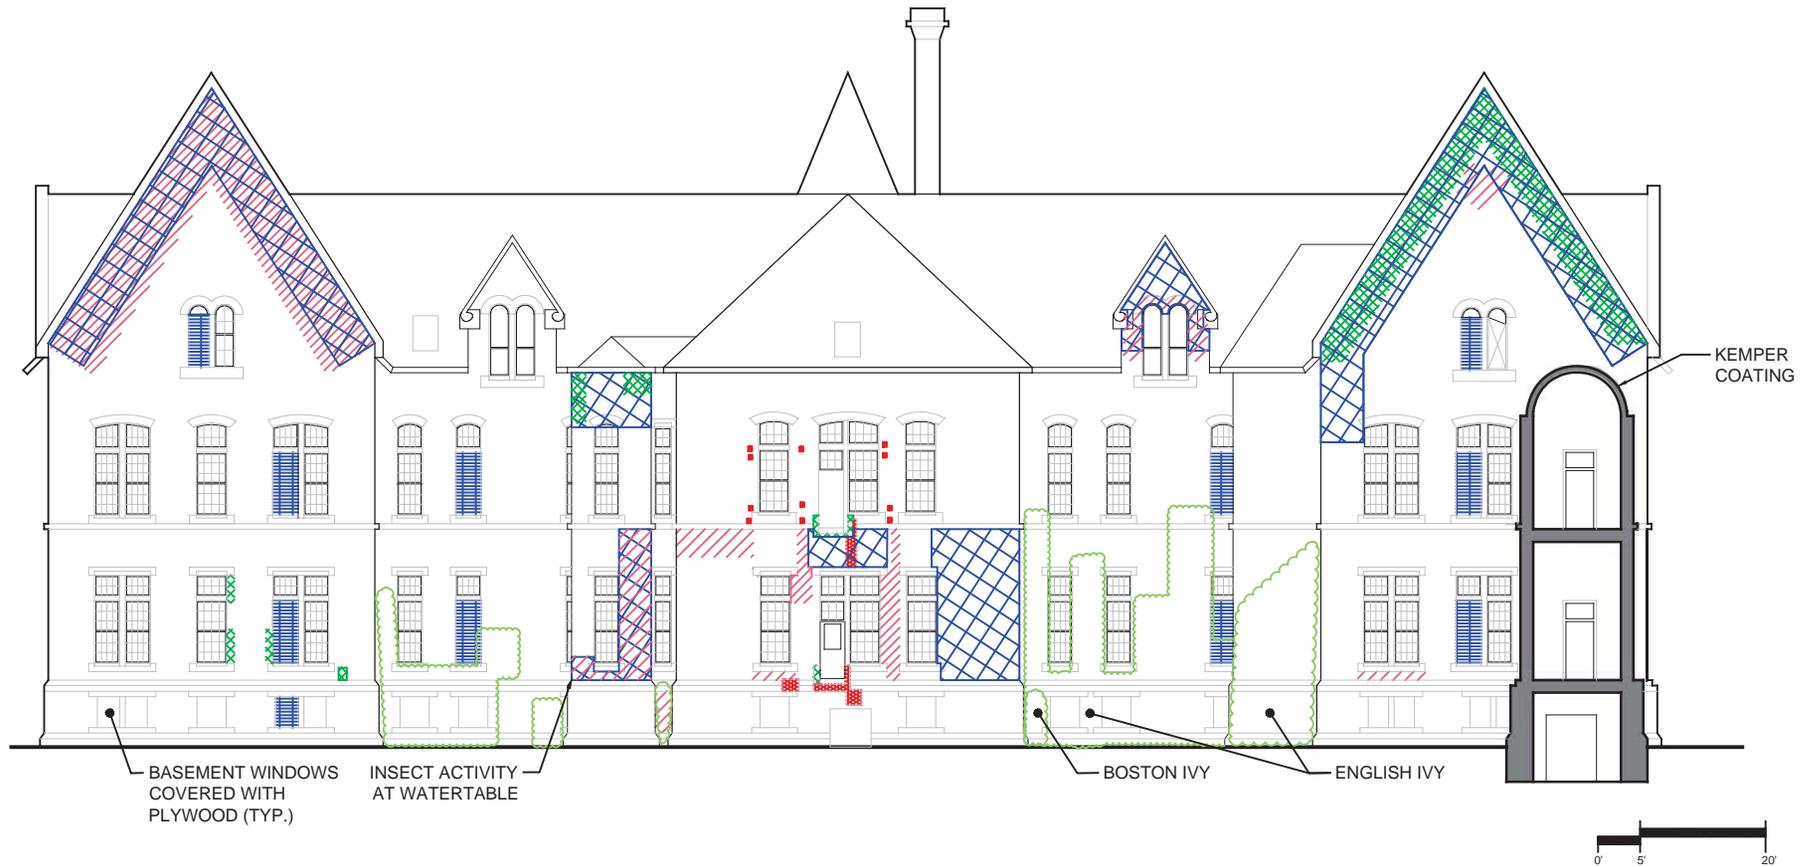
BUILDING 40 (FEMALE WARD H)
NORTH ELEVATION

- 20% SPALLING
- 70% STAINING
- 60% MORTAR EROSION
- 1% MISSING WINDOW PROTECTION

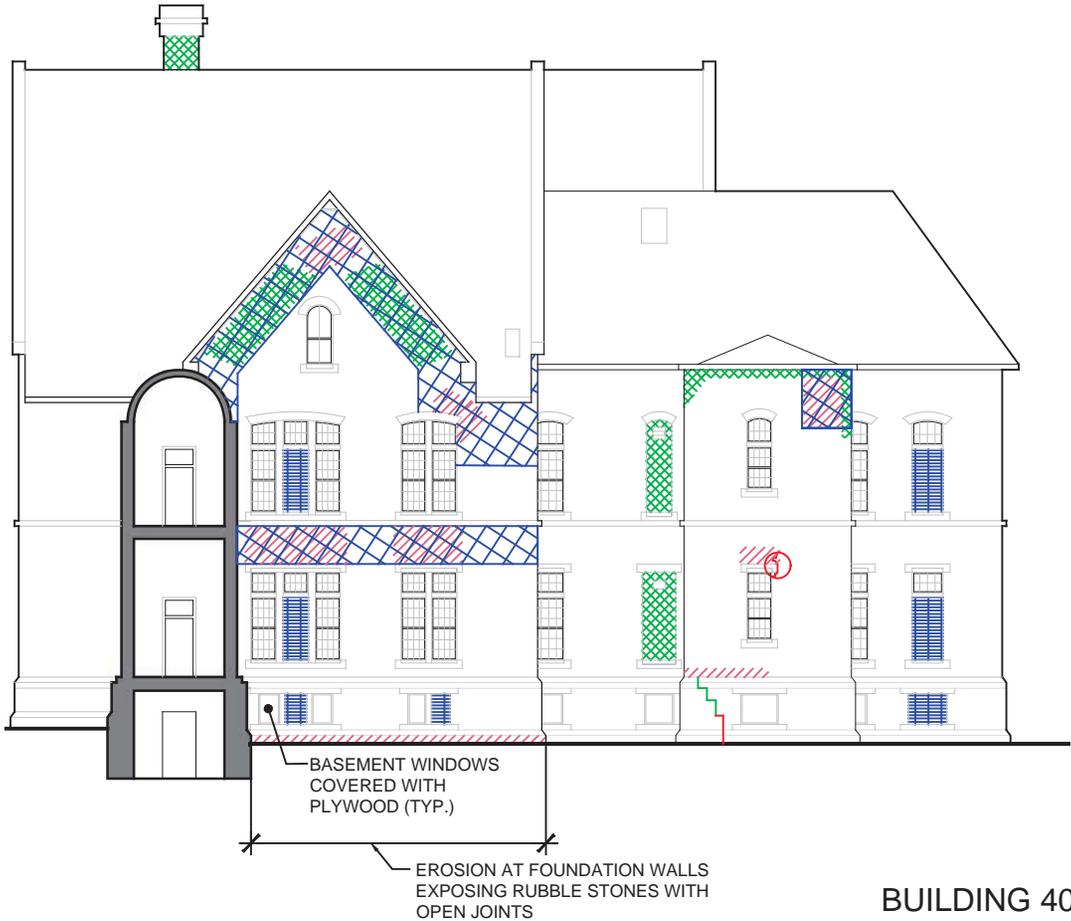
BUILDING 40 (FEMALE WARD H)
EAST ELEVATION

- 15% SPALLING
- 50% STAINING
- 10% MORTAR EROSION
- 0% MISSING WINDOW PROTECTION

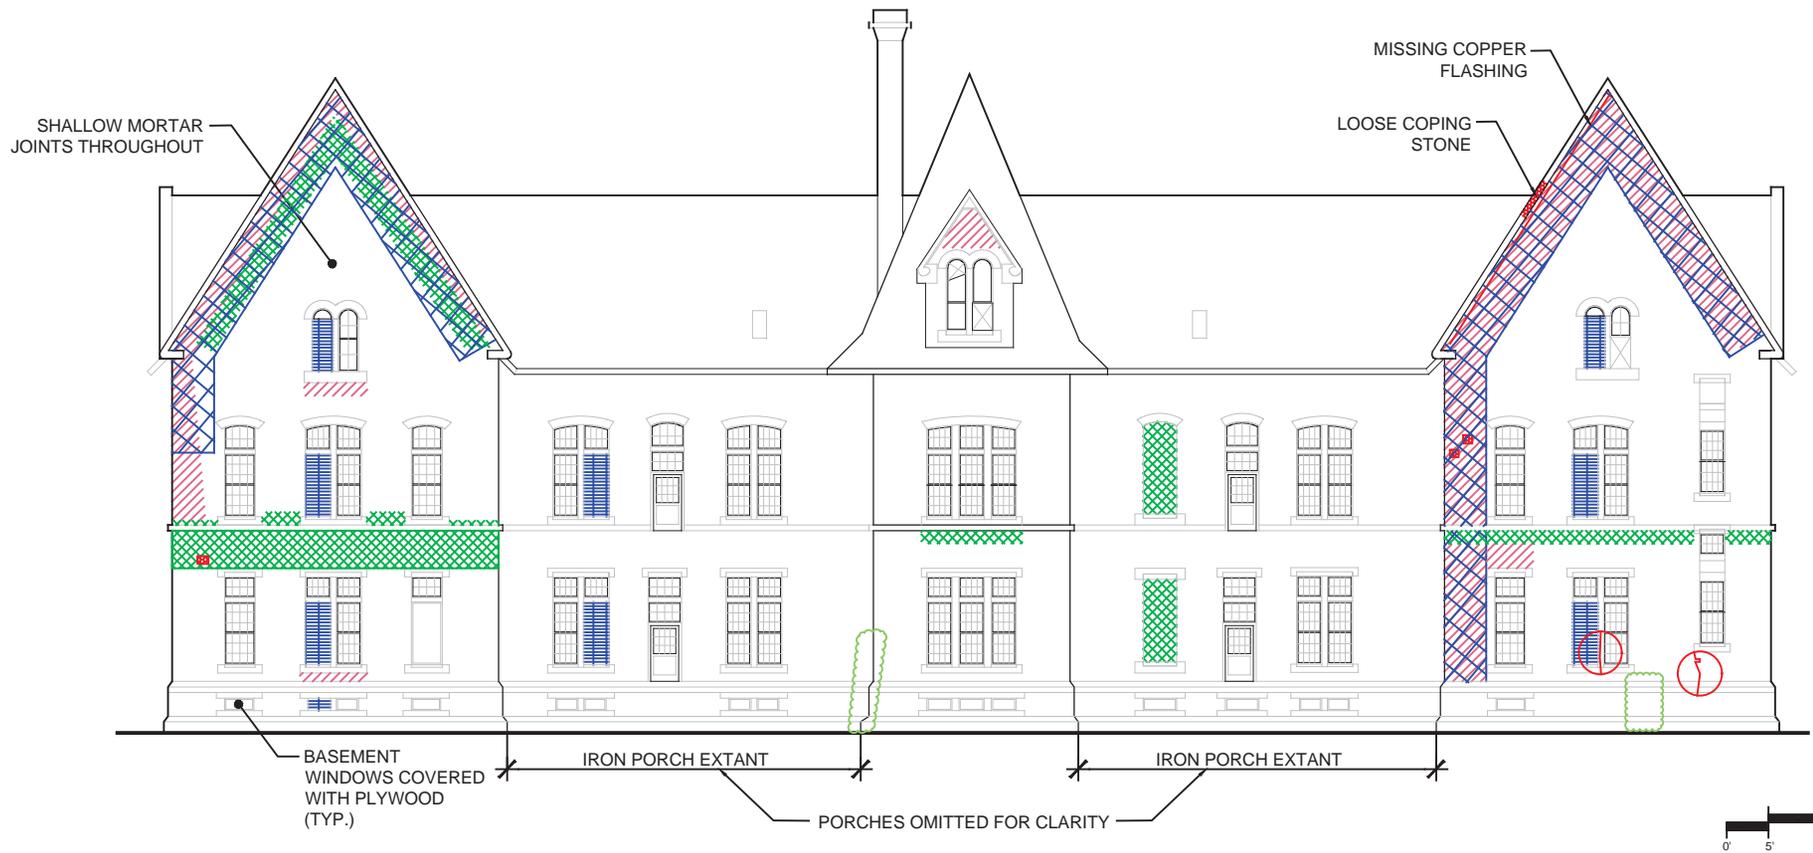
BUILDING 40 (FEMALE WARD H)
SOUTH ELEVATION

- 25% SPALLING
- 50% STAINING
- 55% MORTAR EROSION
- 12% MISSING WINDOW PROTECTION

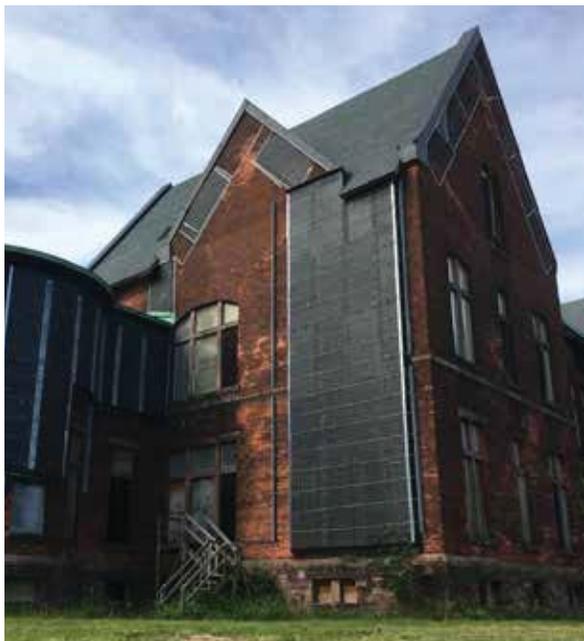
Fig. 3-22: East Elevation with stabilization and masonry spalling (CJSA 2019)

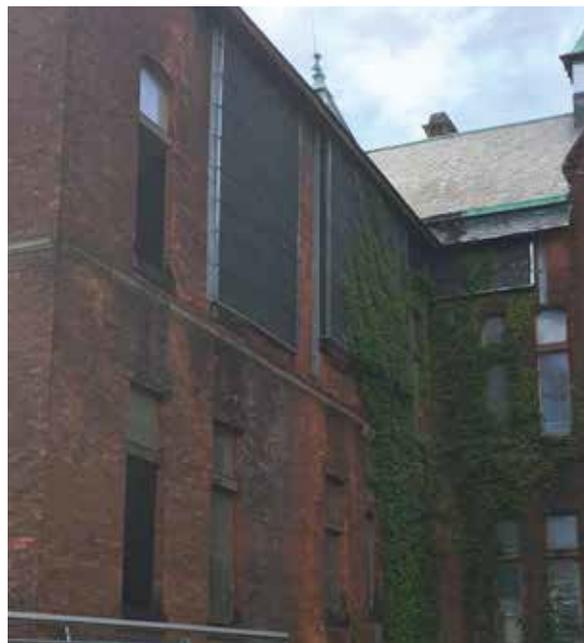
Fig. 3-23: West Elevation corner with stabilization and ivy growth (CJSA 2019)

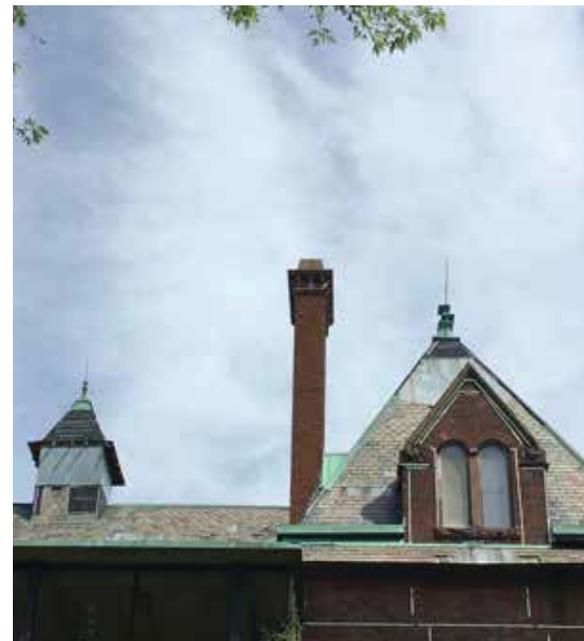
Fig. 3-24: Slate roof with metal patches (CJSA 2019)

The original slate roof and some character defining features still survive on the building. In 2008, the roof was observed to be failing in many locations. While large areas of the roof have been patched with metal sheets, the

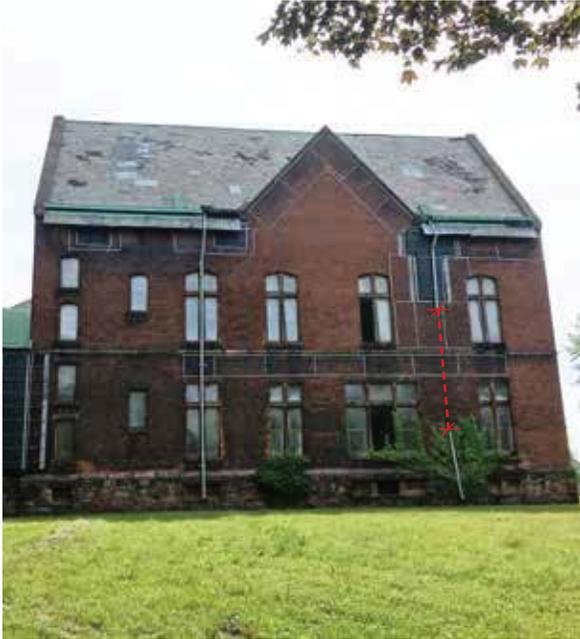
Fig. 3-25: West Elevation, note missing portion of modern downspout (CJSA 2019)

onto the ground, eroding the ground and exposing the foundation stone. On the north and west elevations, new external downspouts were attached to the Yankee gutters and drain out onto the ground below. However, one downspout on the west elevation is missing its middle portion and hangs in place, shedding water onto the brick wall below. On the south elevation, Yankee gutters are still present on the slate roof.

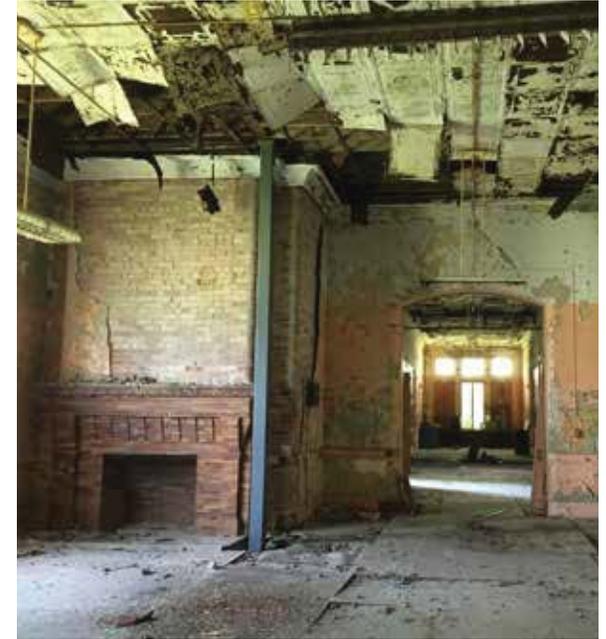
Fig. 3-27: Stabilization in room 30, first floor (CJSA 2019)

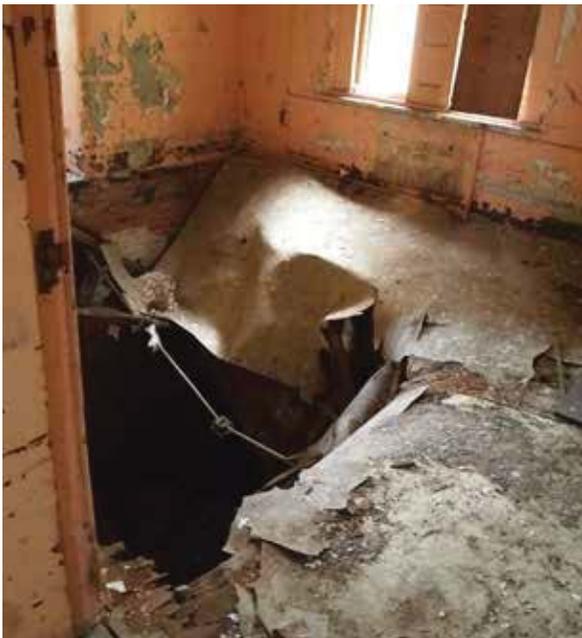
Fig. 3-28: Floor collapse in Room 7, first floor (CJSA 2019)

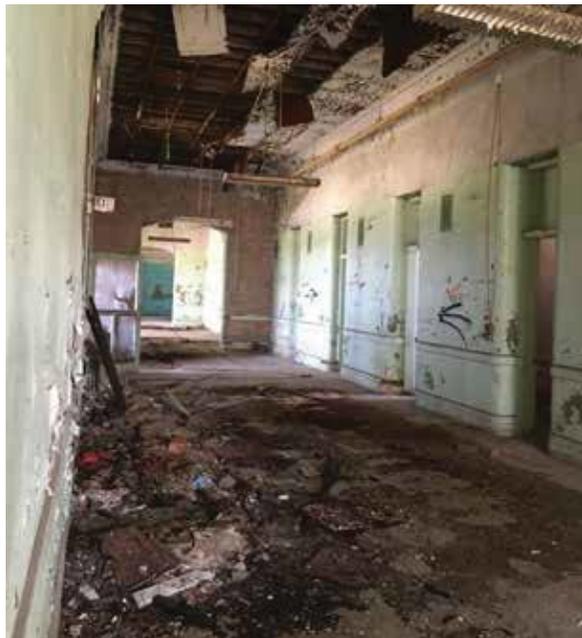
Fig. 3-29: Floor and ceiling damage, second floor hallway looking west (CJSA 2019)

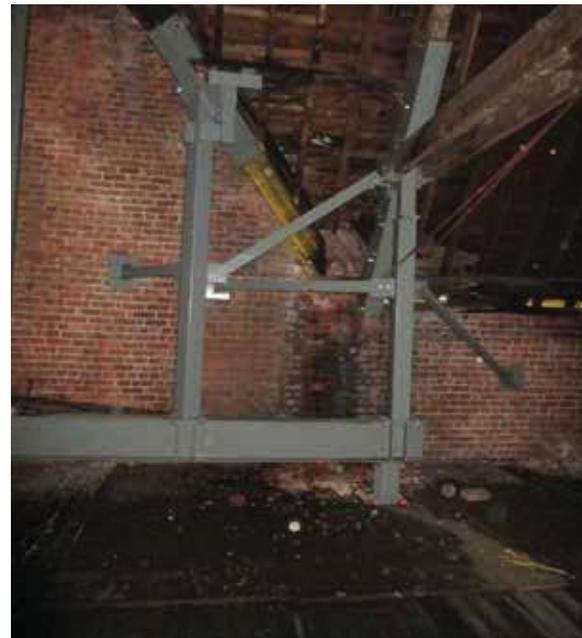
Fig. 3-30: Floor and wall damage and steel stabilization in attic (SGH 2019)

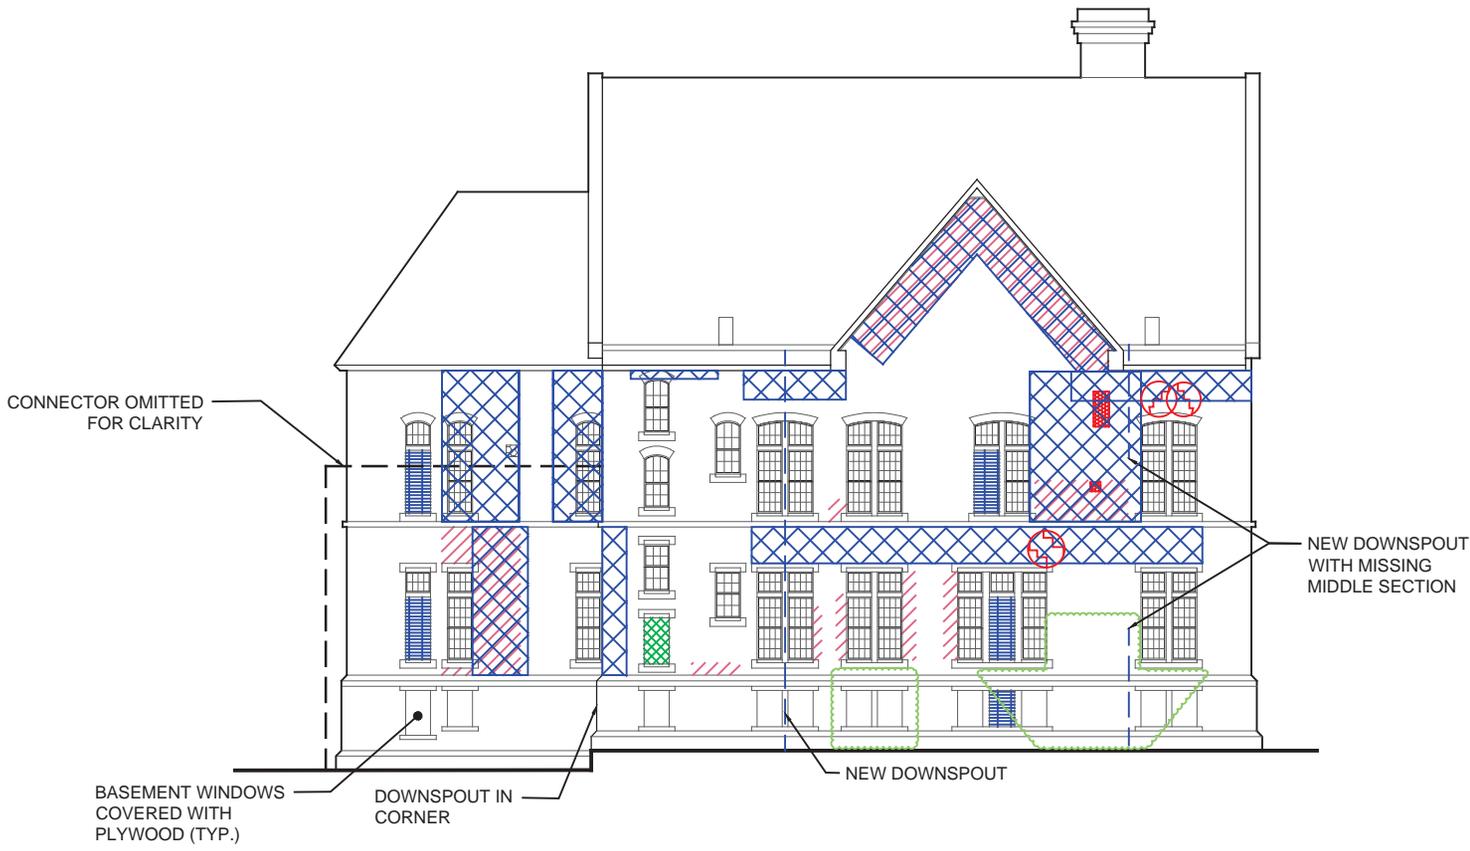
BUILDING 39 (FEMALE WARD I)
WEST ELEVATION

- 10% SPALLING
- 15% STAINING
- 55% MORTAR EROSION
- 0% MISSING WINDOW PROTECTION

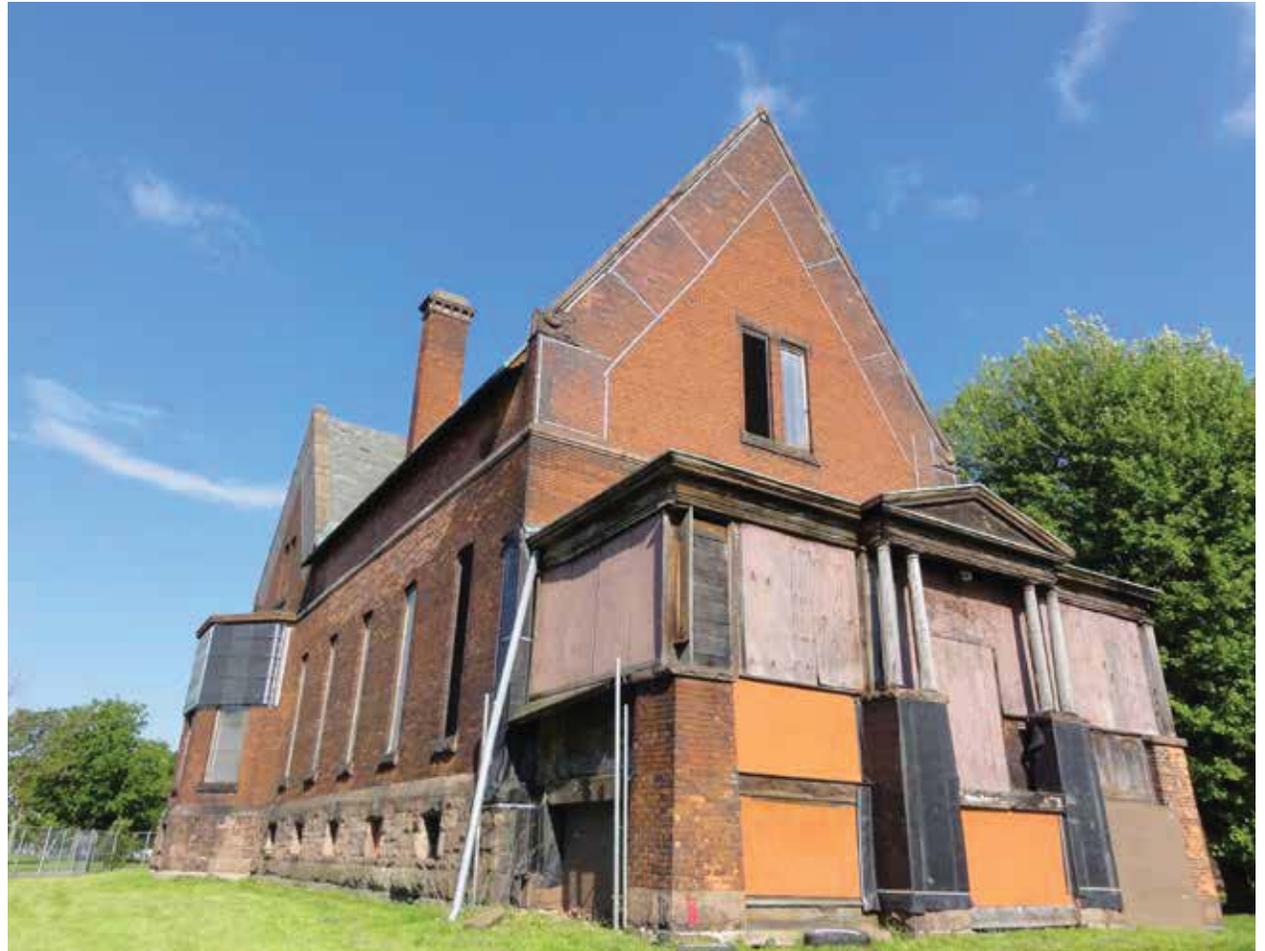
Fig. 3-33: Northwest corner and failing wooden porch (SGH 2019)

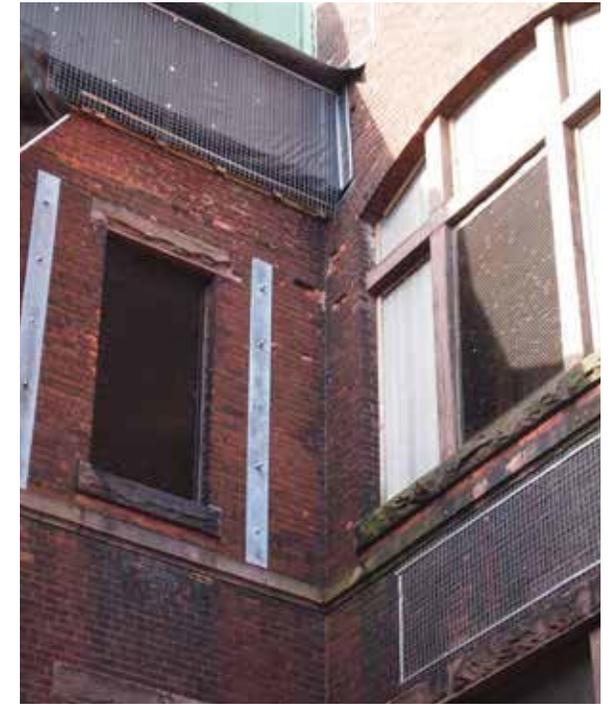
Fig. 3-57: Corner masonry loss (CJSA 2019).
