HISTORIC STRUCTURES REPORT

the RICHARDSON OLMSTED COMPLEX *Buffalo, NY*

July 2008

GOODY
CLANCY

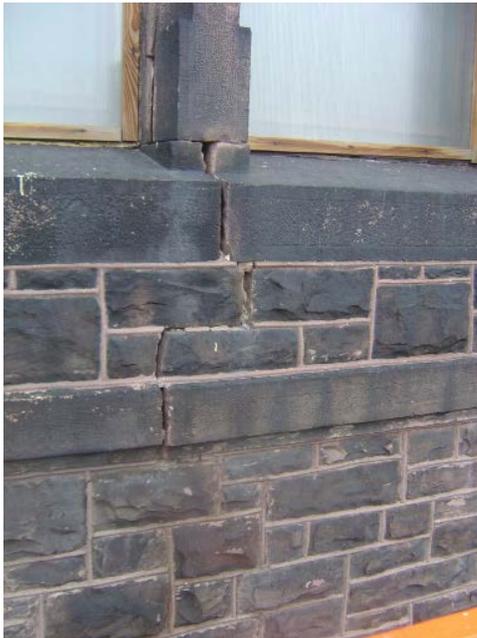
Fig. EX.14 Step crack through mortar joints in stone facade

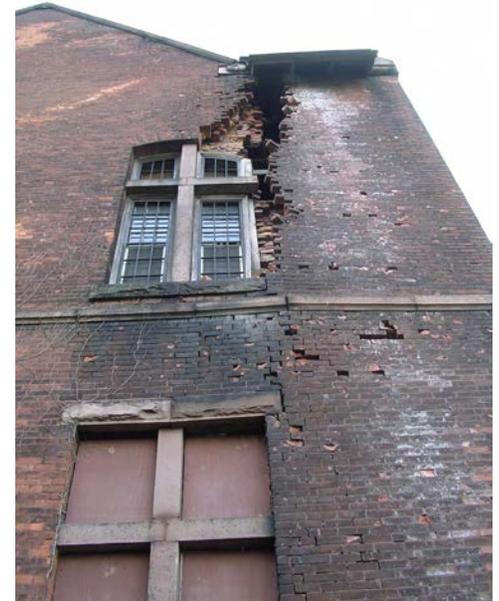
Fig. EX.15 **Brick failure at north elevation in Female Ward I**
Image courtesy GCA

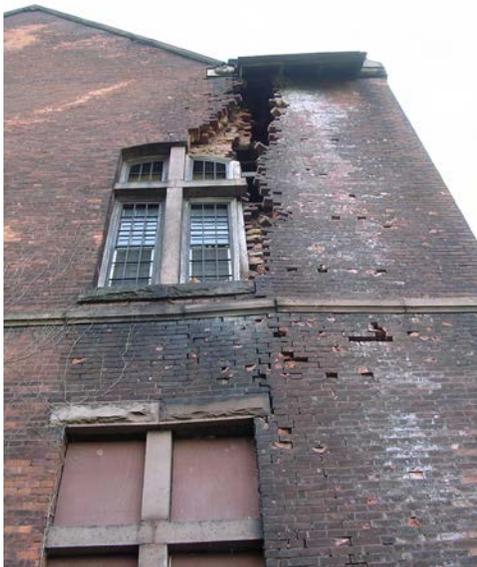
Fig B.60 Severe water damage in Female Ward H
Image courtesy GCA

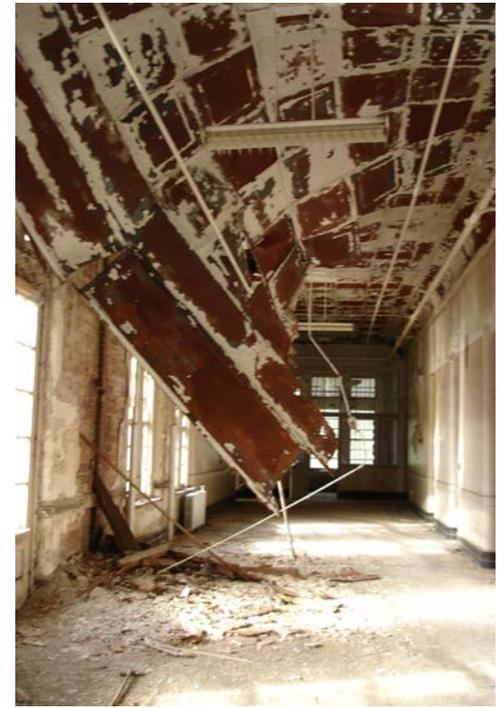
Fig B.64 Severe ceiling damage in Female Ward F
Image courtesy GCA

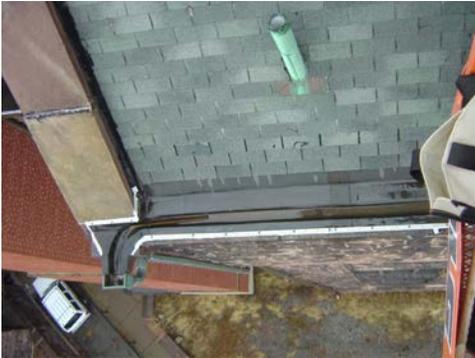
Much of the original copper flashing and gutters were retained in place. This is the only building on the complex designed to have external downspouts. The downspout locations and configurations are evident from early photographs. The gutters have been coated multiple times with various bituminous and sheet membrane materials to seal leaks. (Fig. AB.11)

Fig. AB.11 **Stone scupper, downspout and copper gutter coated with plastic membrane**
Image courtesy GCA

The gutters have been lined with sheet membrane and do not appear to have any current leaks or cracks. The copper step flashing and valley flashing is in poor condition with streaking associated with imminent failure. (Fig. AB.11)

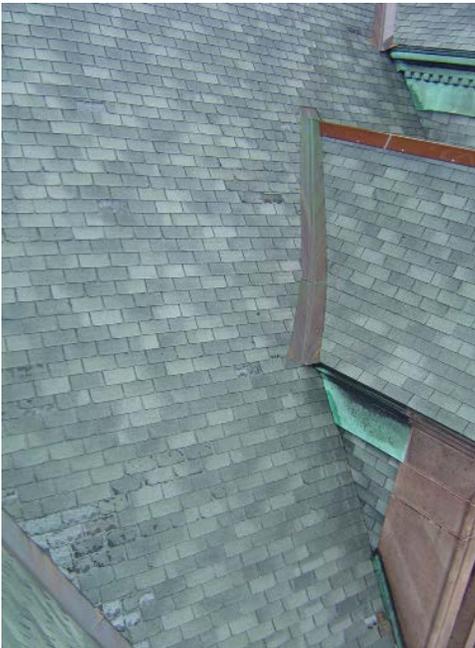
Fig. AB.14 **Asphalt roof - deteriorating condition**
Image courtesy GCA

The existing asphalt roof is in fair to poor condition. Although there are no obvious signs of water infiltration directly related to the roof, the asphalt is deteriorating. (Fig. AB.14)

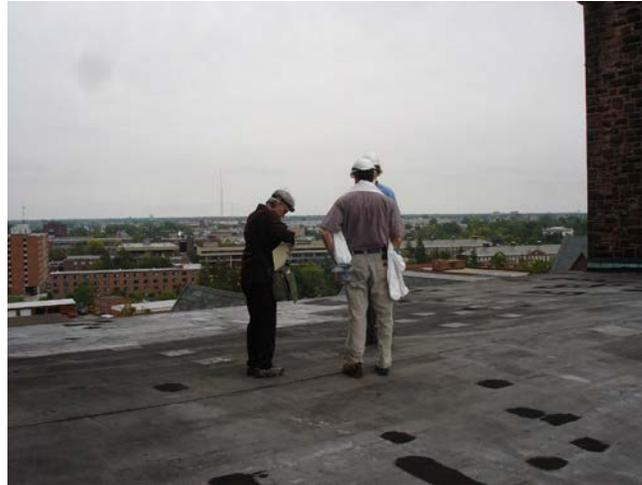
The flat roof between the towers is currently covered with sheet roofing membrane. The original flat roofing material was most likely sheet metal (either copper or tin). (Fig. AB.12)

Fig. AB.12 **Connector roof between towers**
Image courtesy GCA

The sheet roofing membrane flat roof is in poor condition and was recently repaired by the Richardson Center Corporation. These repairs appear to have stopped the leaking to the interior of the building.

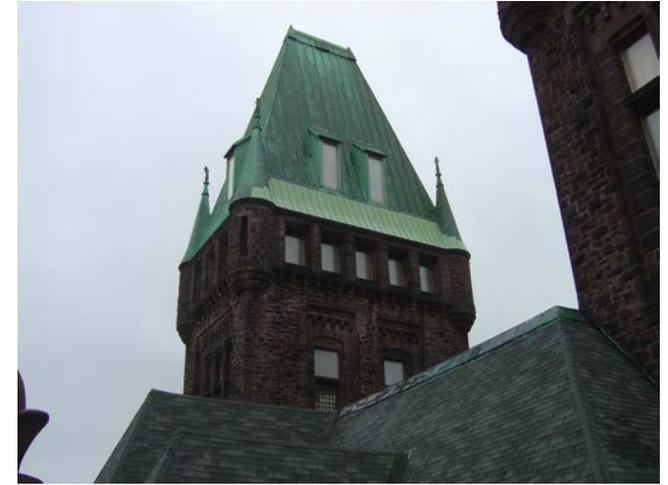
Fig. AB.13 **Copper tower roof**
Image courtesy GCA

The copper cladding on the pyramidal and turret roofs is approximately 100 years old and is experiencing predictable deterioration patterns. Sheet copper is typically serviceable for 50-75 years, more when installed on such a steeply pitched roof. The copper on the roofs is nearing the end of the range. It does not appear to be leaking at this time and is still providing a solid weathertight barrier.

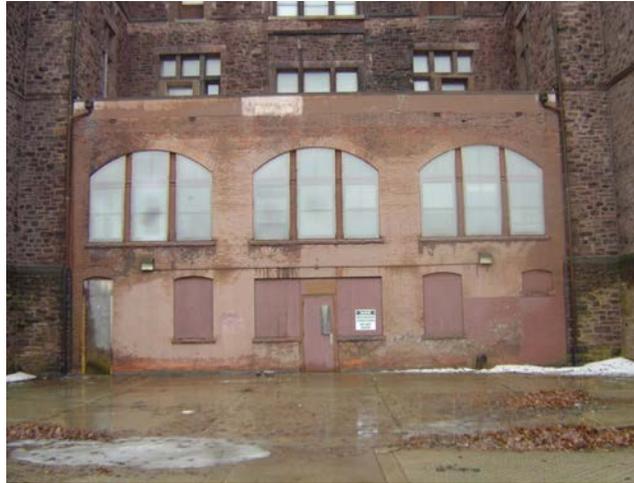
- A one story addition was added to the north elevation of the building in the early 1900's. The addition is brick painted brown, presumably in an attempt to have it blend in with the surrounding stone. (Fig. AB.15) There is physical evidence of a porch or enclosure from the first floor addition roof to the third floor. The porch or enclosure was removed. There is no date recorded regarding any of these changes. The alterations made to the elevation for the enclosure are:

Fig. AB.15 **North elevation first story addition**
Image courtesy GCA

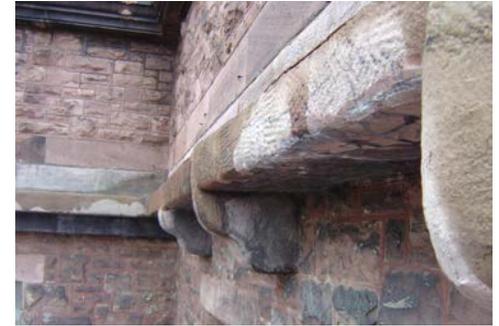
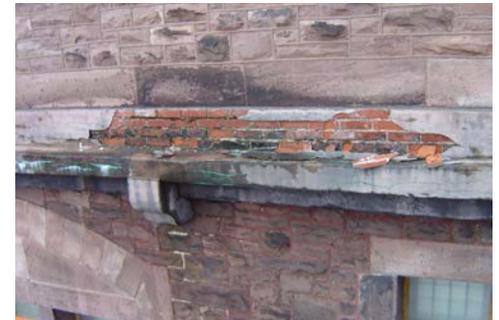
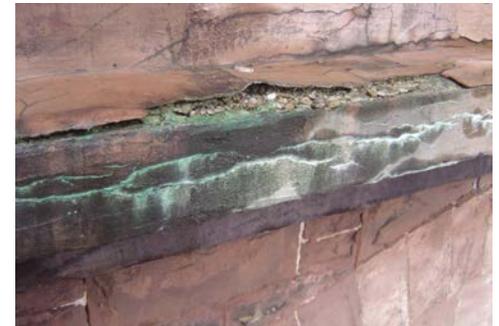
- The stone cornice above the third floor windows was encased in a plywood and stucco structure when the porch was constructed, or when it was removed. It appears to have encased the cornice stone modillions at this location, but they were only visible at the ends of the enclosure where the plywood was peeled away. The plywood and stucco enclosure is in poor condition and is deteriorating rapidly. (Figs. AB.16, 17 and 18) There are multiple birds' nests in the openings of the enclosure, and possibly bats living in the enclosure as well. (Fig. AB.19)
- The window openings on the second and third floors were modified to door openings. The infill around the openings is brick and visually inconsistent with the remainder of the elevation. (Fig. AB.20)

Fig. AB.16 **North elevation plywood and stucco cornice**
Image courtesy GCA

Fig. AB.17 **North elevation plywood and stucco cornice**
Image courtesy GCA

Fig. AB.18 **North elevation plywood and stucco cornice**
Image courtesy GCA

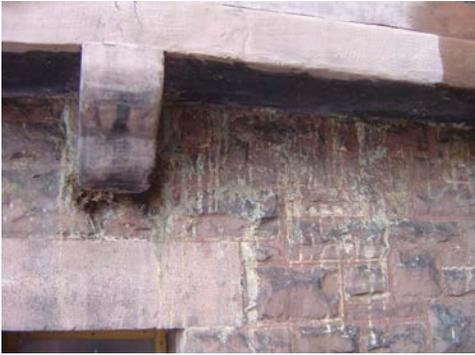
Fig. AB.19 **Bird or bat droppings below plywood/stucco cornice**
Image courtesy GCA

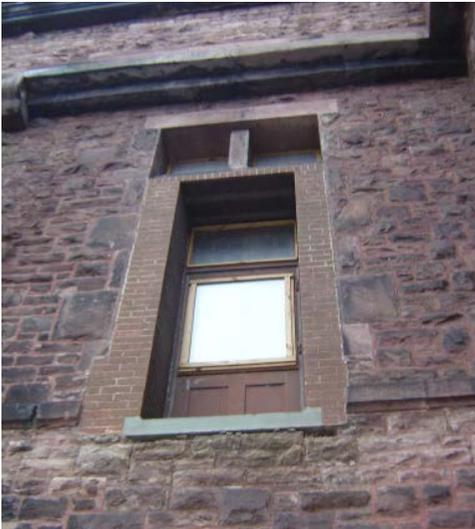
Fig. AB.20 **Window opening modified to door opening**
Image courtesy GCA

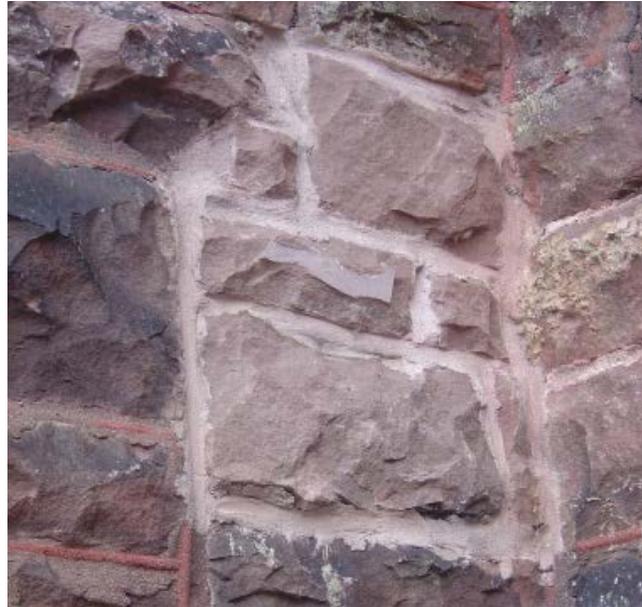
Fig. AB.21 **Stone infill at beam locations**
Image courtesy GCA

- There are several patches at the porch roof and third floor slab location where structural steel was once embedded in the stone wall. Some of the patching was done with Medina sandstone, some patching was done with brick and mortar. (Fig. AB.21)

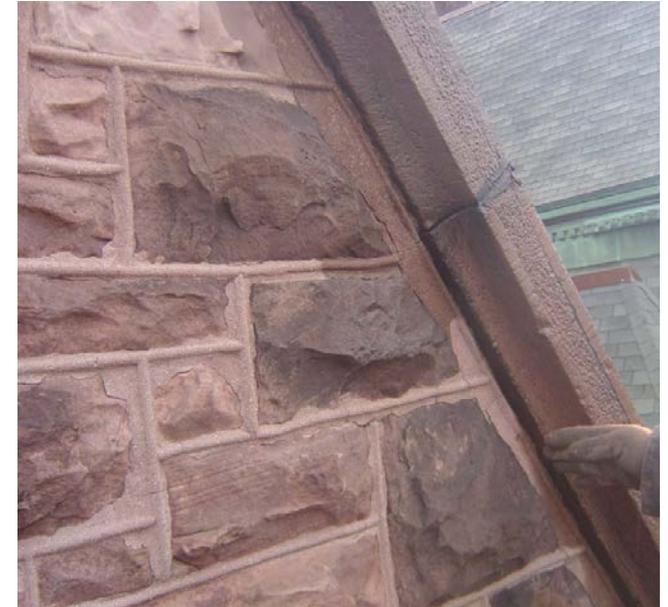
- **Dormer Gables:** The stones are shifting out of plane due to water infiltration under the stones and heaving during freeze/thaw conditions. (Fig. AB.22) Some of the gables have iron cramps that are helping to hold the stones in place. Other gables do not have cramps, or the cramps are rusting and no longer performing their intended function. (Fig. AB.23)

Fig. AB.22 **Lifted and displaced gable stones**
Image courtesy GCA

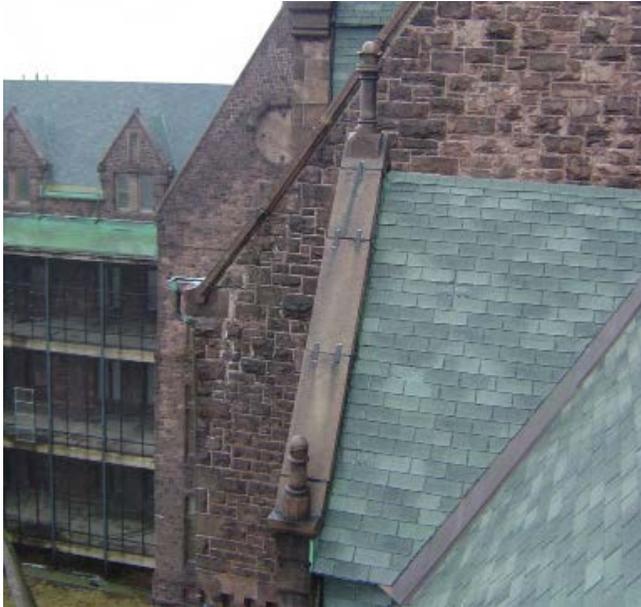
Fig. AB.23 **Iron cramps at dormer gable rake stones**
Image courtesy GCA

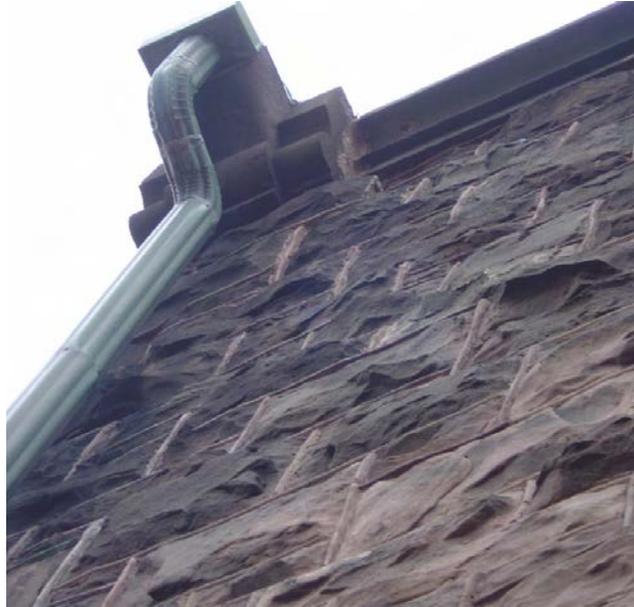
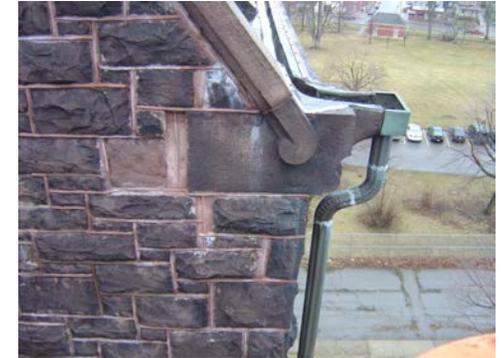
- **Building Corners:** There are locations around the building where the corner stones are shifting out of plane. This occurs in locations where water runoff has caused the mortar to wash out of the joints, and subsequent freeze/thaw action has continued to move the stones outward. (Figs. AB.24 and AB.25)

Fig. AB.24 **Shifted (and repaired) cornice stones**
Image courtesy GCA

Fig. AB.25 **Shifted (and repaired) cornice stones**
Image courtesy GCA

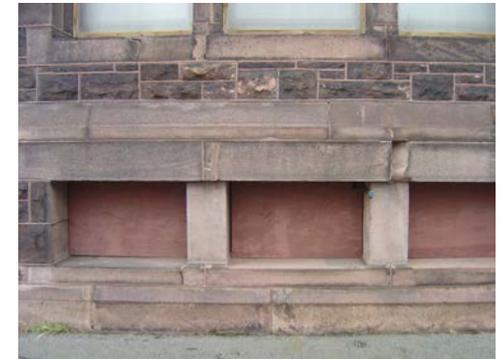
- **Surface Spalling:** Spalling of the surface of the stone occurs to varying degrees on the different elevations. The dirt coating bonds to the surface of the stone and forms a crust. This crust is brittle, expands and contracts at a different rate than the underlying stone, and can trap moisture below the surface.

Fig. AB.26 **Stone surface and unit spalling**
Image courtesy GCA

Ultimately, when moisture is trapped below the surface, it can lift the brittle crust, and a thin surface of the stone. When this happens, the underlying stone is exposed. The surface of the stone contains minor surface spalling (15%) on the south and east elevations with slightly more spalling (25%) on the north and west elevations. (Fig. AB.26)

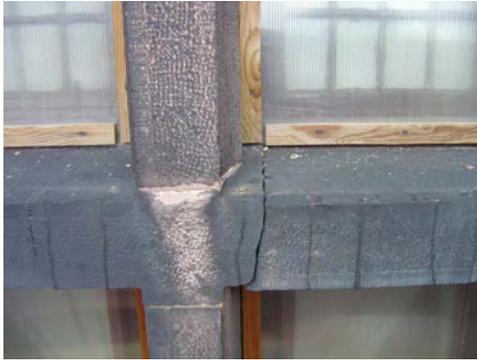
Fig. AB.27 Crack through stone with displacement

- Stone Cracks: There are many locations on all elevations where there are cracks through sill, header and quoin stones. Many of these cracks are part of a continuous step crack in through the mortar joints. (Fig. AB.27)
- Step Cracks: Some of the step cracks run continuously for one to three stories. The cause of the cracks appears to be moisture or water infiltration in the wall, causing bulging of the backup stone and separation of the stone at the joints. This does not indicate a structural problem with the building, only a maintenance issue. (Fig. AB.28)

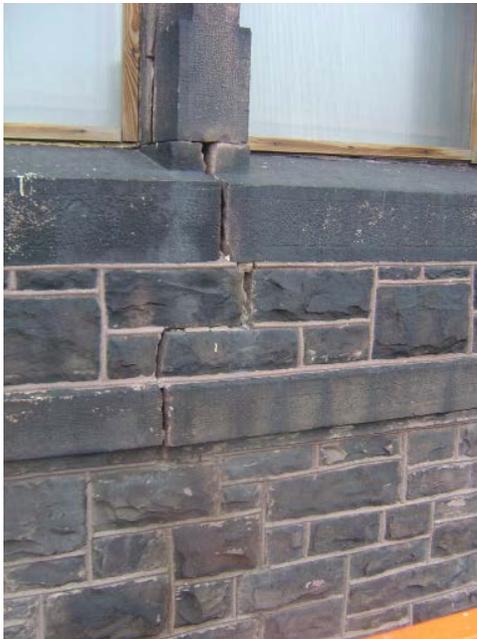
Fig. AB.28 Step crack through mortar joints
Image courtesy GCA

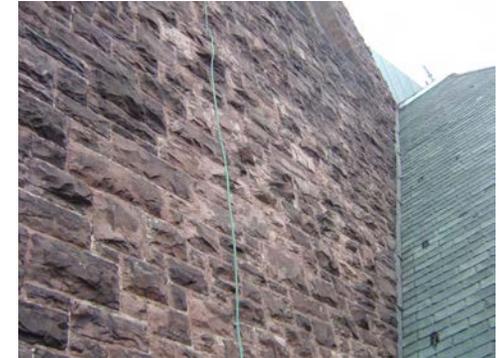
- Repointing Mortar: (Fig AB.31) The majority of the Administration Building has been repointed with buff colored mortar with a raised bead profile that is oversized compared to original. The mortar appears to be harder than it should be for a sandstone joint and may be causing spalling of the surrounding stone edges. Mortar should be softer than the surrounding masonry, compressing when the masonry units expand and contract. When mortar is harder than the surrounding stone, it doesn't compress when the masonry units expand, but spalls the edges of the stone. The repointing mortar is failing quite extensively on the building, with varying degrees of failure around the building.

Fig. AB.31 **Typical mortar joint condition**

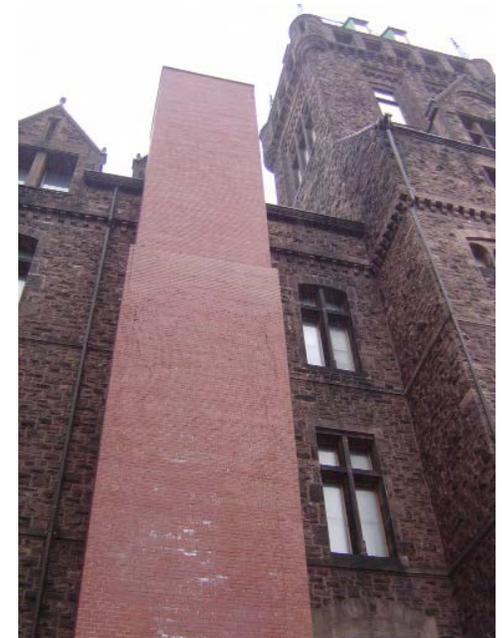
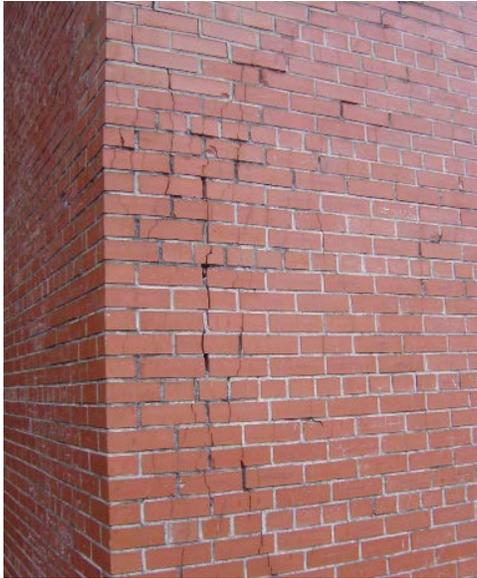
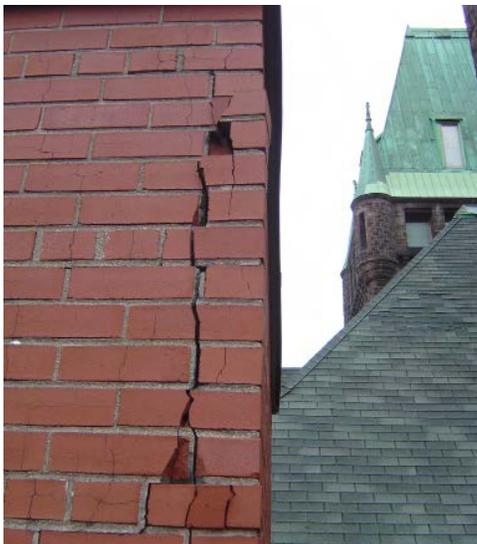
The brick elevator shaft on the west elevation of the building is in poor condition. It is experiencing vertical cracking the entire height of the shaft. Areas of brick, at the corners, are loose and displaced. Water infiltration and freeze thaw action

are accelerating the deterioration of the shaft. There are loose elements that should be removed in upcoming stabilization work on the buildings. (Figs. AB.32-34)

Fig. AB.32 **Brick elevator shaft on west elevation**

Fig. AB.33 **Brick elevator shaft on west elevation**
Image courtesy GCA

Fig. AB.34 **Brick elevator shaft on west elevation**
Image courtesy GCA

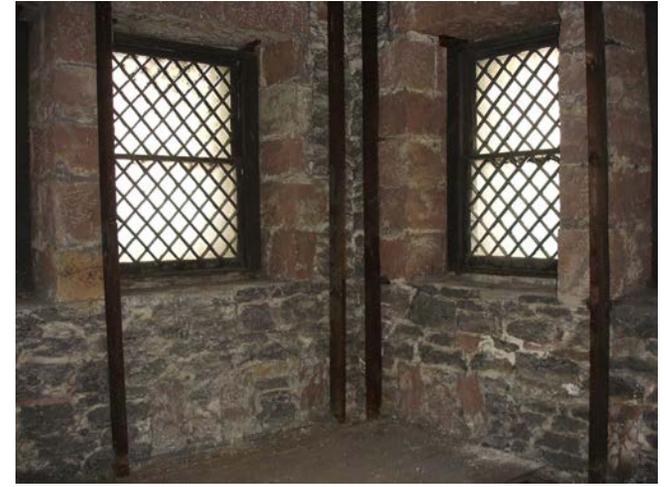
The interior walls show signs of water infiltration and appear to be in sound condition. (Fig. AB.43)

Fig. AB.43 **Typical interior tower condition**
Image courtesy GCA

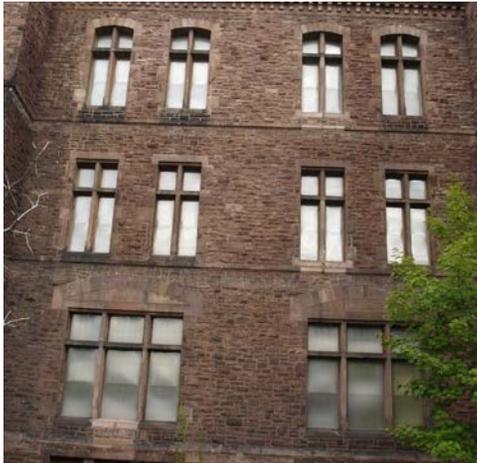
Fig. A.3 South elevation showing wall where porches were removed
Image courtesy GCA

- There are windows located in the dormer gable peaks (Fig. A.2)
- The porches on the south elevation were removed in the 1990's and the openings were reconfigured to remove the door openings. (Fig. A.3)
- Large areas of original pointing mortar was exposed by removal of porches. (Fig. A.4)

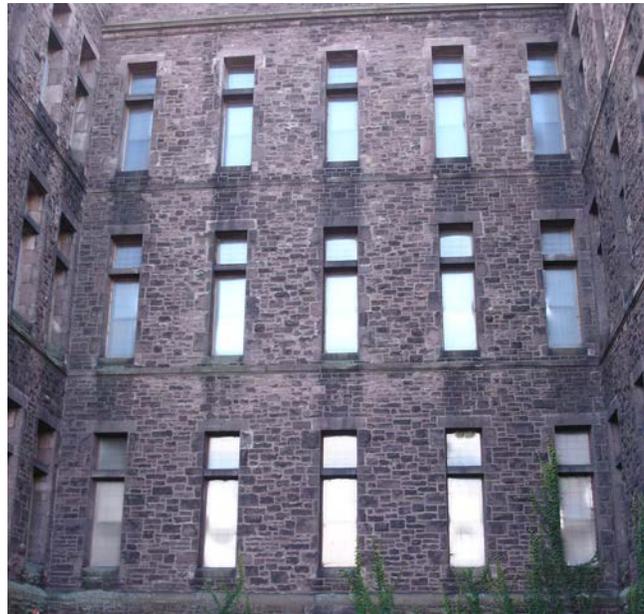
Fig. A.4 South elevation porch removal revealing original pointing mortar
Image courtesy GCA

The mortar joints are mostly intact, with evidence of several repointing campaigns. In addition to the buff colored repointing, there are large areas of exposed original red and brown mortar scheme. (Fig. A.4) Due to some ongoing water infiltration and saturation, the mortar continues to deteriorate with approximately 15-35% of the building requiring repointing at this time.

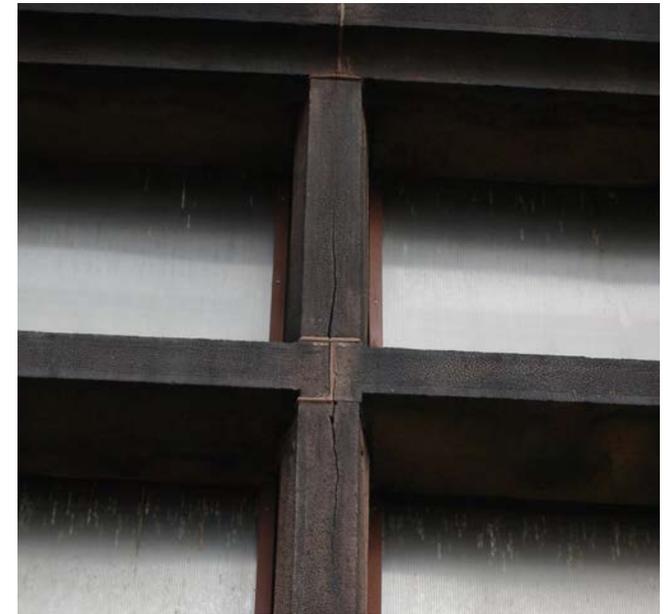
Fig. A.5 Vertical cracking at stone window muntin
Image courtesy GCA

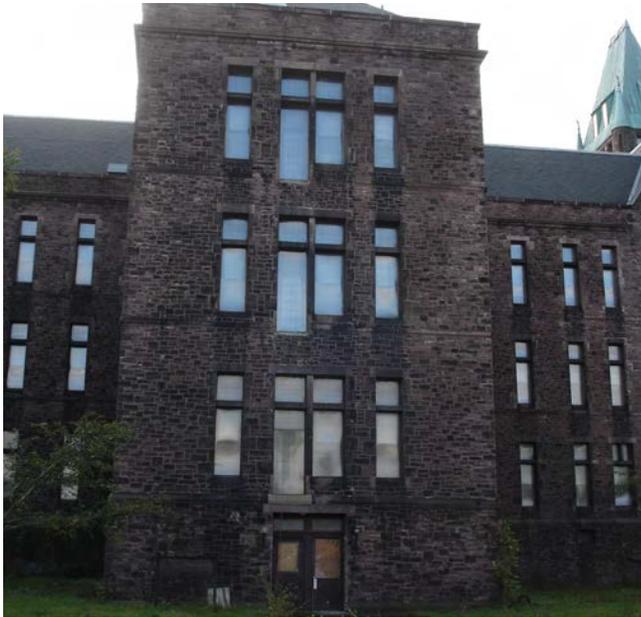
Fig. A.6 **Previous fire escape location and alterations**
Image courtesy GCA

- Fasteners from the iron bars remain in place in most of the window openings. The pins are embedded in the stone and are beginning to rust in most instances. In some locations, the rust has expanded to the point of spalling the large pieces stone from the face.
- Vertical cracking at the thin stone window muntins due to embedded and rusting iron pins. (Fig. A.5)
- Alterations to central north bay for previous fire escape have left exposed brick and inappropriate materials exposed. Window locations expanded to door openings at each floor, bad repairs and infill materials. (Fig. A.6)

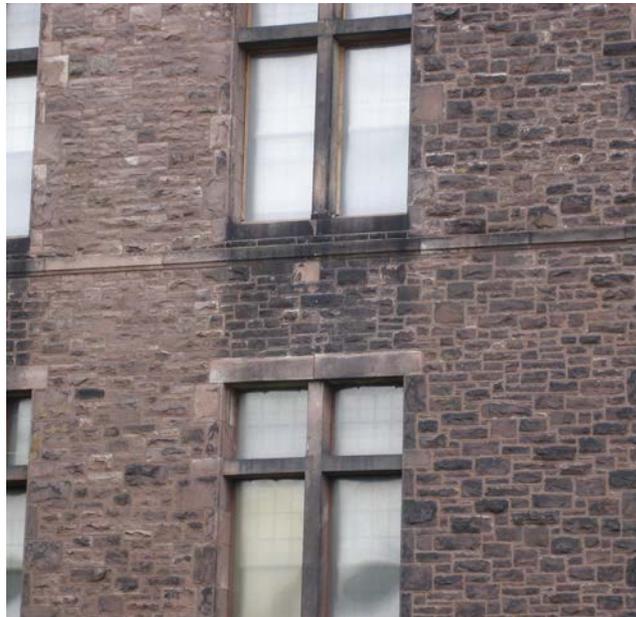
Fig. A.7 **Step cracking on north elevation**
Image courtesy GCA

- Step cracking occurs on the south and east elevations. The cracking occurs mostly between the window locations. The stones have not shifted out of plane, but further water infiltration could cause displacement. (Fig. A.7)

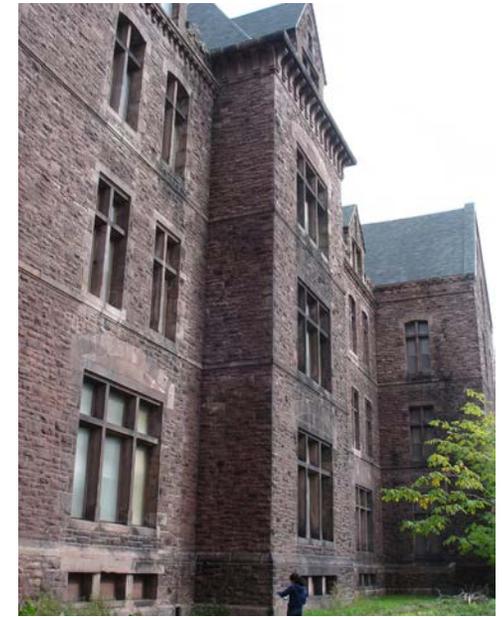
Fig. A. 8 **South elevation – iron porch removal, original mortar and patching**
Image courtesy GCA

a reminder of the porches and the alterations to the buildings. The most interesting result of the porch removal is the exposure of the original mortar. In the areas where the mortar was revealed, it is possible to see large expanses of the building as it was intended, with the red and brown mortars. (Fig. A.8)

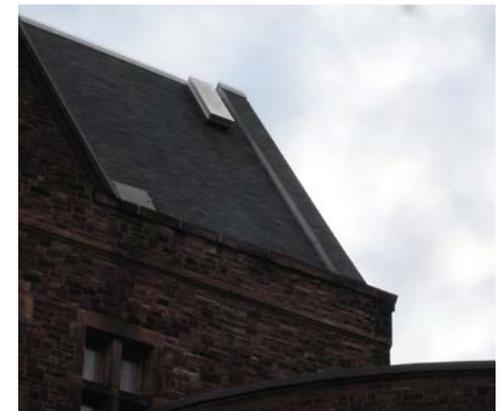
Fig. A. 9 **Roof with asphalt covered gable**
Image courtesy GCA

- The roof is covered in asphalt 3 tab shingles. It is in good condition with no open holes or missing shingles. The main portion of roof was installed in 1990. The asphalt shingles cover the gable rake. (Fig. A.9)
- The gutters are built into the stone parapet wall. The original copper gutter lining and flashing remain on the roof. The gutter was lined with EPDM in 1996, according

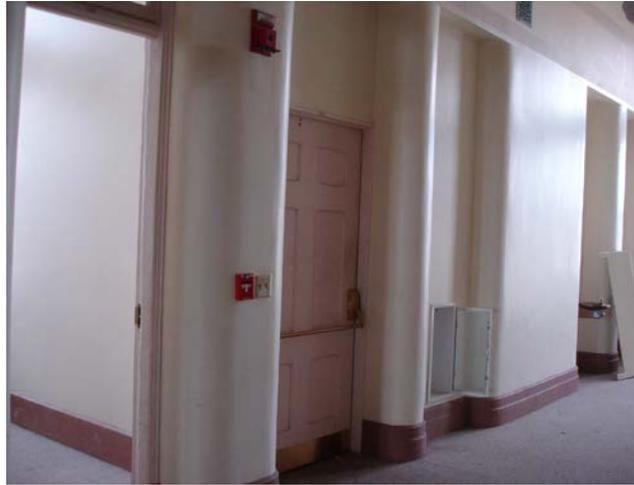
The interior of the building is in good to fair condition. The interior was renovated in the 1990's. The walls, ceilings and trim were repaired and painted, carpet installed and low walled cubicles were built in the central corridor of the building. (Fig. A.11) The original materials in the building – plaster and wood moldings (Fig. A.12), wood windows and wood doors – were restored and left in place. (Fig. A.13) The impact of the renovation of the interior was minimal, opting for reuse of existing elements and infill around the original floor plan. Some alterations were made to the side corridors to install a code compliant egress stair. In these locations, the original door openings were left in place and infilled with sheetrock. (Fig. A.14)

Fig. A.14 **Side corridor at egress stair**
Image courtesy GCA

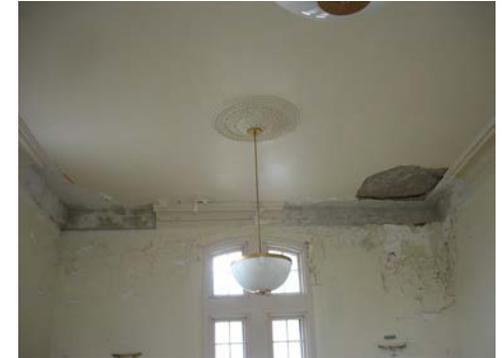
The damage to the building since the renovation is at isolated areas where the internal downspout have failed again, (Fig. A.15) and moisture related deterioration of the paint and plaster (Fig. A.16).

Fig. A.15 **Plaster damage at roof or downspout leak**
Image courtesy GCA

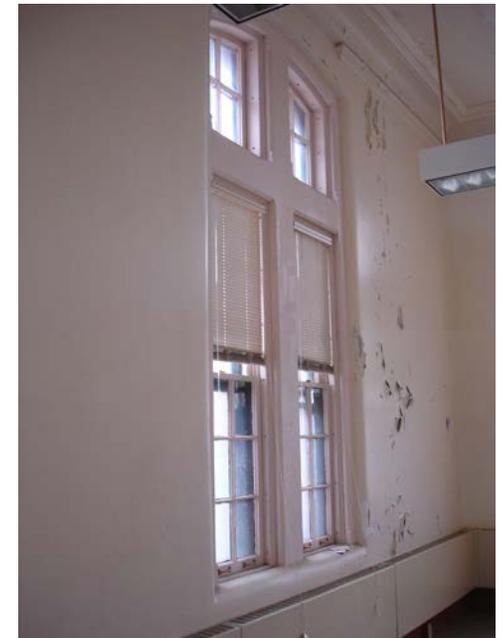
Fig. A.16 **Moisture damage to walls**
Image courtesy GCA

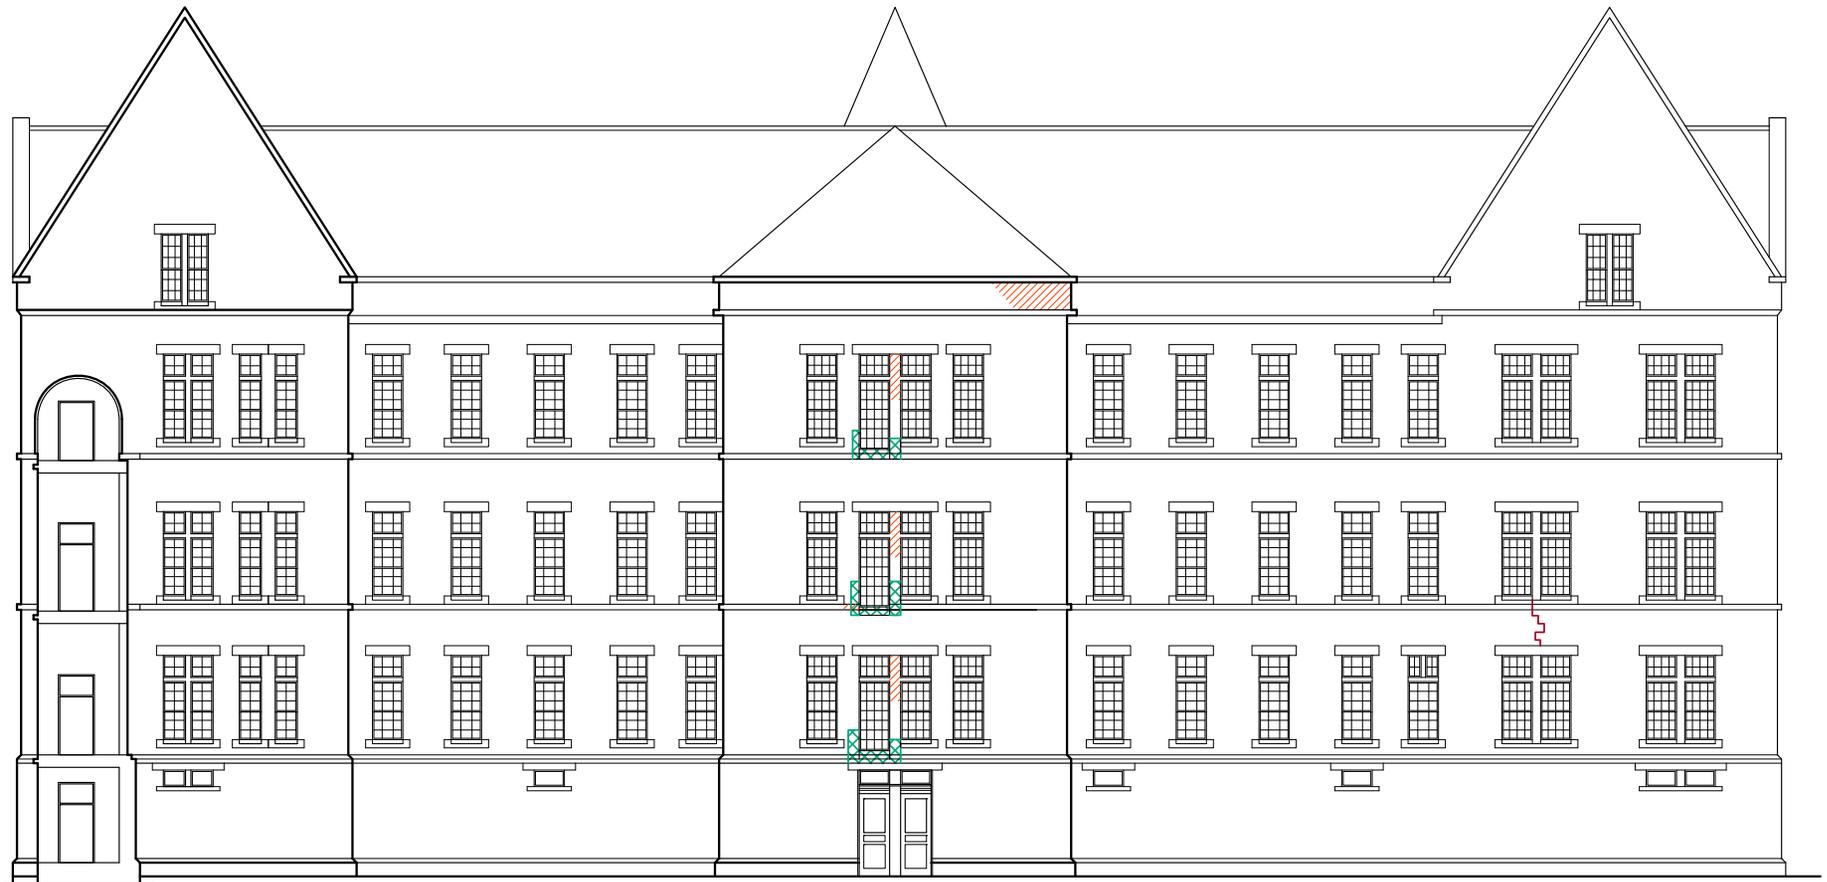
A
2.1 **North Elevation** MALE WARD A
These drawings show estimated existing conditions.

Step Cracking	26% Spalling

Rebuilt Areas	69% Staining

Open Joints / Shifting / Masonry Damage	15% Mortar Erosion

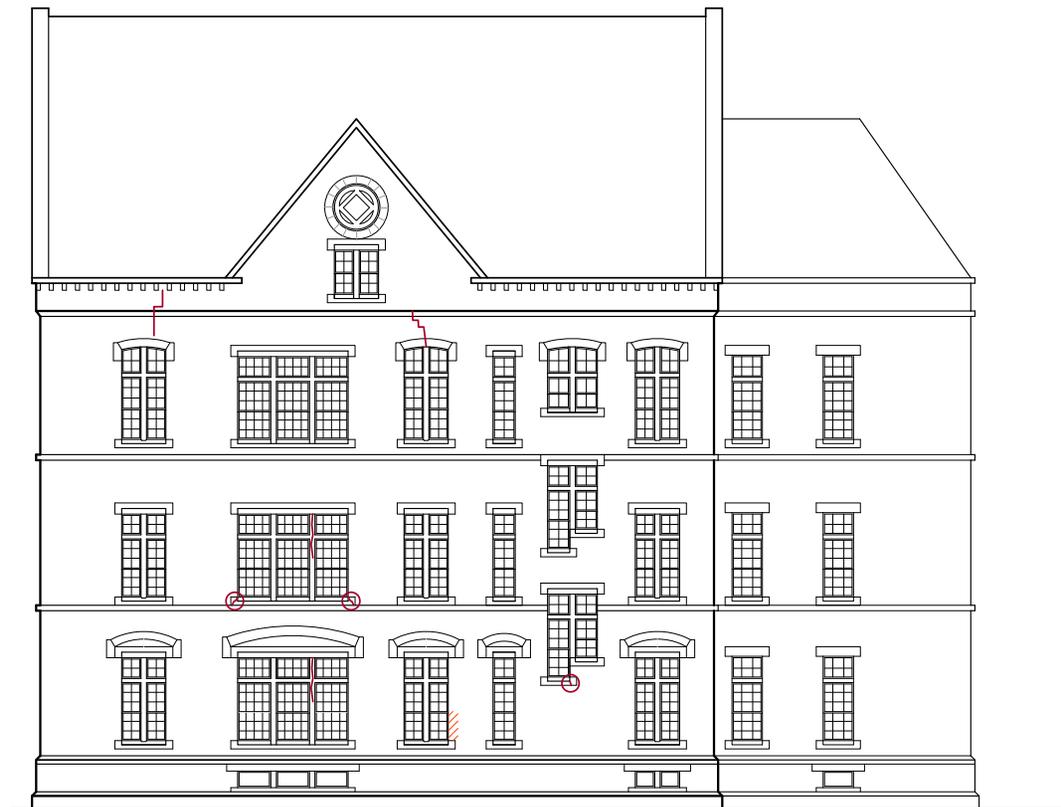
A
2.2 **East Elevation** MALE WARD A
These drawings show estimated existing conditions.

Step Cracking	40% Spalling

Rebuilt Areas	25% Staining

Open Joints / Shifting / Masonry Damage	25% Mortar Erosion

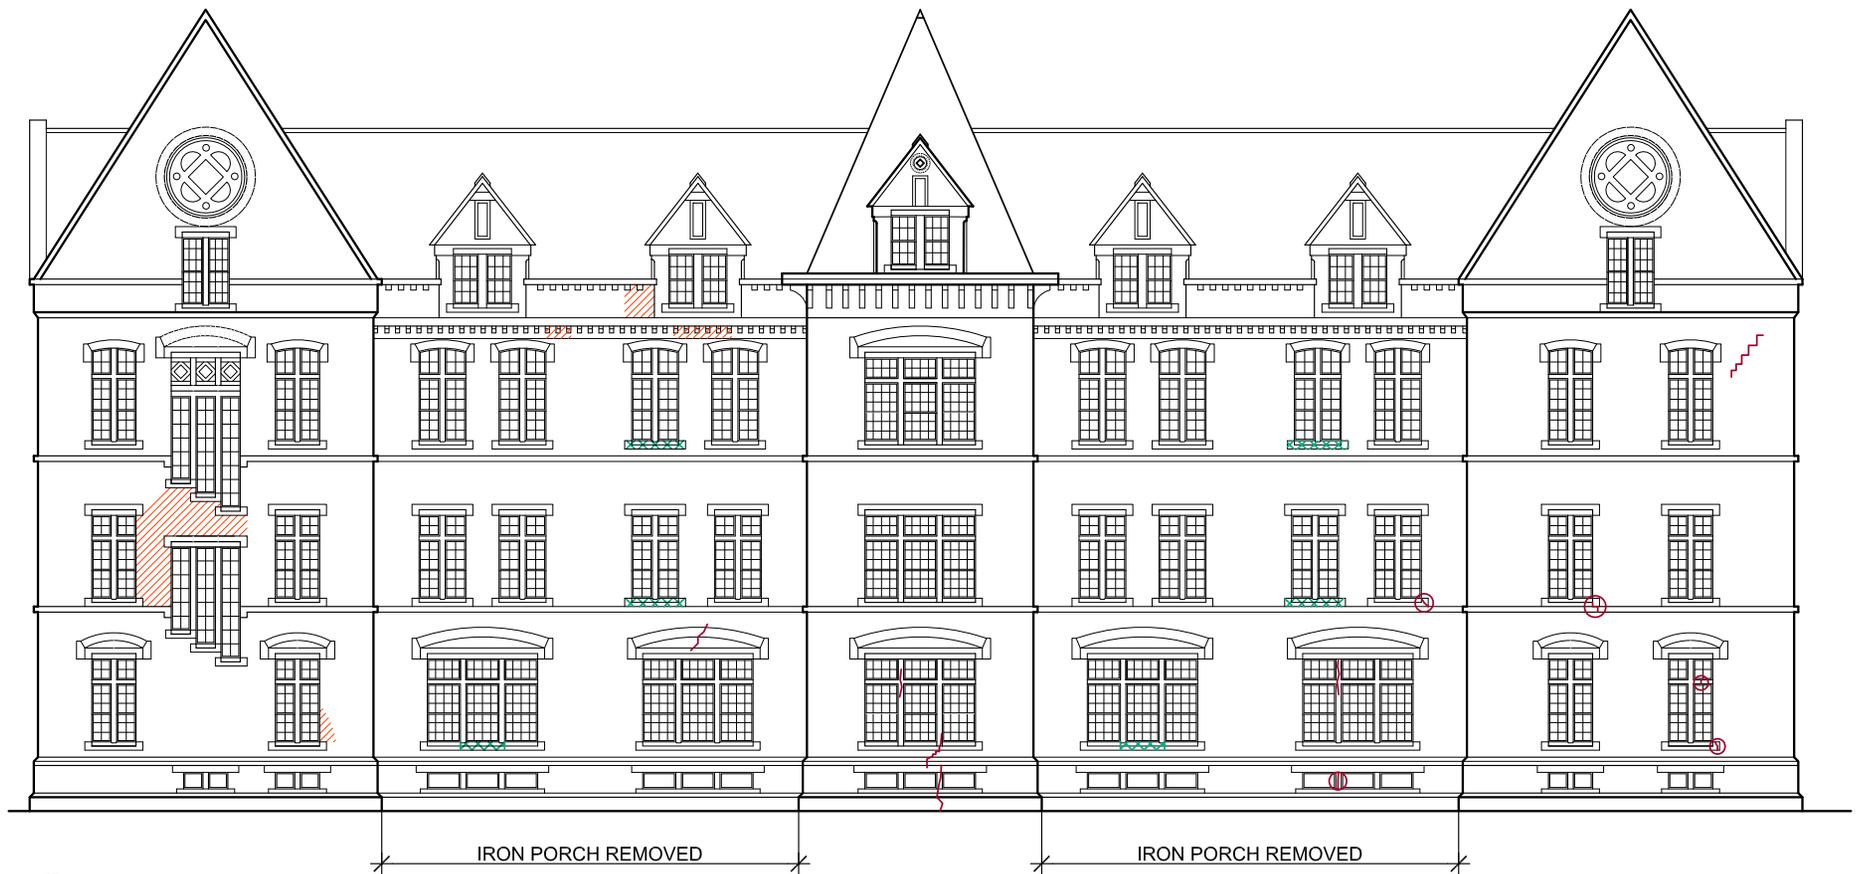
A
2.3 **South Elevation** MALE WARD A
These drawings show estimated existing conditions.

| | Step Cracking | 21% Spalling |
| | Rebuilt Areas | 46% Staining |
| | Open Joints / Shifting / Masonry Damage | 35% Mortar Erosion |

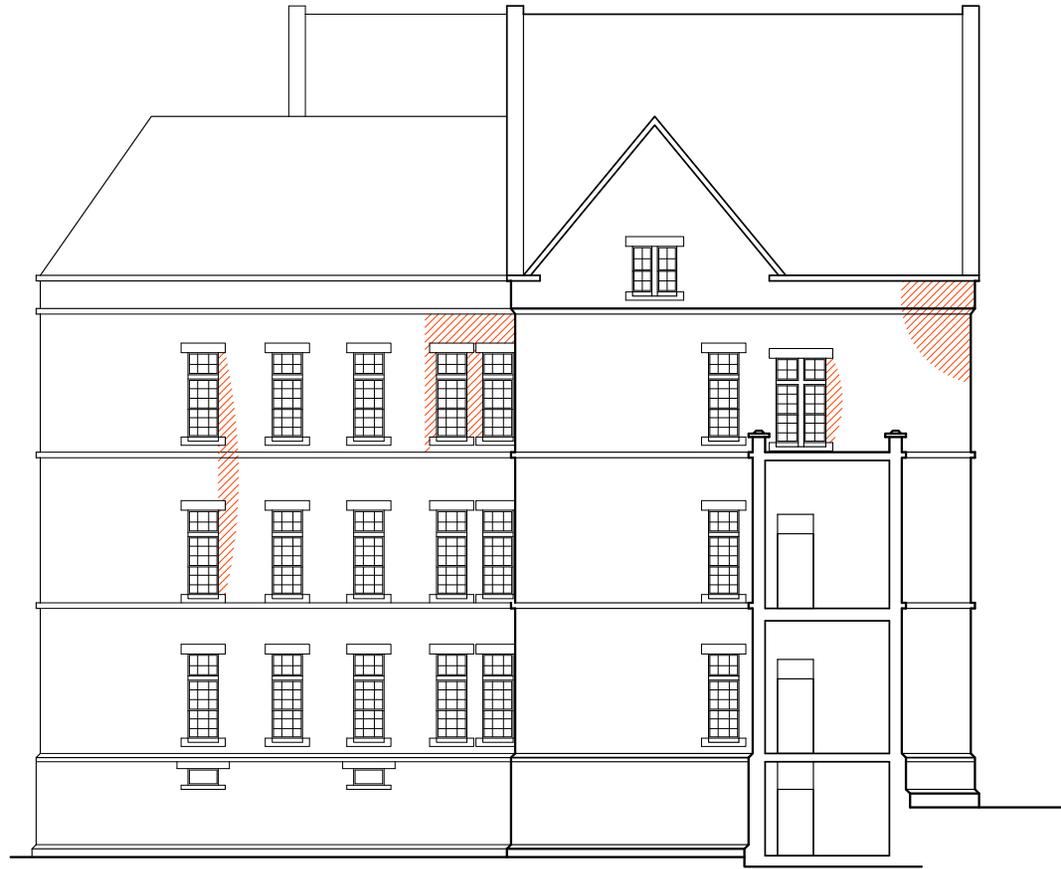
A
2.4 **West Elevation** MALE WARD A
These drawings show estimated existing conditions.

Step Cracking	50% Spalling

Rebuilt Areas	60% Staining

Open Joints / Shifting / Masonry Damage	25% Mortar Erosion

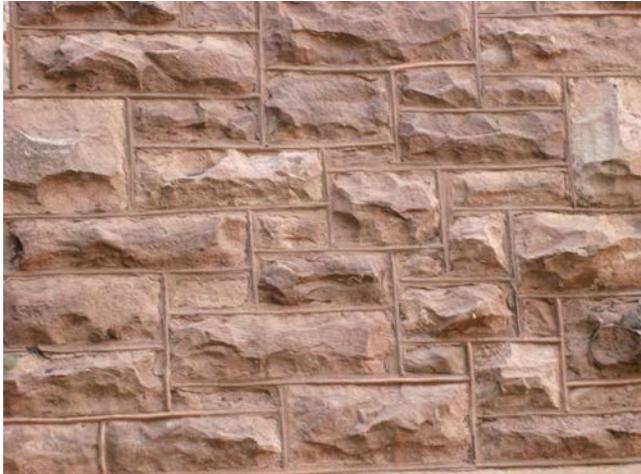
The mortar joints are mostly intact, with evidence of several repointing campaigns. In addition to the buff colored repointing evident on the Female wings, there is red mortar. (Fig 6) Due to some ongoing water infiltration and saturation, the mortar continues to deteriorate with only approximately 5-15% of the building requiring repointing at this time.

Fig. B.6 **Example of red mortar used in some repointing campaigns**

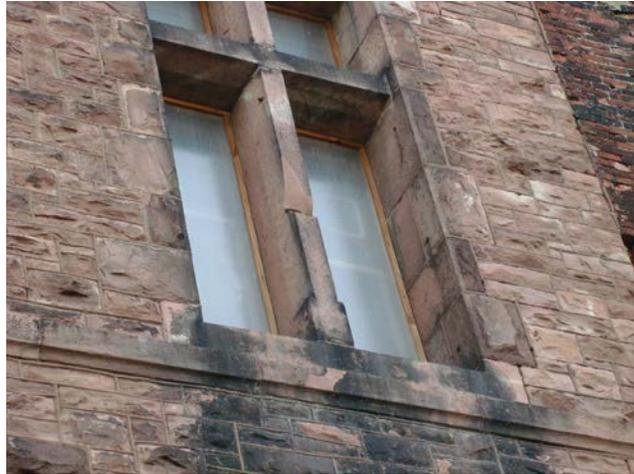
- Fasteners from the iron bars remain in place in most of the window openings. The pins are embedded in the stone and are beginning to rust in most instances. In some locations, the rust has expanded to the point of spalling the large pieces stone from the face. (Fig. B.7)
- Alterations to central north bay for previous fire escape have left exposed brick and inappropriate materials exposed. Window locations expanded to door openings at each floor, bad repairs and infill materials. (Fig. B.8)
- Step cracking occurs on the south and east elevations. The cracking occurs mostly between the window locations. The stones have not shifted out of plane, but further water infiltration could cause displacement. (Fig. B.9)

Fig. B.7 **Spalled stone due to embedded rusting iron fasteners**
Image courtesy GCA

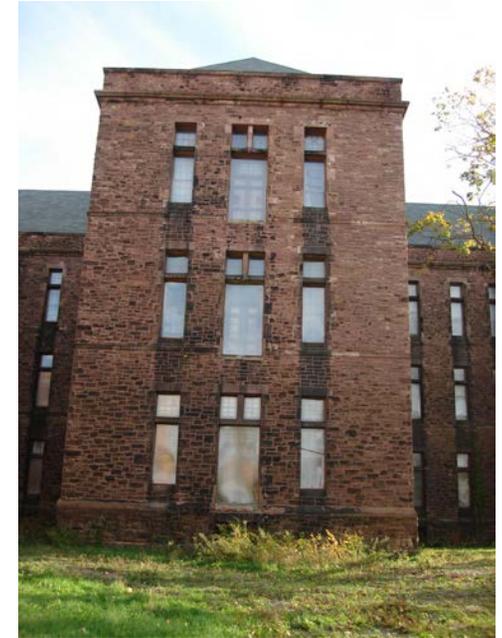
Fig. B.8 **Alterations to central north bay for previous fire escape**

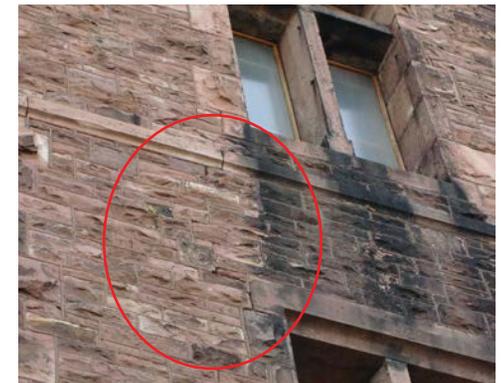
Fig. B.9 **Step cracking on the east elevation**
Image courtesy GCA

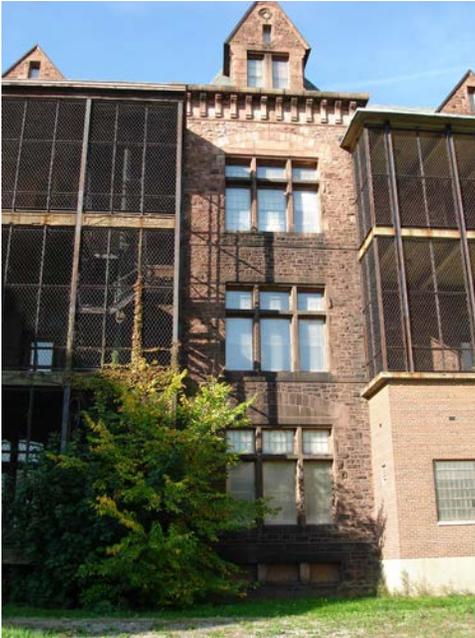
- The iron porches remain on the east and west ends of the south elevation (Fig. B.10). Both are in poor condition with spalling concrete and rusting steel structure, grating and mesh. The first floor of the east porch is constructed of brick, added in the 1950' or 60's.

Fig. B.10 **Iron porches on the east and west ends of the south elevation**

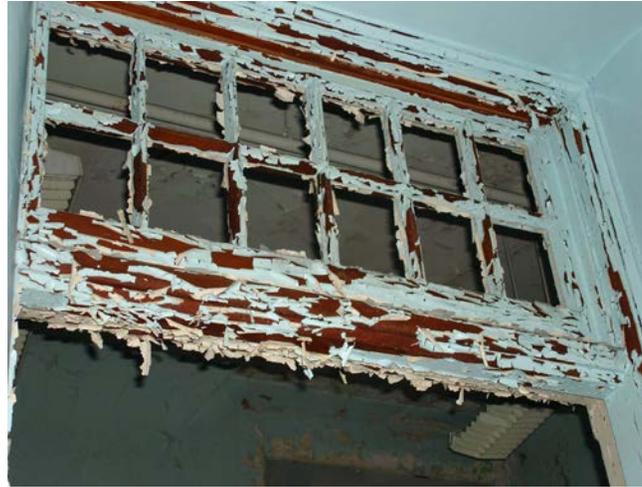
Fig. B.12 **Peeling paint at door and window trim**

Where the walls and ceilings have not collapsed from water damage, there is significant surface finish damage due to high moisture levels and a lack of ventilation. Paint is generally peeling (Fig. B.12), the surface coat of plaster is cracked (Fig. B.13), tin ceilings are rusted, and plaster ceilings are cracked.

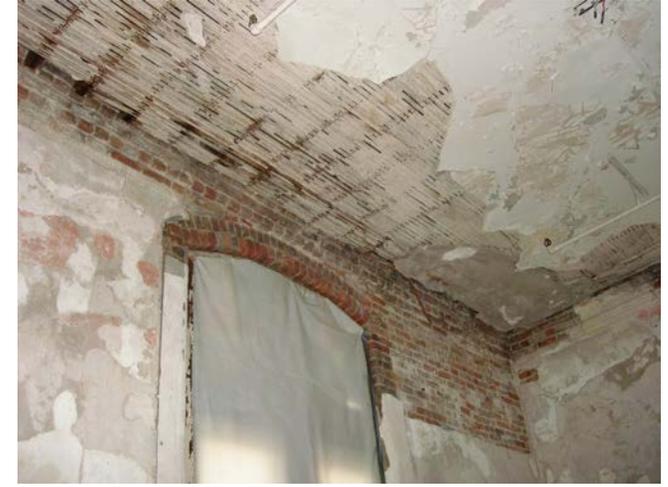
Fig. B.13 **Plaster damage at walls and ceiling**
