HISTORIC STRUCTURES REPORT

the RICHARDSON OLMSTED COMPLEX *Buffalo, NY*

July 2008

GOODY
CLANCY

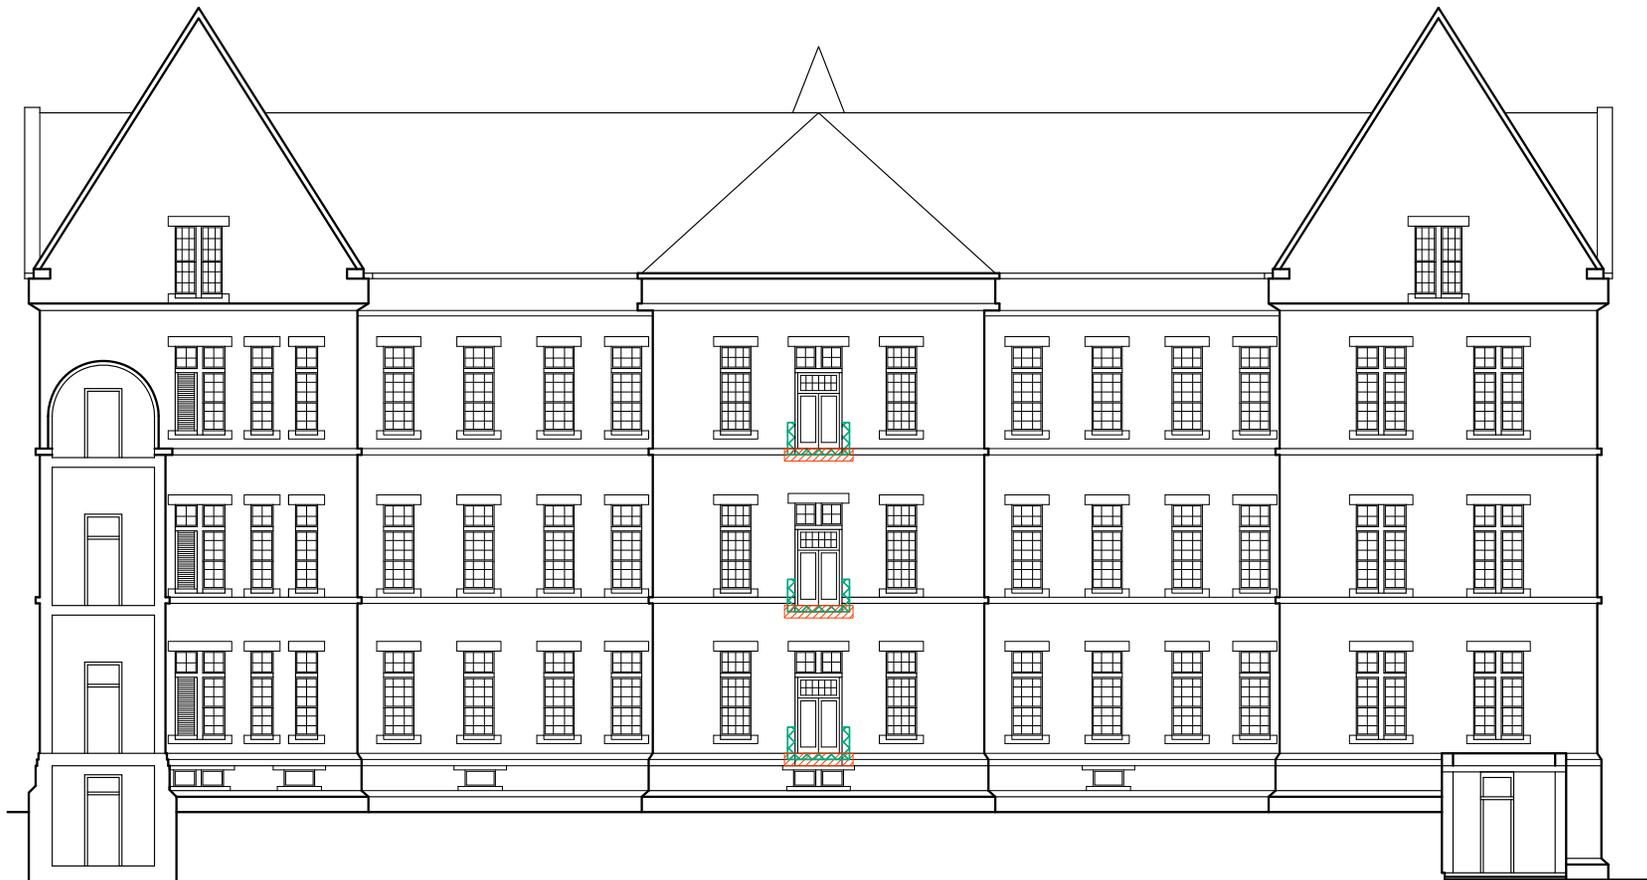
B
2.1 **North Elevation** MALE WARD B
These drawings show estimated existing conditions.

36% Spalling

32% Staining

5% Mortar Erosion

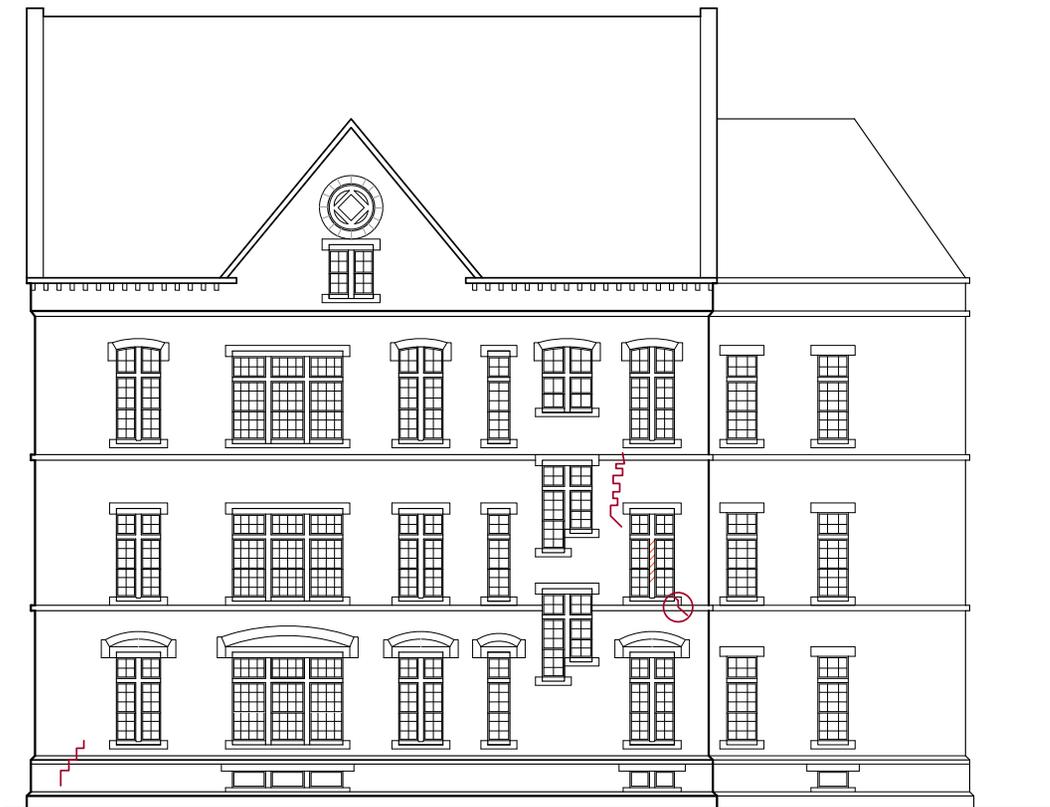
B
2.2

15% Spalling

50% Staining

5% Mortar Erosion

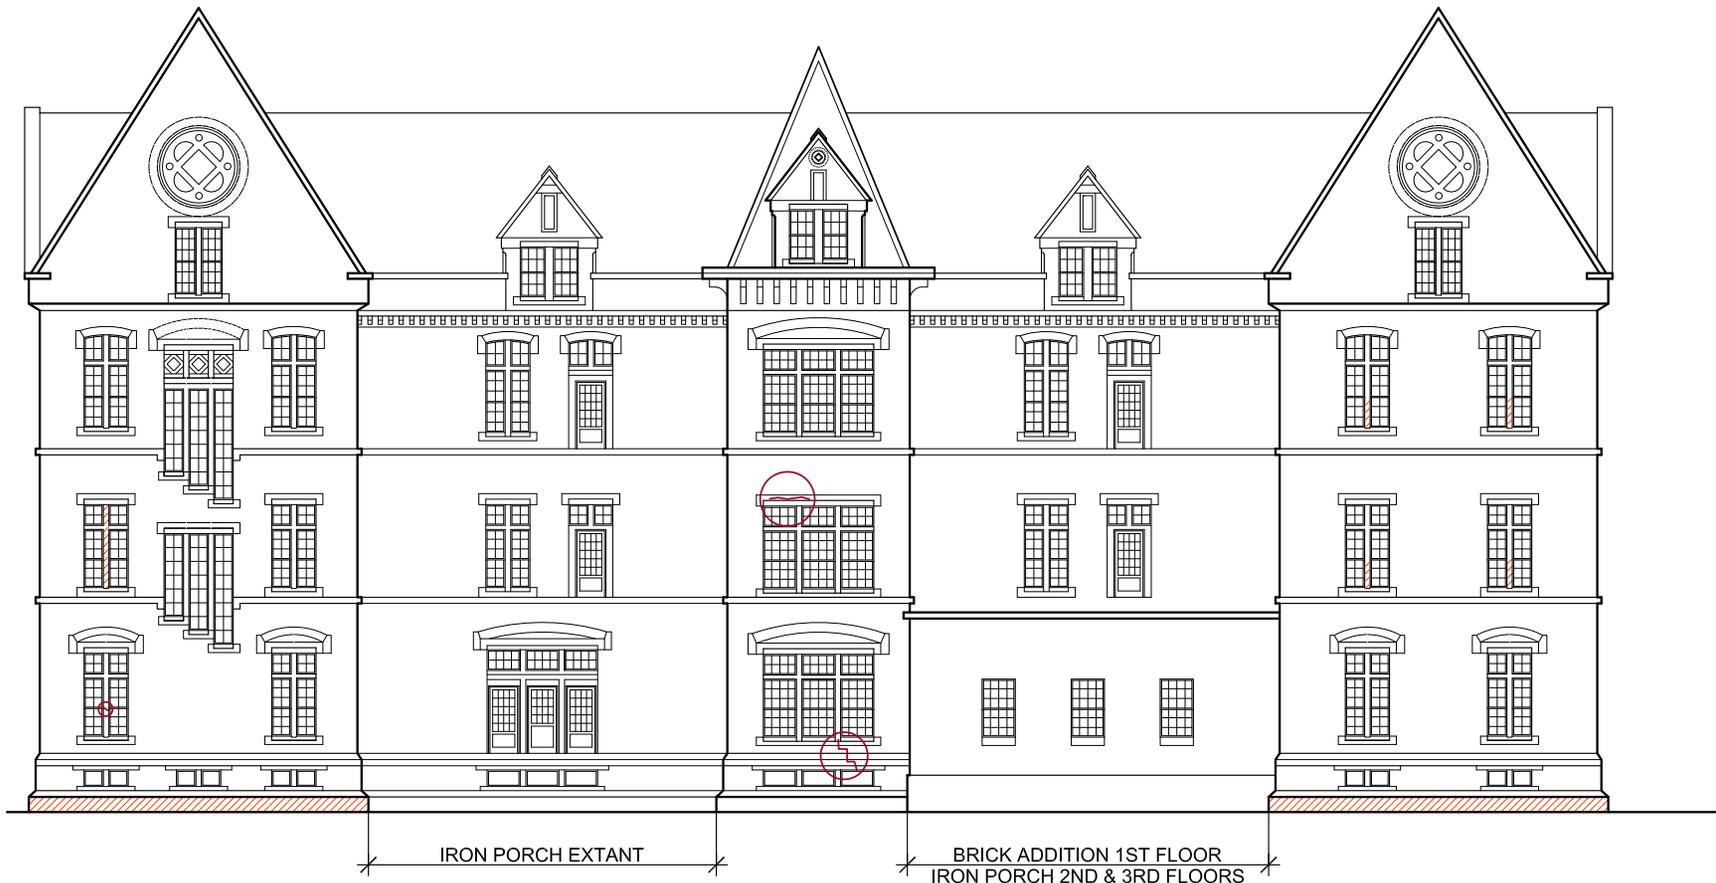
B
2.3 **South Elevation** MALE WARD B
These drawings show estimated existing conditions.

Step Cracking	13% Spalling

Rebuilt Areas	56% Staining

Open Joints / Shifting / Masonry Damage	16% Mortar Erosion

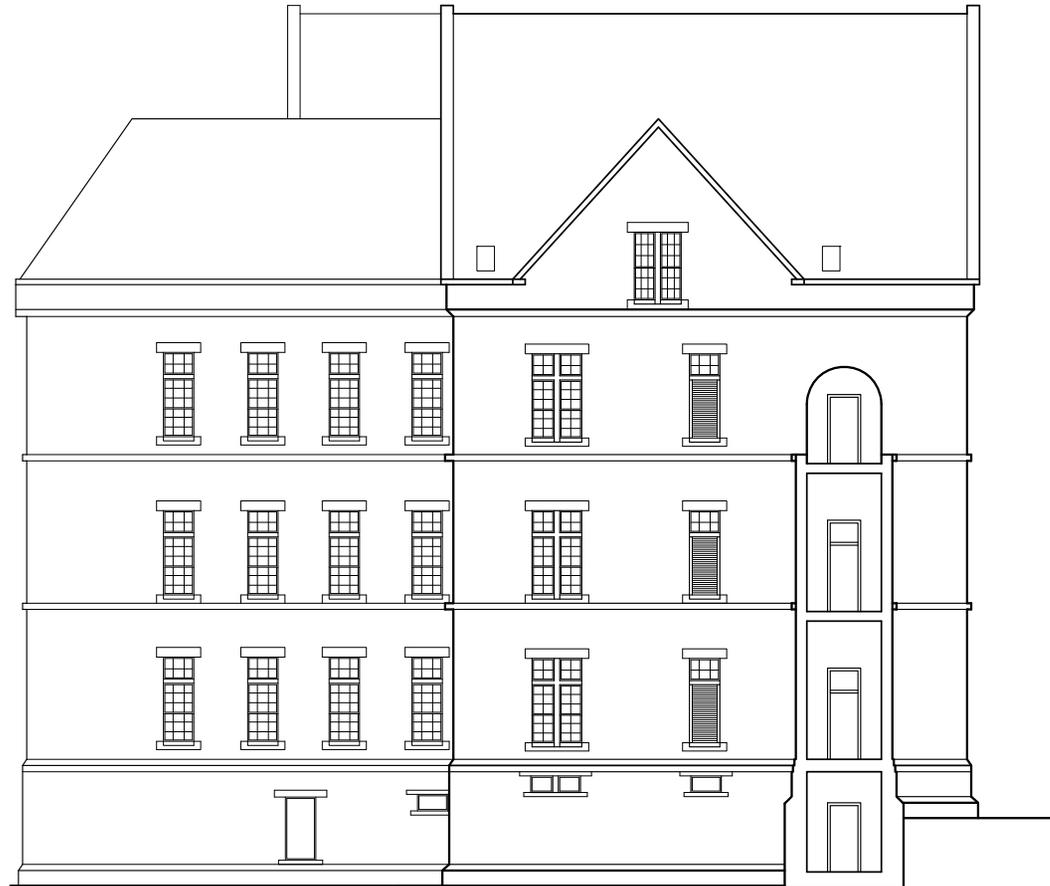
B
2.4

Step Cracking	60% Spalling

Rebuilt Areas	30% Staining

Open Joints / Shifting / Masonry Damage	5% Mortar Erosion

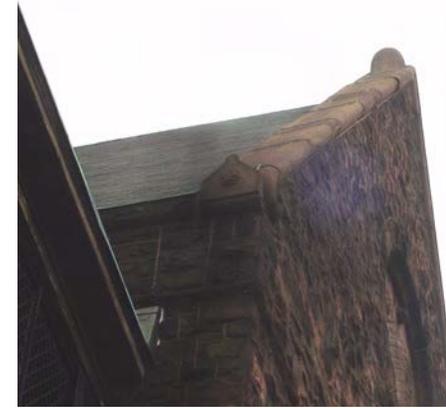
Fig. F.5 **Gable cap stone decorative scroll**
Image courtesy GCA

- The joints between the gable stones are exposed (there is no flashing over the gable stones), allowing water to infiltrate into the core of the gable wall. Some of the gable stones are lifting due to freeze/thaw action. The saturation of the masonry from the cap stones is also causing accelerated deterioration of the mortar joints in the stone wall directly below the gable. (Fig. F.5 & F.8)

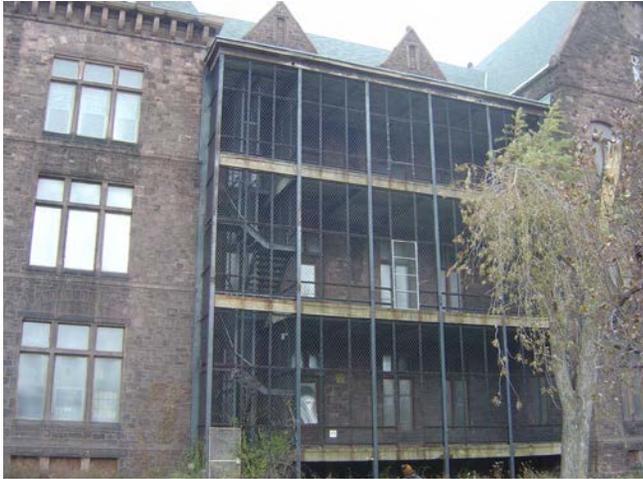
Fig. F.6 **South elevation – east porch**
Image courtesy GCA

The iron porch remains on the east end (Fig. F.1) of the south

elevation. It is in poor condition with rusting steel structure, grating and mesh. The iron porch on the west elevation was removed some time after 2002. The 2002 report refers to the west porch as wood, and the east porch as concrete. This indicates that the two porches were of different construction, and likely constructed at different times.

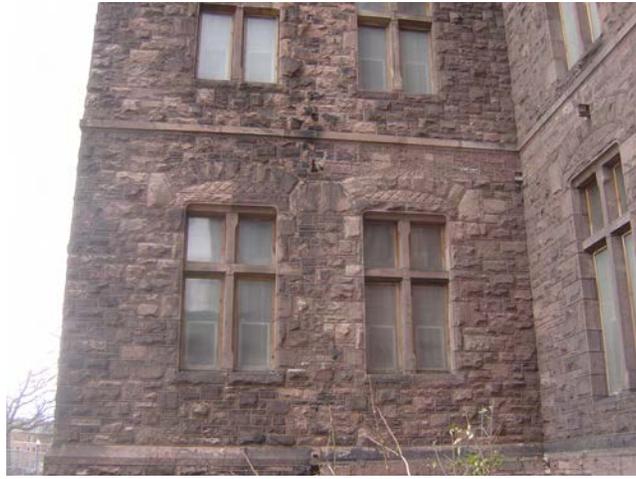
Fig. F.7 **South elevation – stone conditions at removed west porch**
Image courtesy GCA

The removal of the “wood” porch on the west end has left the following conditions: (Fig. F.7 & F.12)

- The rock faced building stone located at the porch roof and floor connections was honed flatter, leaving chisel marks and distinct flat planes.
- The stone that was covered by the porch is cleaner than the exposed stone.
- One window opening on each floor was enlarged to create a door opening for access to the porch. These openings are no longer relevant with the porch removed.

- The steel beams that supported the roof and floor structure were cut off approximately 4” from the face of the building, leaving exposed and rusting steel elements in the stone. The rusting and subsequent expansion of the steel will crack the surrounding stone.
- There are holes in horizontal bands where fasteners have been removed.

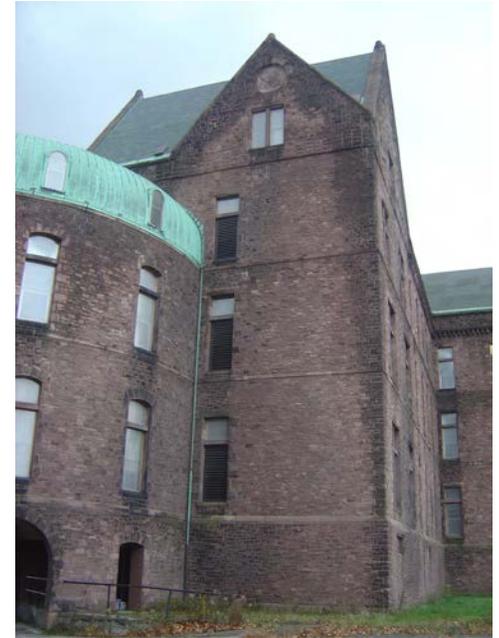
subsequently. The area has begun to fail again since its last repair. It appears that there is no outlet for pooled water to drain from this corner. The water saturates the corner, and freeze/thaw action quickly causes the masonry to heave out of plane. (Fig. F.8 & F.10)

Fig. F.8 **Northeast corner showing saturation of masonry below gable and at corner (dark stone)**
Image courtesy GCA

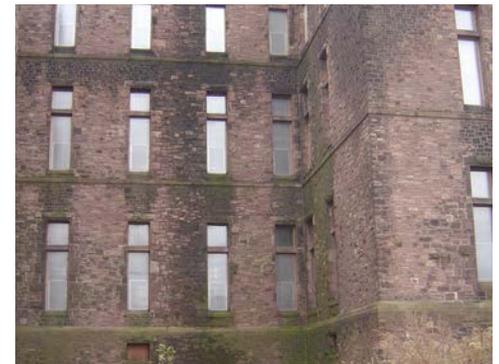
In general, the stone is in good condition. The surface of the stone contains minor spalling (15-30%), atmospheric soiling (20% on south elevation to 90% on west elevation) and algae growth confined to the lower floors of the north elevation. (Fig. F.9)

Fig. F.9 **Elevation showing algae (green), soiling (black), and spalled areas (light red)**
Image courtesy GCA

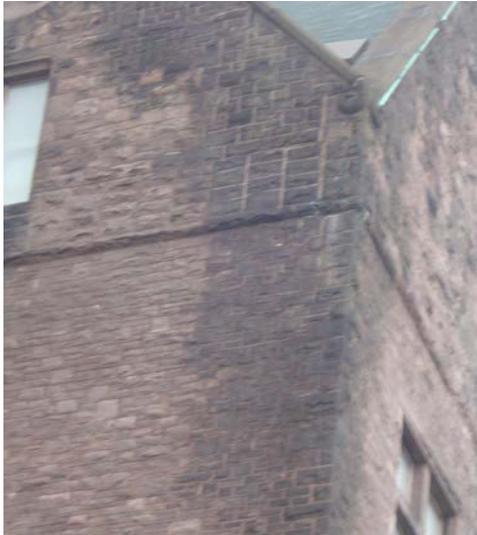
Fig. F.10 **Northeast corner – detail of masonry deterioration**

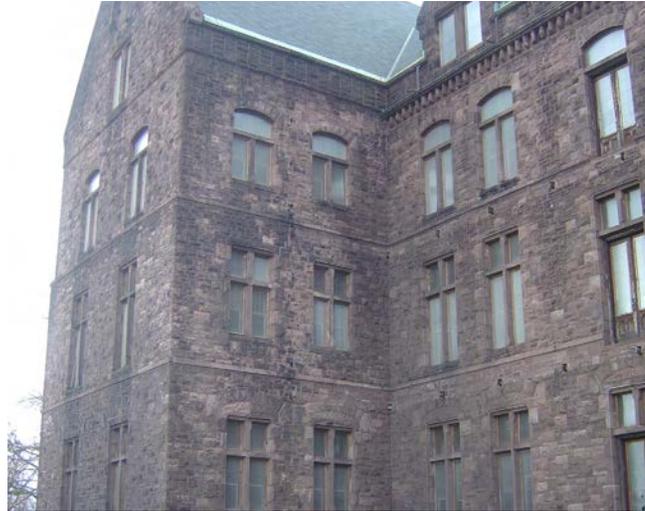
Fig. F.12 **South elevation – area at removed west porch**

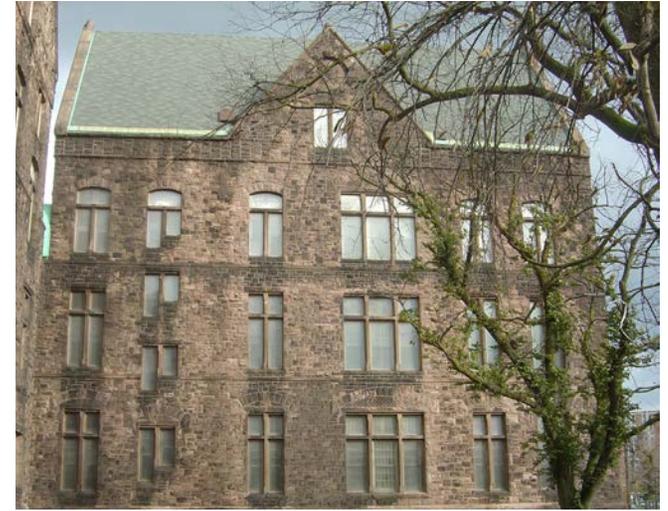
- The roof is covered in asphalt 3 tab shingles. It is in good condition with no open holes or missing shingles. The main portion of roof was installed after 2002. The north wing roof was installed between 1994 and 2002 and is also in good condition.
- There are integral stone gutters on the building. The original copper gutter lining and flashing remain on the

Fig. F.13 **West elevation showing asphalt roof and copper gutter**

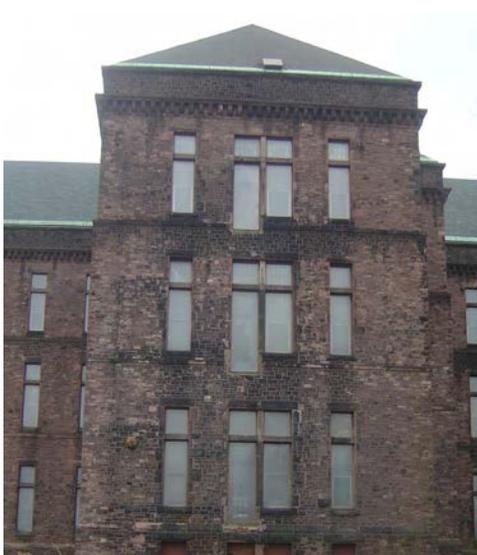
Alterations to central north bay for previous fire escape have left exposed brick and inappropriate materials exposed. Window locations expanded to door openings at each floor, bad repairs and infill materials. (Fig. F.11)

Fig. F.11 **North elevation fire escape alterations**

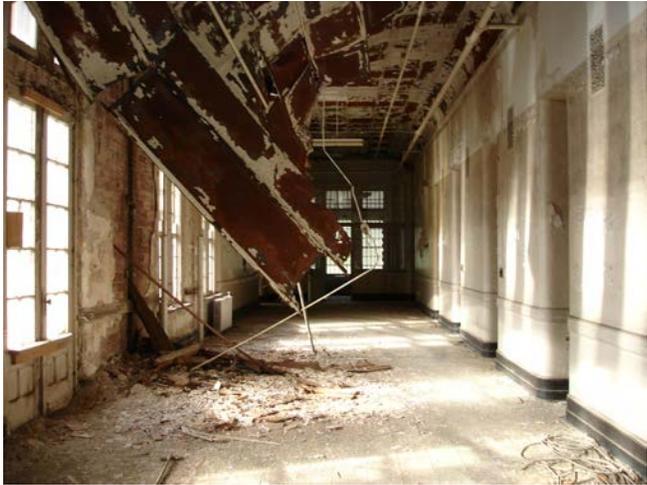
Fig. F.14 **Rusted, falling tin ceilings**
Image courtesy GCA

Where the walls and ceilings have not collapsed from water damage, there is significant surface finish damage due to high moisture levels and a lack of ventilation. Paint is generally peeling, the surface coat of plaster is cracked, tin ceilings are rusted (Fig. F.14), and plaster ceilings are cracked.

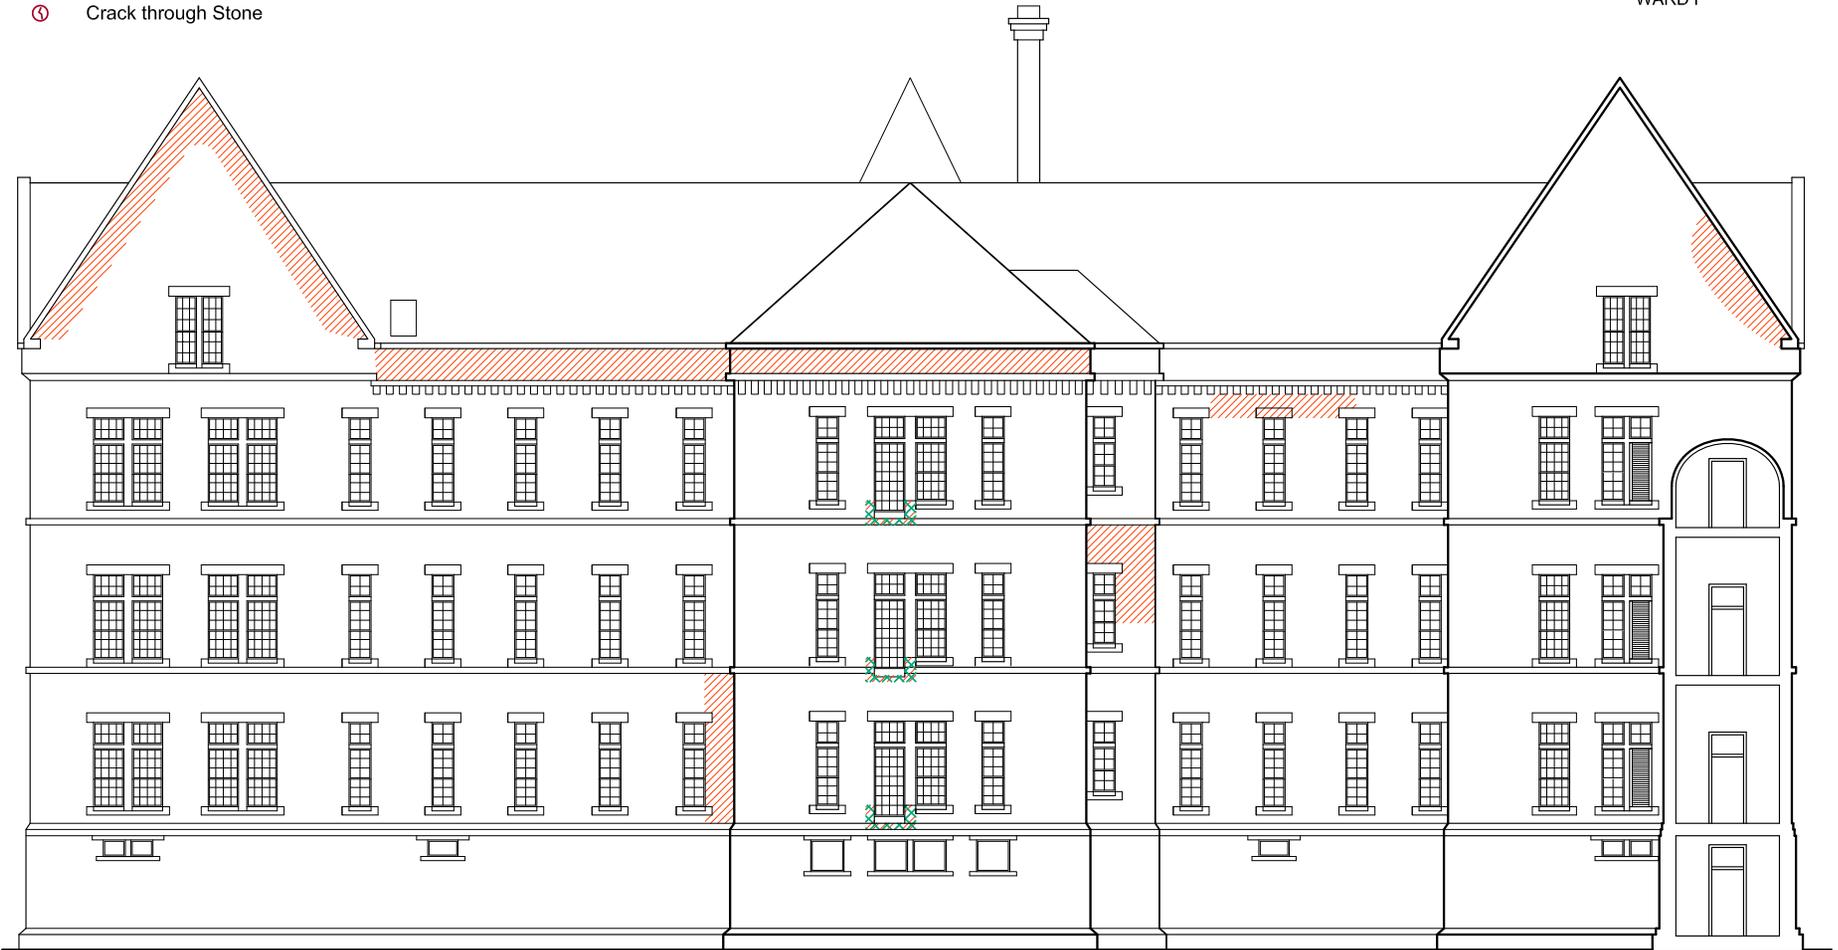
F
2.1 **North Elevation** FEMALE WARD F
These drawings show estimated existing conditions.

29% Spalling

25% Staining

19% Mortar Erosion

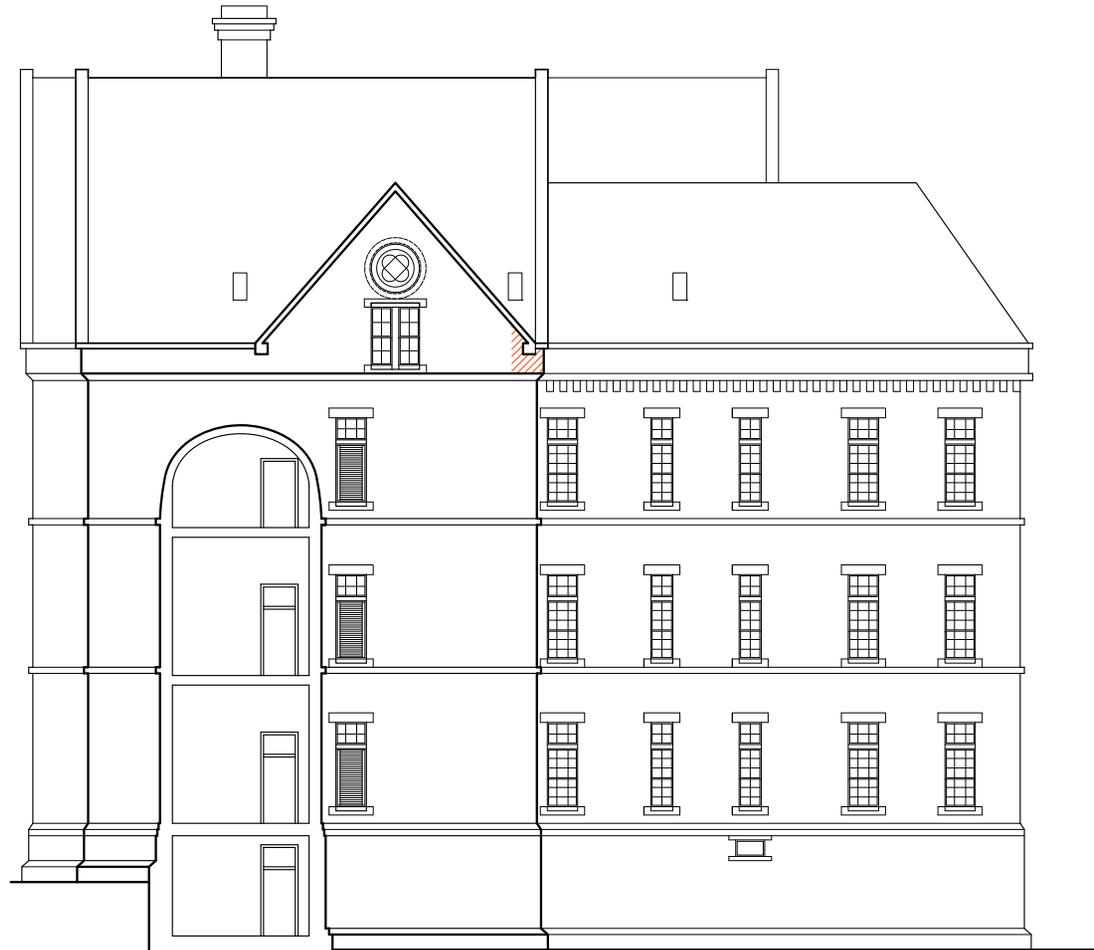
F
2.2 **East Elevation** FEMALE WARD F
These drawings show estimated existing conditions.

30% Spalling

20% Staining

25% Mortar Erosion

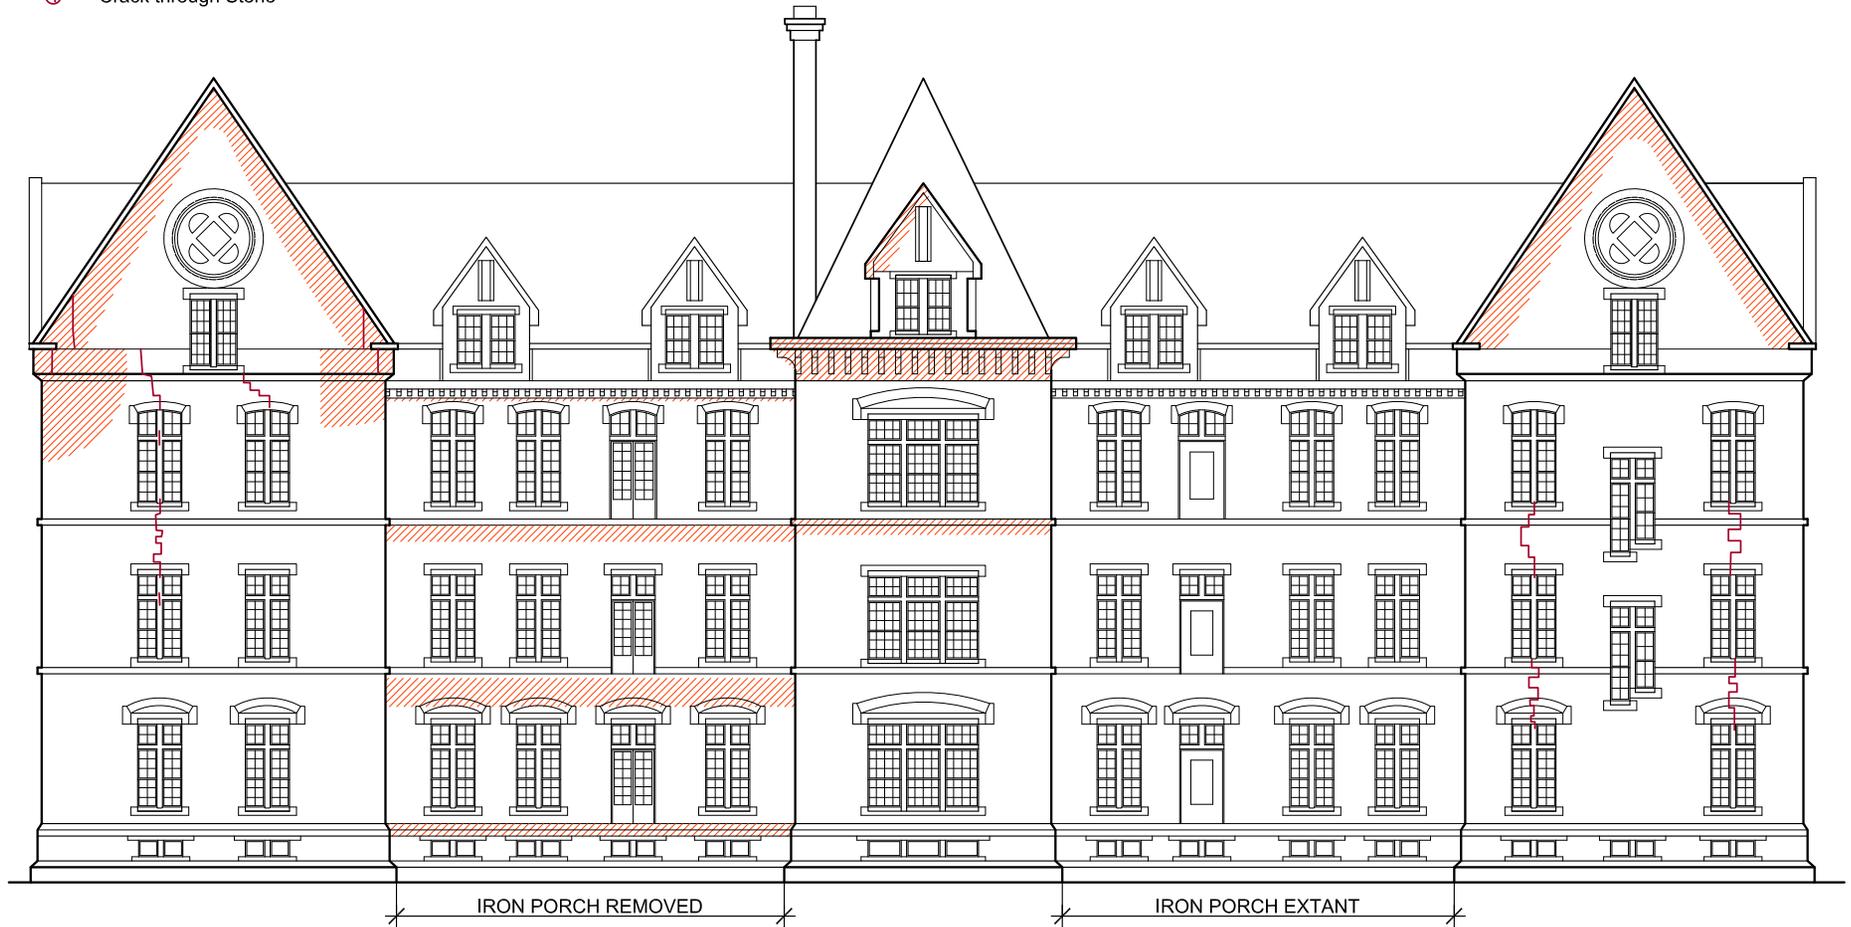
F
2.3 **South Elevation** FEMALE WARD F
These drawings show estimated existing conditions.

Step Cracking	15% Spalling

Rebuilt Areas	21% Staining

Open Joints / Shifting / Masonry Damage	18% Mortar Erosion

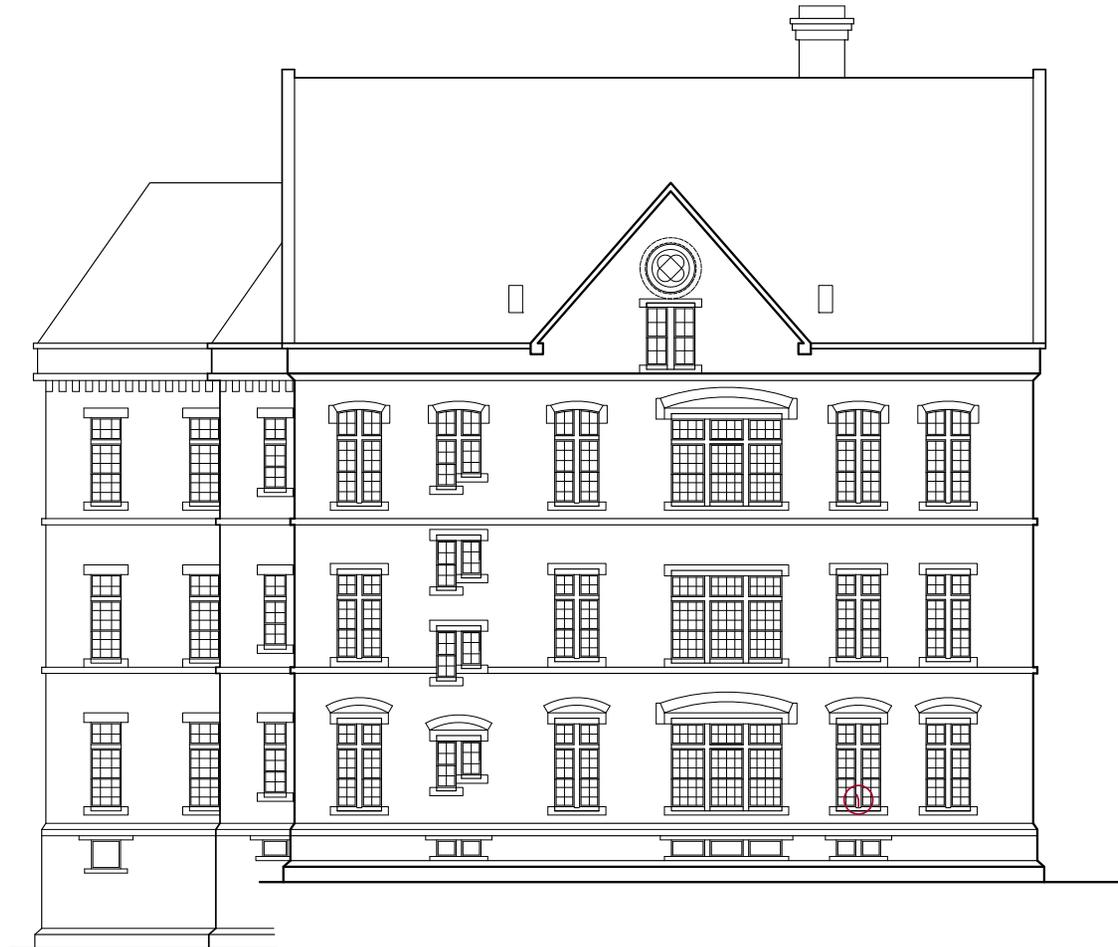
F
2.4 **West Elevation** FEMALE WARD F
These drawings show estimated existing conditions.

Step Cracking	35% Spalling

Rebuilt Areas	90% Staining

Open Joints / Shifting / Masonry Damage	25% Mortar Erosion

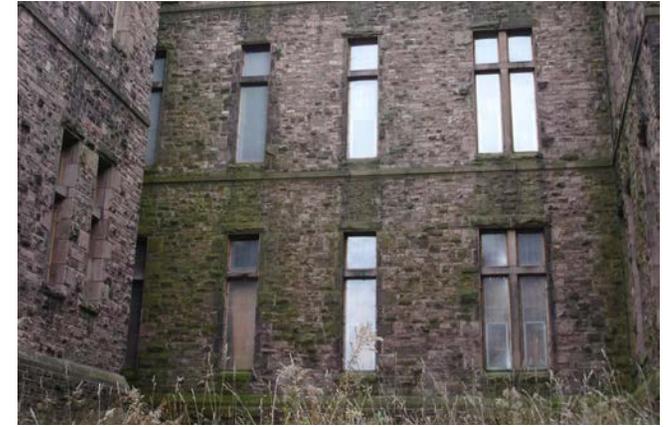
In general, the stone is in good condition. The surface of the stone contains moderate spalling (25-50%), atmospheric soiling (40-50%) and algae growth confined to the lower floors of the north elevation. (Fig. G.5)

Fig. G.5 North Elevation showing algal growth

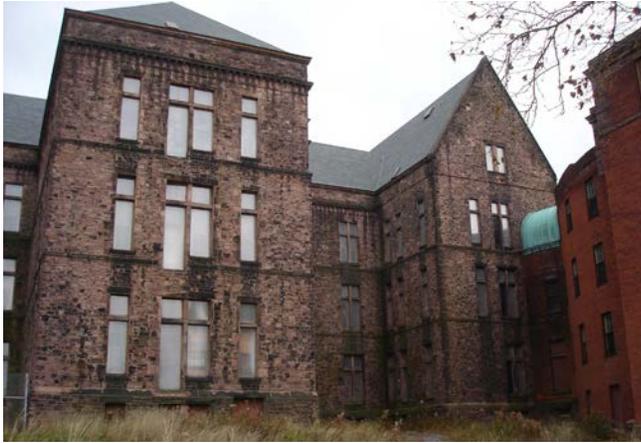
- The joints between the gable stones are exposed (there is no flashing over the gable stones), allowing water to infiltrate into the core of the gable wall. Some of the gable stones are lifting due to freeze/thaw action. The saturation of the masonry from the cap stones is also causing accelerated deterioration of the mortar joints in the stone wall directly below the gable.
- Alterations to central north bay for previous fire escape have left exposed brick and inappropriate materials exposed. Window locations expanded to door openings at each floor, bad repairs and infill materials. (Fig. G.6)

Fig. G.6 North Elevation showing fire escape alterations

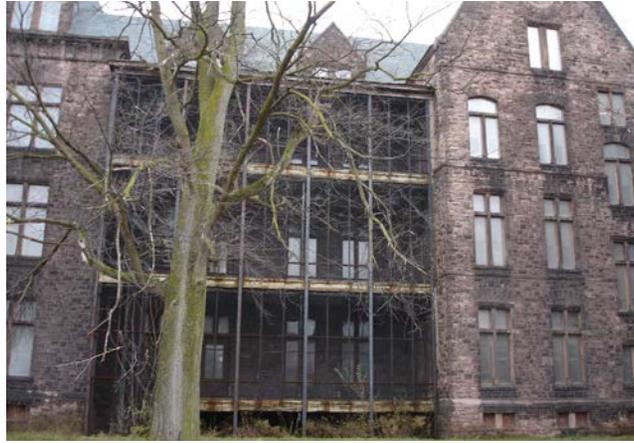
Two iron porch remain on the south elevation. (Fig. G.7) They are in poor condition with rusting steel structure, grating and mesh.

Fig. G.7 South Elevation showing porch

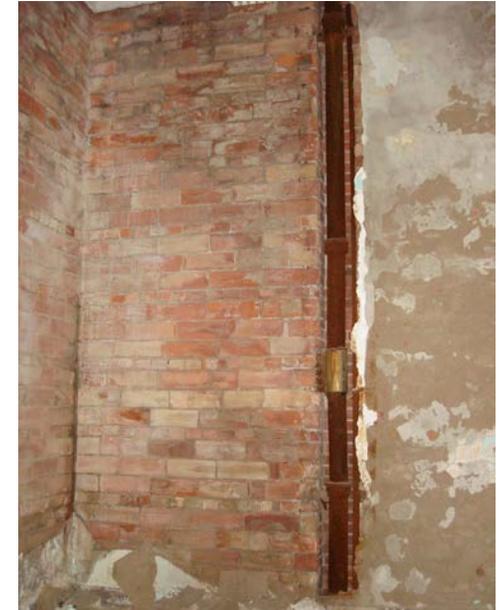
The interior of the building is in fair condition. The interior damage is focused around previous roof leaks, broken internal downspouts. (Fig. G.8) and water saturation and

Fig. G.8 Internal downspout and associated plaster and wall damage

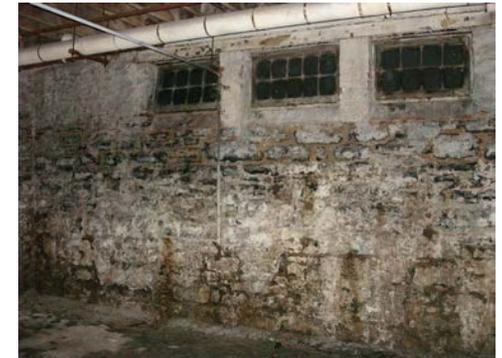
Fig. G.9 Basement water infiltration through wall

infiltration at the basement walls. (Fig. G.9) The damage at water infiltration locations includes: deteriorated and failed plaster, exposing the brick walls, collapsed ceilings and floors and deteriorated wood window sash and trim. (Fig. G.10)

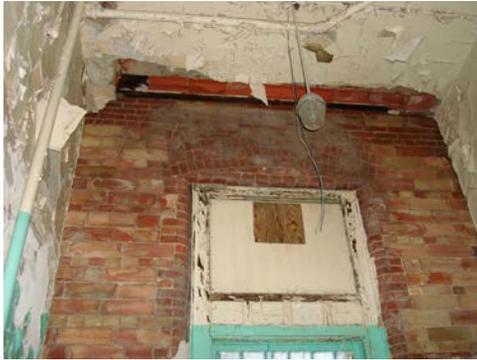
Fig. G.10 Typical interior condition at ongoing water infiltration locations
Image courtesy GCA

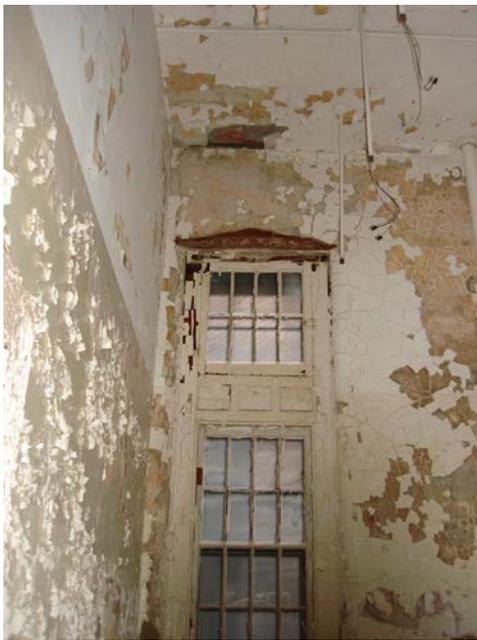
Fig. G.11 Typical interior condition due to high moisture content
Image courtesy GCA

Where the walls and ceilings have not collapsed from water damage, there is significant surface finish damage due to high moisture levels and a lack of ventilation. Paint is generally peeling, the surface coat of plaster is cracked, tin ceilings are rusted, and plaster ceilings are cracked. (Fig. G.11)

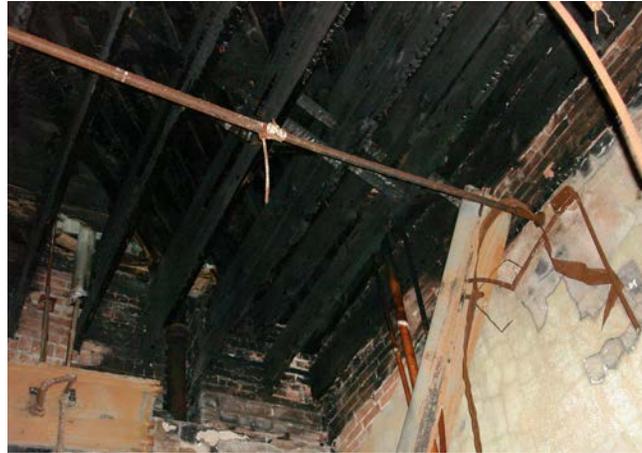
Fig. G.12 Fire damage to Room 10
Image courtesy GCA

There are charred first floor joists and some localized fire damage in Room 10. The fire was fairly contained, although the floor joists will require replacement. (Fig. G.12)

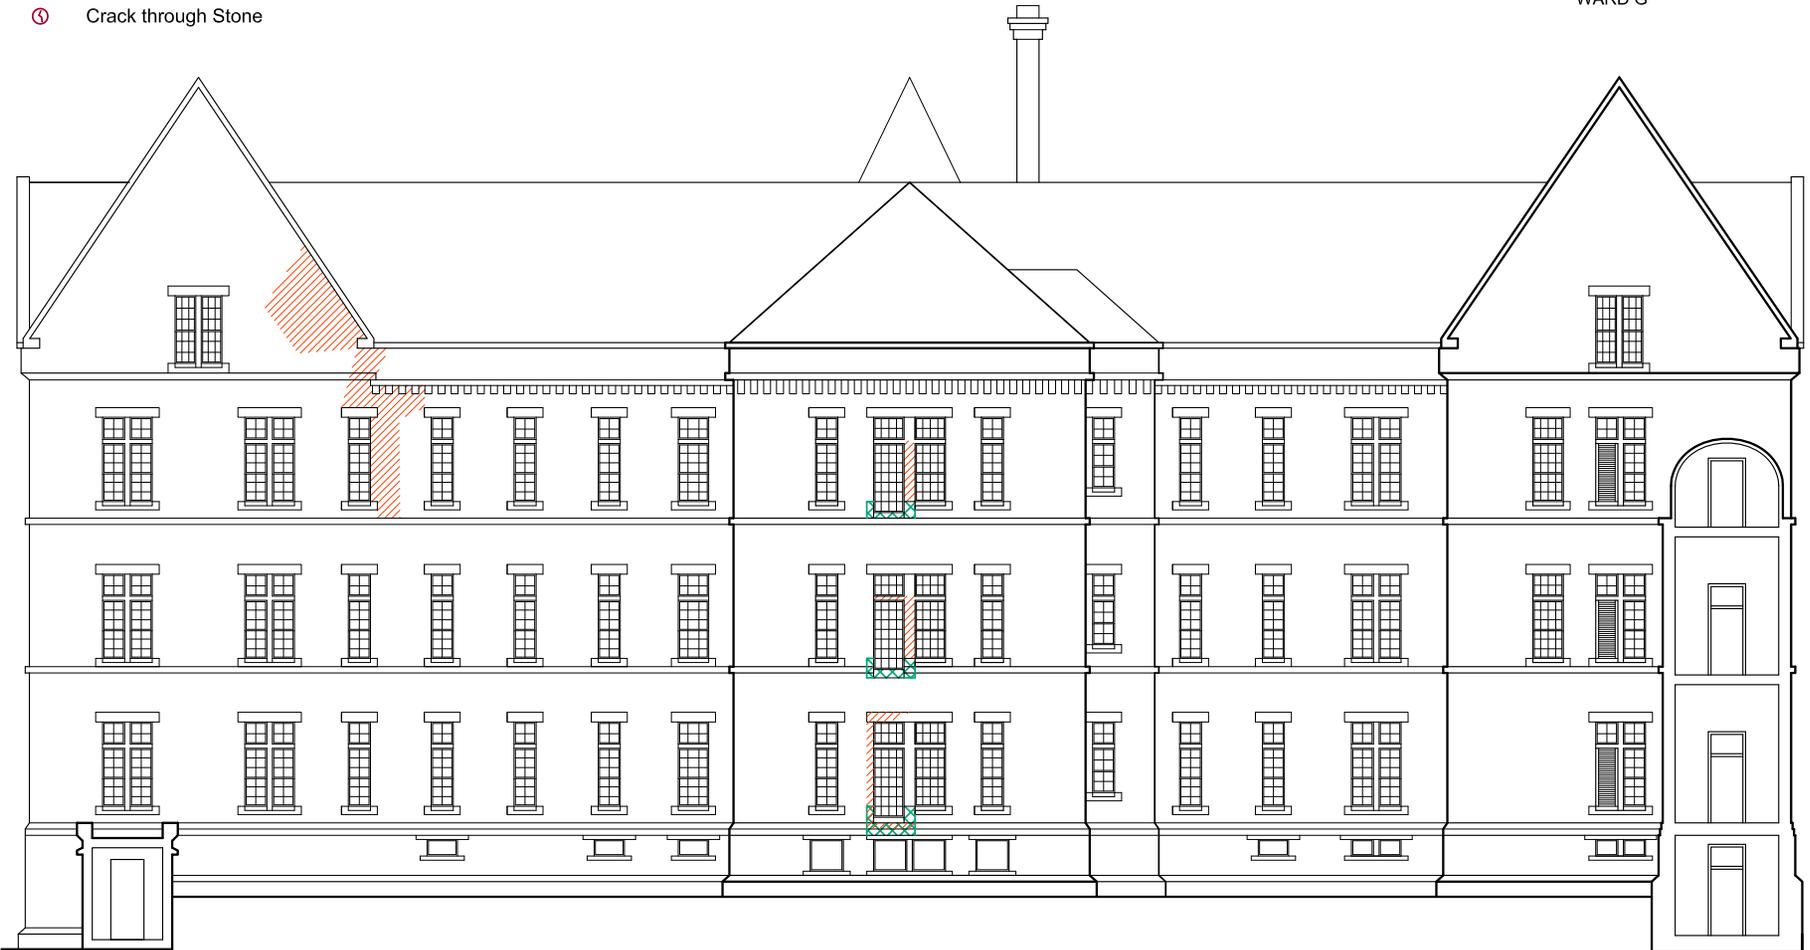
G
2.1 **North Elevation** FEMALE WARD G
These drawings show estimated existing conditions.

Step Cracking	25% Spalling

Rebuilt Areas	40% Staining

Open Joints / Shifting / Masonry Damage	20% Mortar Erosion

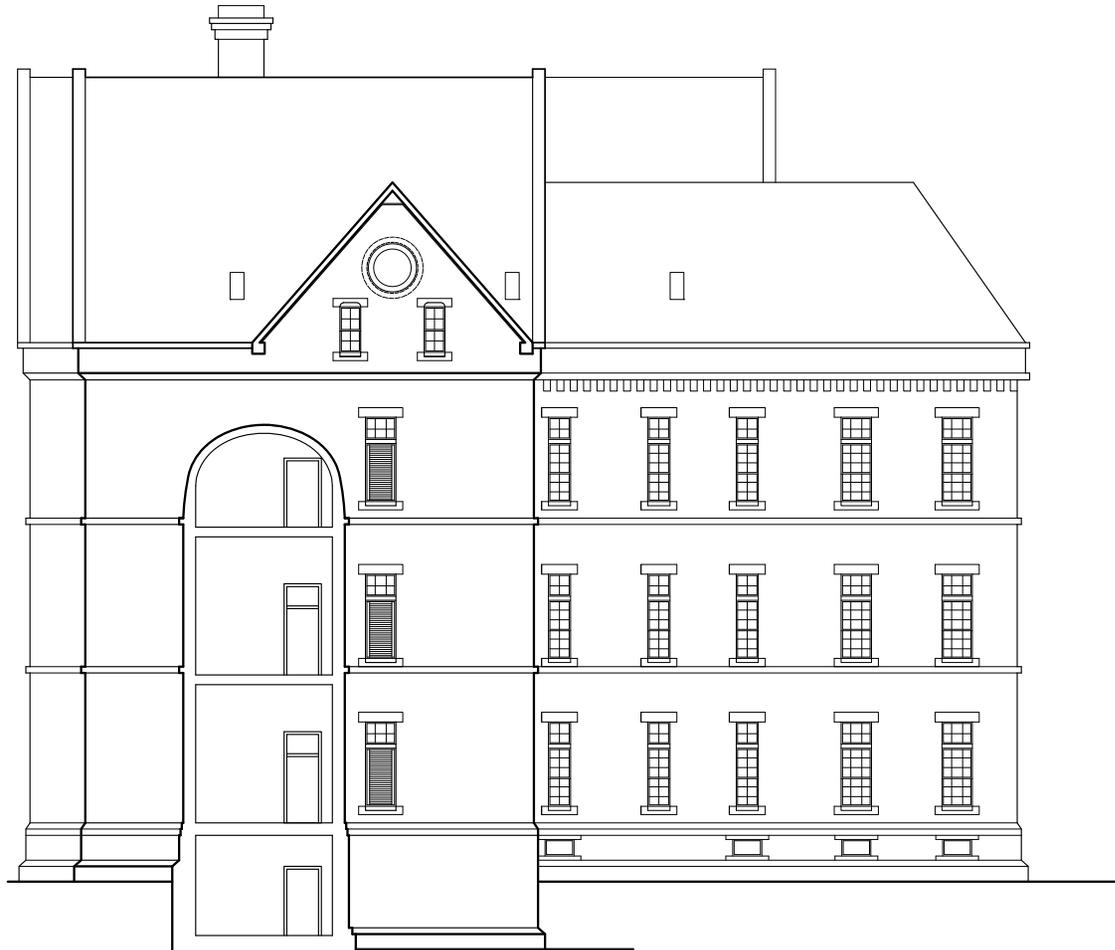
G
2.2 **East Elevation** FEMALE WARD G
These drawings show estimated existing conditions.

Step Cracking	10% Spalling

Rebuilt Areas	50% Staining

Open Joints / Shifting / Masonry Damage	25% Mortar Erosion

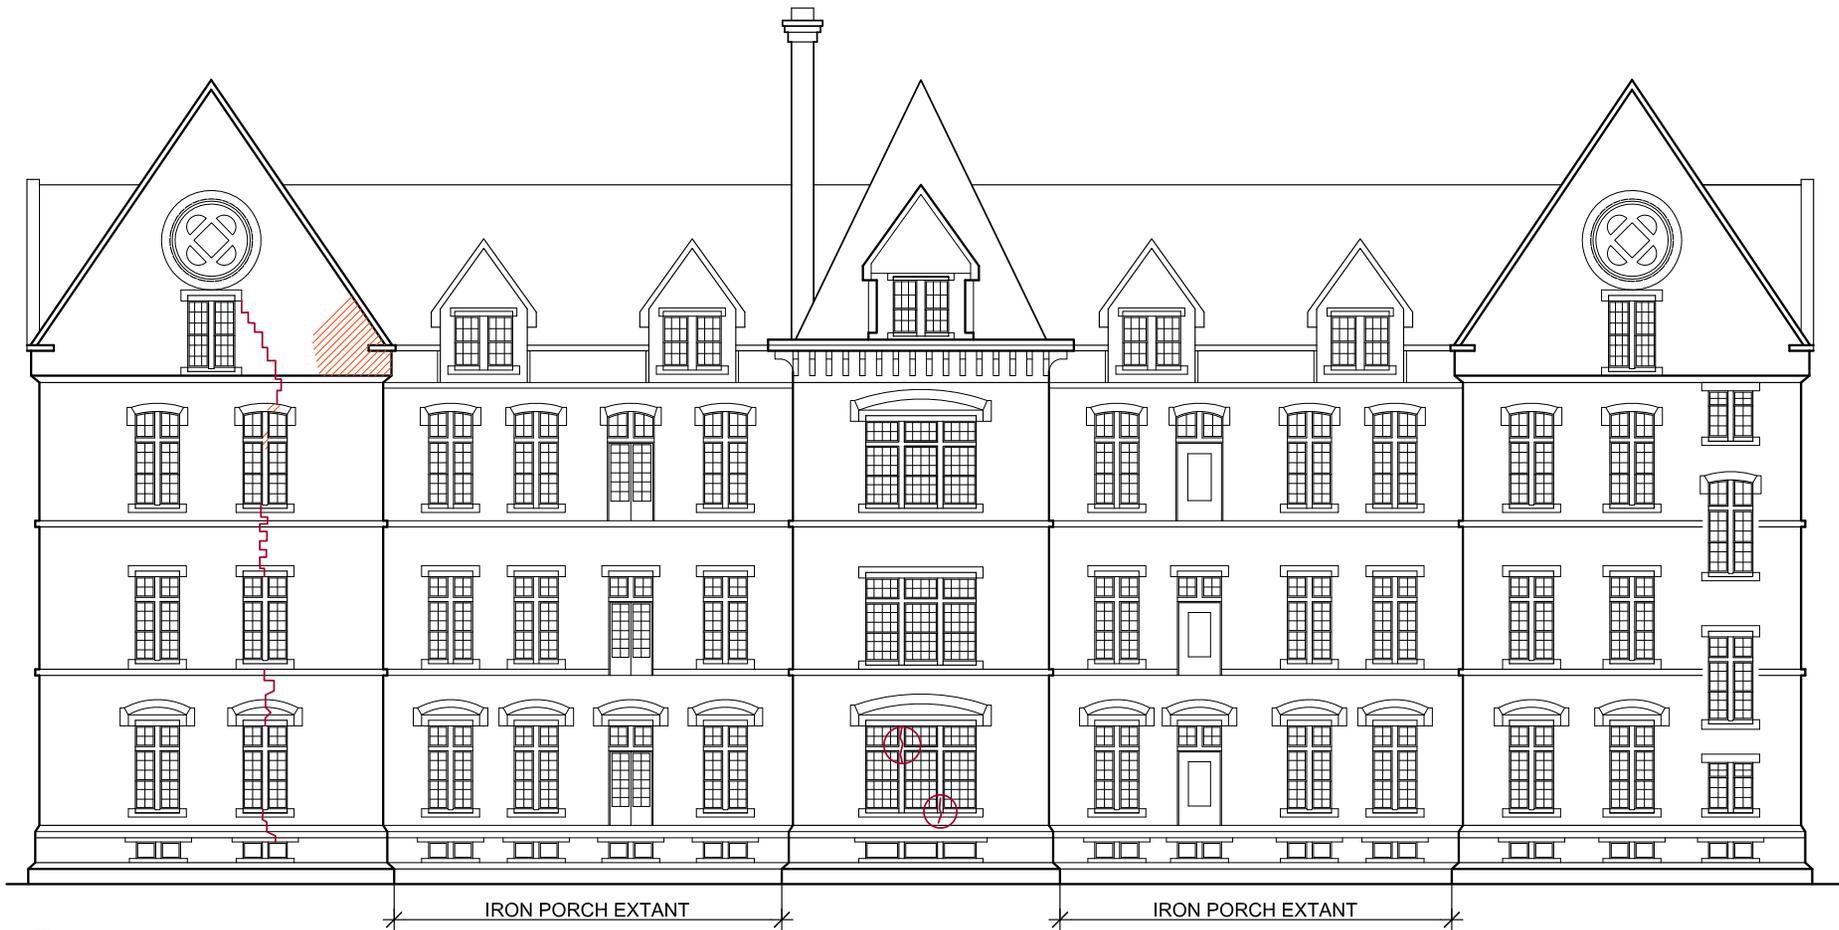
G
2.3 **South Elevation** FEMALE WARD G
These drawings show estimated existing conditions.

| | Step Cracking | 25% Spalling |
| | Rebuilt Areas | 50% Staining |
| | Open Joints / Shifting / Masonry Damage | 25% Mortar Erosion |

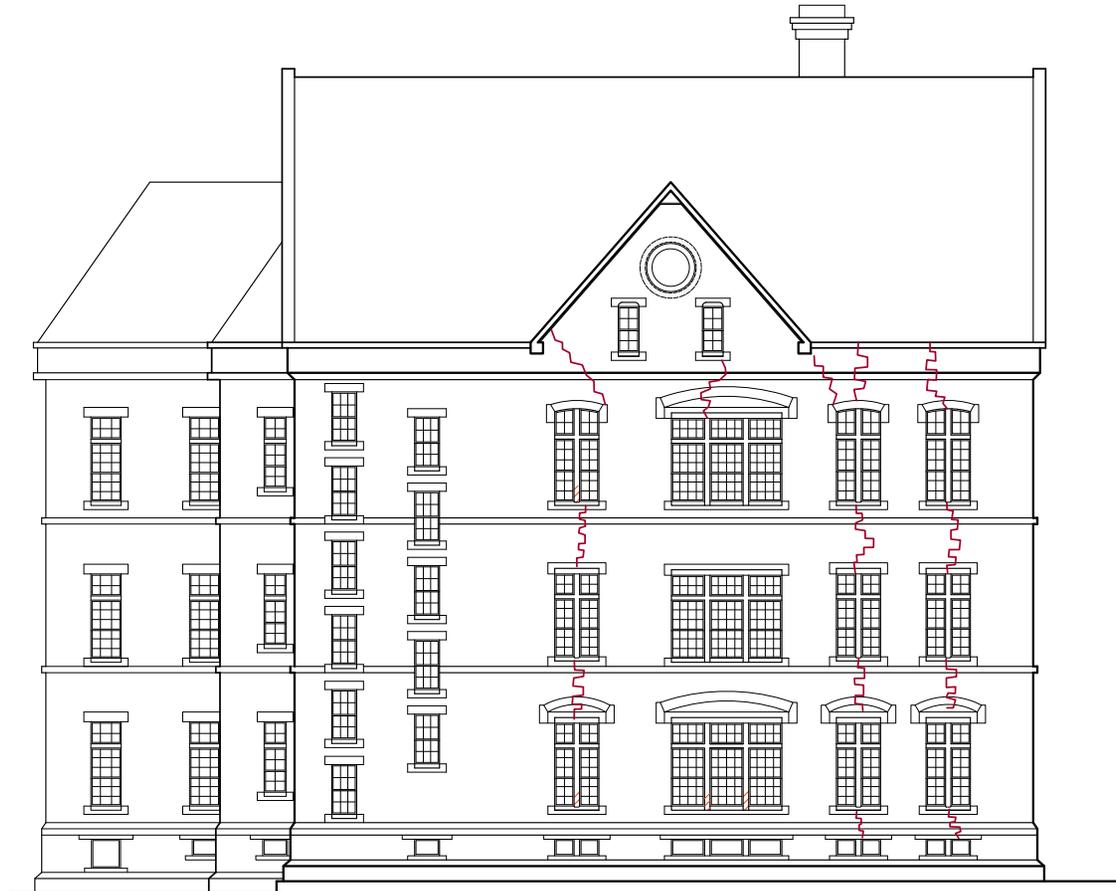
G
2.4 **West Elevation** FEMALE WARD G
These drawings show estimated existing conditions.

50% Spalling

50% Staining

50% Mortar Erosion
