HISTORIC STRUCTURES REPORT

the RICHARDSON OLMSTED COMPLEX *Buffalo, NY*

July 2008

GOODY
CLANCY

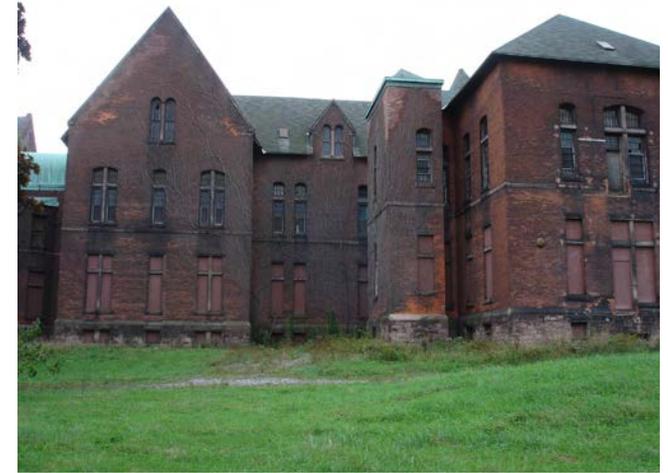
Fig. H.5 **Overall elevation showing soiling and spalling at brick wall**
Image courtesy GCA

The brick is in good condition, with isolated areas of deterioration that can be categorized as poor. The surface contains spalling of 5% on the east, 10% on the south and west, and 20% on the north; fairly extensive atmospheric soiling (50-75%); and limited algae growth on the north elevation. There is extensive ivy growth on the north elevation, covering 100% of some of the walls. (Fig. H.5 & H.6)

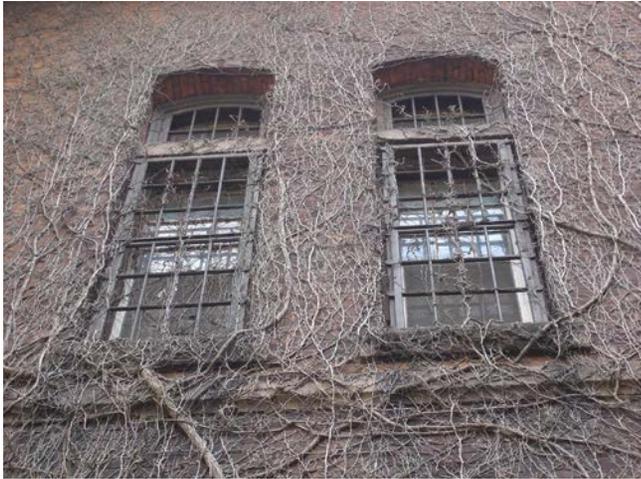
Fig. H.6 **Ivy growth on north elevation**
Image courtesy GCA

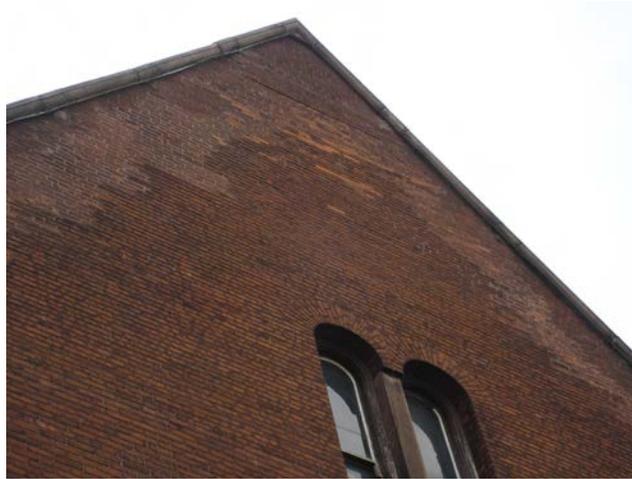
- Large areas of the brick have been rebuilt on the north elevation at the upper areas of the wall, and at the corners. These rebuilt areas are continuing to be saturated and are deteriorating again. (Fig. H.7 & H.9)
- The joints between the gable stones are exposed (there is no flashing over the gable stones), allowing water to infiltrate into the core of the gable wall. Some of the gable stones are lifting due to freeze/thaw action. The saturation of the masonry from the cap stones is also causing accelerated deterioration of the mortar joints in the brick wall directly below the gable. (Fig. H.9)

Fig. H.7 **Detail of previous repointing and ongoing deterioration of masonry**
Image courtesy GCA

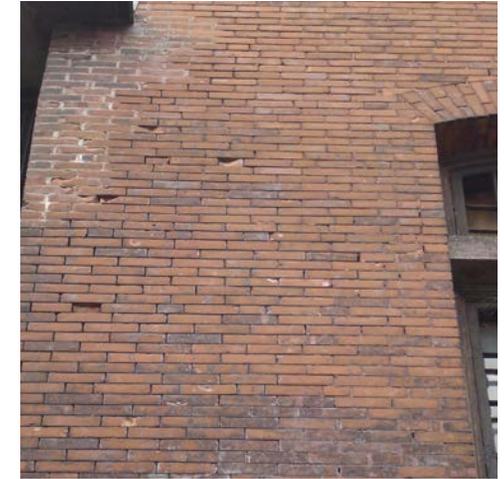
- In areas of water saturation of the brick (below the gable, at the corners) there is efflorescence and spalling of the brick (Fig. H.8)
- Alterations to central north bay for previous fire escape have left exposed brick and inappropriate materials exposed. Window locations expanded to door openings at each floor, bad repairs and infill materials. (Fig. H.10)
- Step cracking occurs in the brick and stone in locations shown on the elevations. (Fig. H.11)
- Some original red mortar visible in porch area. (Fig. H.13)

Fig. H.8 **Efflorescence and spalling of brick**
Image courtesy GCA

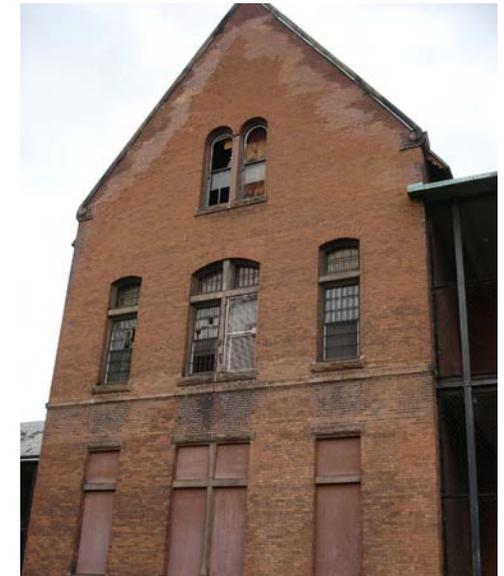
continues to deteriorate, affecting the gable ends and eave areas most severely. (Fig. H.9)

Fig. H.9 **Previous repointing and ongoing deterioration**
Image courtesy GCA

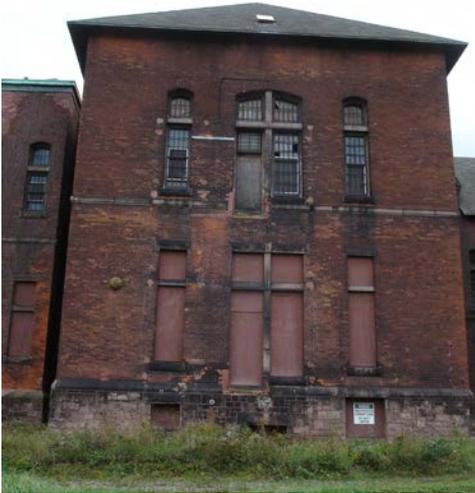
Fig. H.10 Previous alterations for fire escape – north elevation

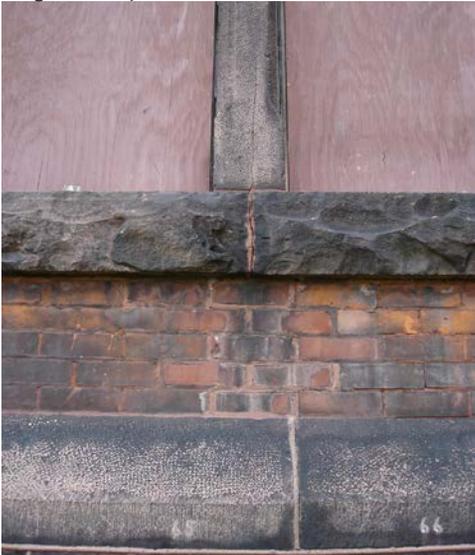
Fig. H.11 Step cracking at brick and stone – north elevation

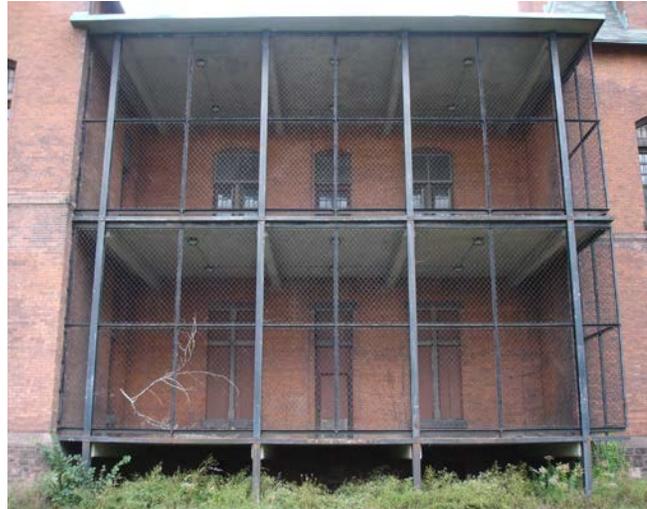
- The iron porches remain on the east and west ends of the south elevation (Fig. H.12). Both are in fair condition

with some rusting of the steel structure, grating and mesh.

Fig. H.12 Porch on south elevation

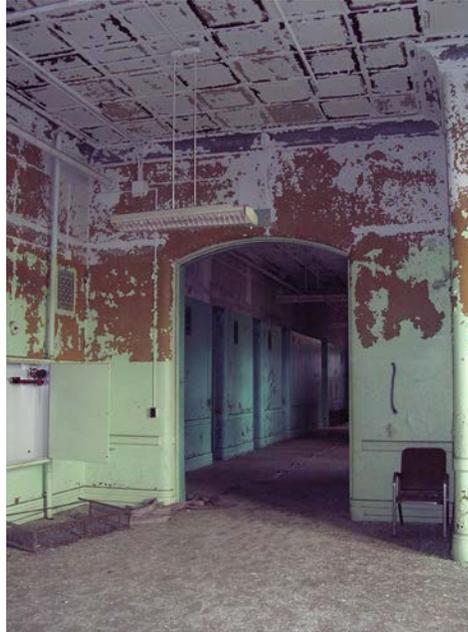
The interior of the building is in good condition, if the condition of the finishes is not taken into account in the assessment. The interior damage is limited and occurs around previous roof leaks and broken internal downspouts. There is limited failure and structural instability in two rooms on the second floor. There is surface finish damage due to high moisture levels and a lack of ventilation. (Fig. H.15) Paint is generally peeling, tin ceilings are rusted, and plaster ceilings are cracked.

Fig. H.15 **Surface finish damage - peeling paint and rusted tin ceilings**
Image courtesy GCA

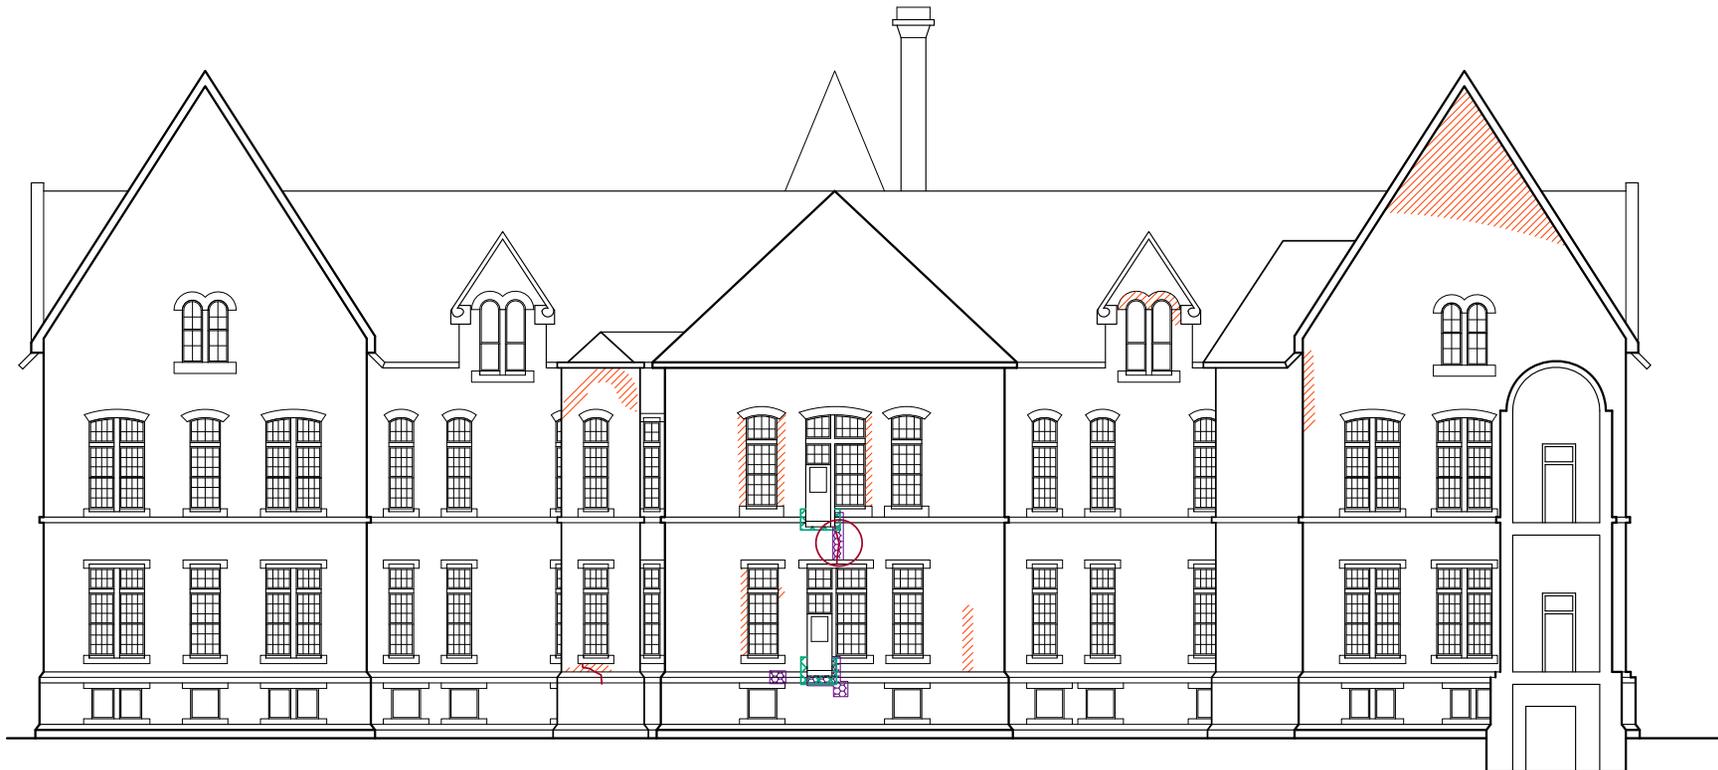
H
2.1 **North Elevation** FEMALE WARD H
These drawings show estimated existing conditions.

Step Cracking	18% Spalling

Rebuilt Areas	68% Staining

Open Joints / Shifting / Masonry Damage	64% Mortar Erosion

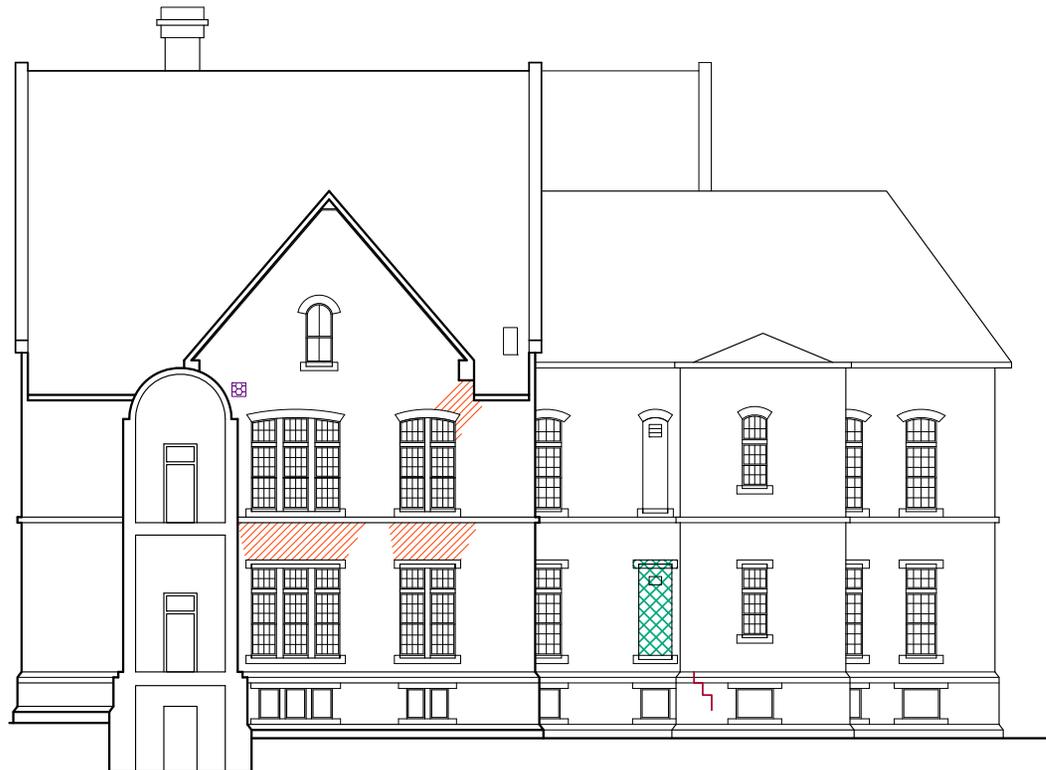
H
2.2

Step Cracking	5% Spalling

Rebuilt Areas	50% Staining

Open Joints / Shifting / Masonry Damage	1% Mortar Erosion

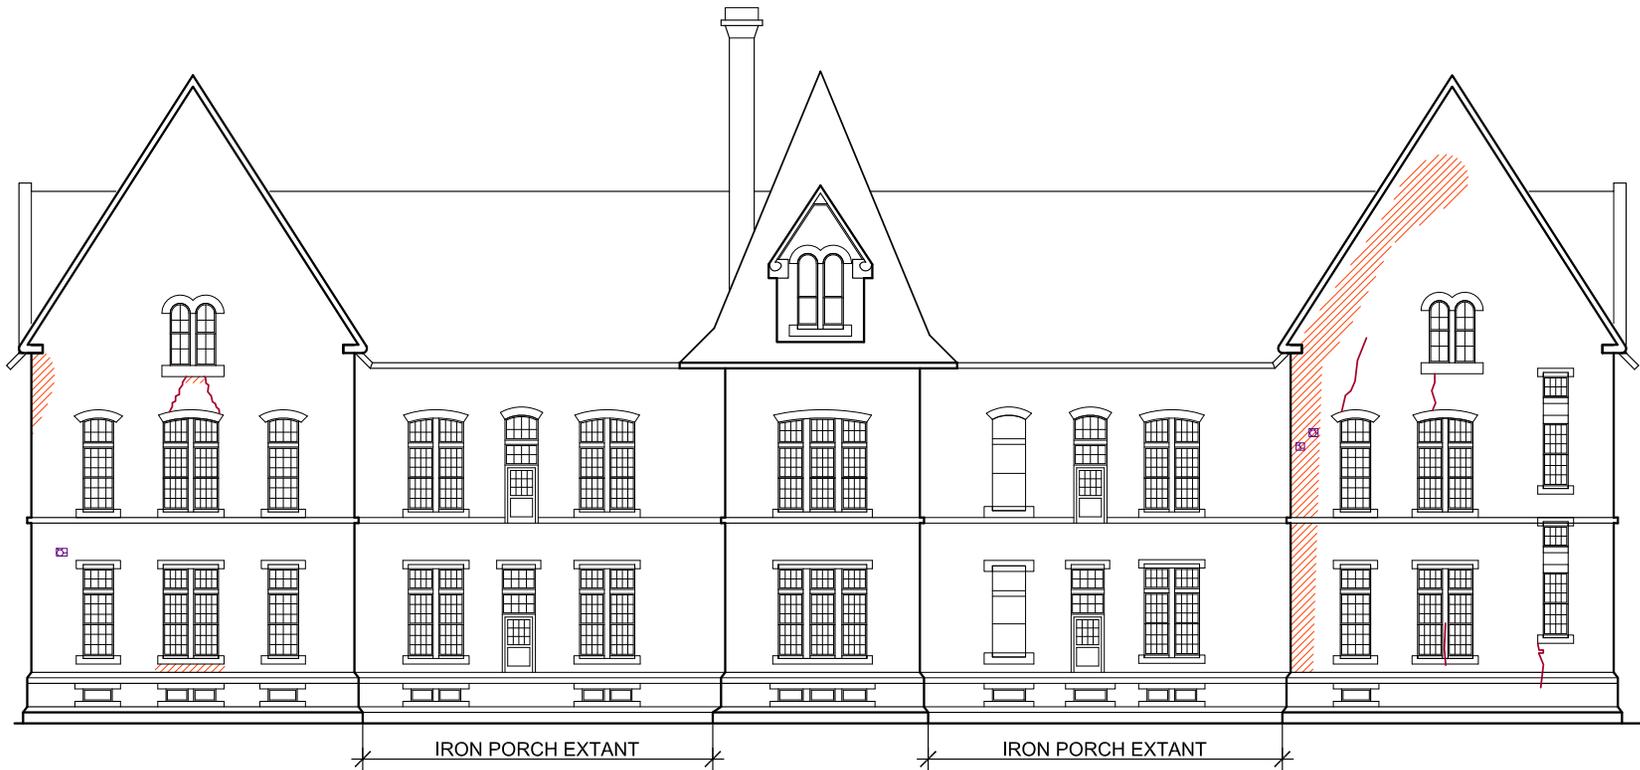
H
2.3 **South Elevation** FEMALE WARD H
These drawings show estimated existing conditions.

12% Spalling

47% Staining

63% Mortar Erosion

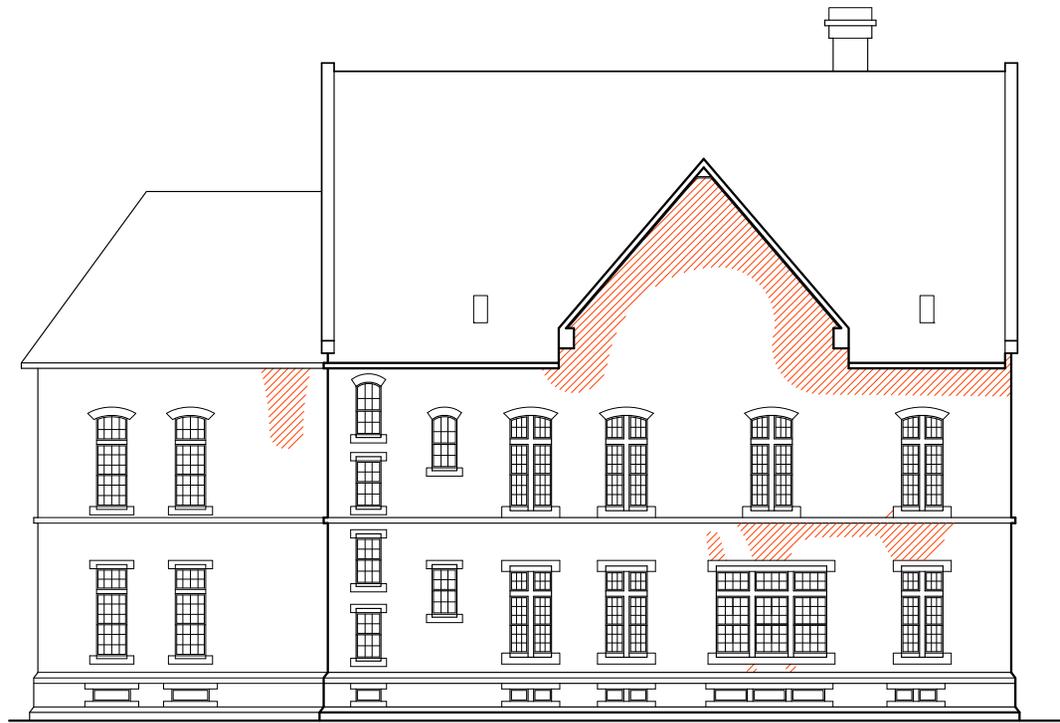
H
2.4

10% Spalling

75% Staining

50% Mortar Erosion

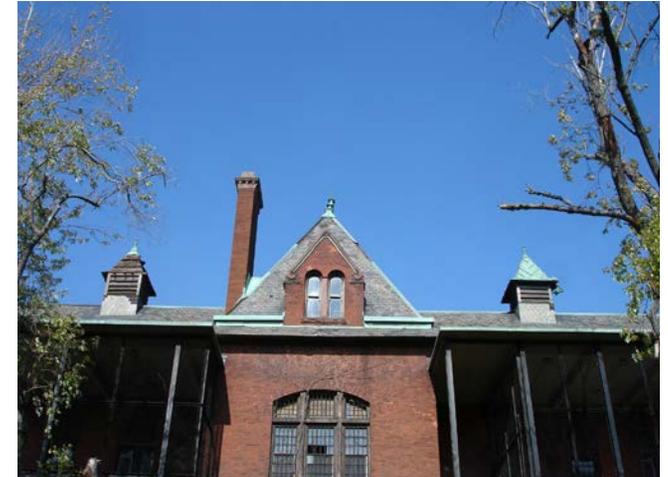
Fig. I.5 **Photo of ventilation cupolas – current condition**
Image courtesy GCA

ventilation cupolas are the only ones remaining on the complex. They are in poor condition but provide a key to understanding the construction and detailing of these important components. (Fig. I.5)

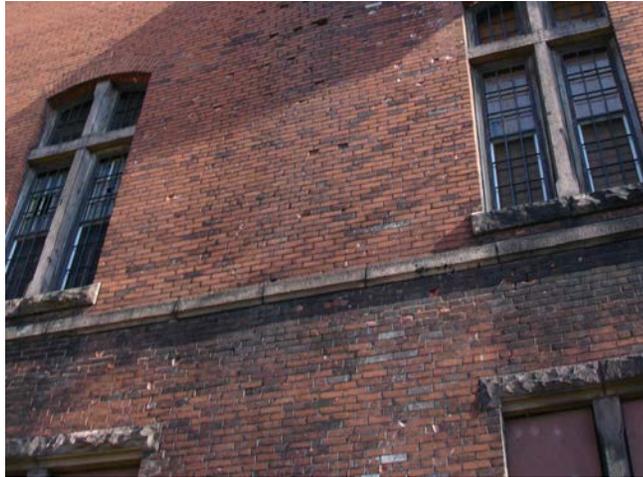
The surface contains spalling of 5% on the west and south, 20% on the north, and 40% on the east; fairly extensive atmospheric soiling (20-50%); and limited algae growth on the north elevation. There is extensive ivy growth on the north elevation, covering 100% of some of the walls. (Fig. I.6)

Fig. I.6 **Surface conditions of brick showing spalling, efflorescence and soiling**

- The joints between the gable stones are exposed (there is no flashing over the gable stones), allowing water to infiltrate into the core of the gable wall. Some of the gable stones are lifting due to freeze/thaw action. The saturation of the masonry from the cap stones is also causing accelerated deterioration of the mortar joints in the brick wall directly below the gable. (Fig. I.10)
- In areas of water saturation of the brick (below the scuppers, at the corners, etc.) there is efflorescence and spalling of the brick (Fig. I.6)

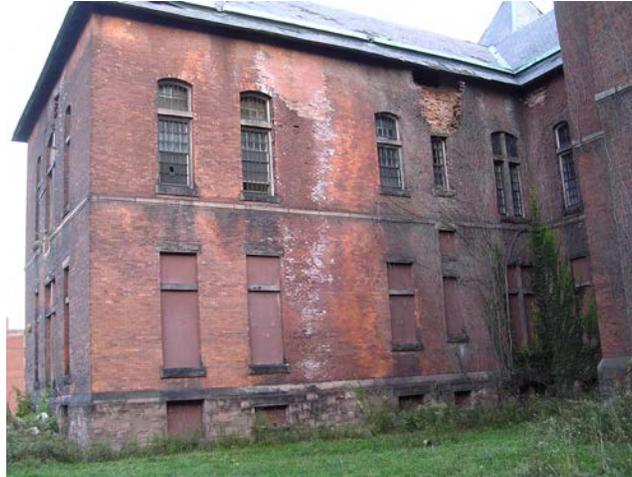
The mortar joint erosion ranges from 50% on the north and west elevations to 100% on the east elevation. There is evidence of several repointing campaigns. Due to ongoing water infiltration and saturation, the mortar (often in the areas of previous repair) continues to deteriorate, affecting the gable ends and eave areas most severely. (Fig. I.7)

Fig. I.7 **Saturated masonry and mortar deterioration**

These rebuilt areas are continuing to be saturated and are deteriorating again. (Fig. I.7)

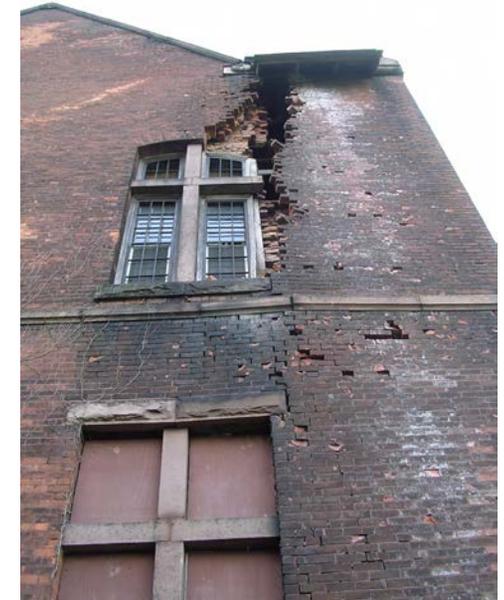
- Large areas of brick have failed on the north elevations of the building. In some instances the outer wythe of brick is missing, exposing the brick inner wythes. In other instances, all wythes of brick have failed, creating a hole in the masonry wall. These conditions occur at internal failed drains. (Fig. I.8 & I.9)
- Large areas of the brick have been rebuilt on the north elevation at the upper areas of the wall, and at the corners.

Fig. I.8 **Brick failure at north elevation**

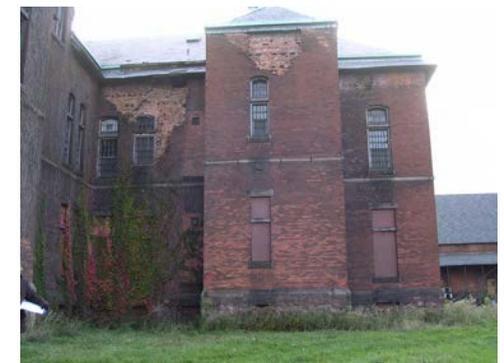
Fig. I.9 **Brick failure at north elevation**

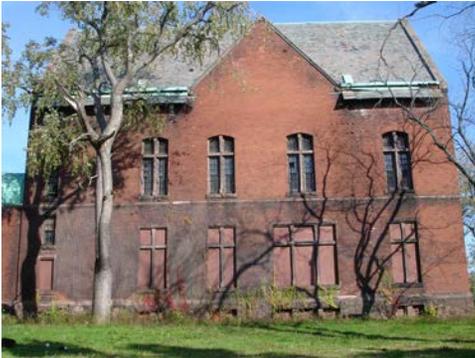
Fig. I.10 Saturated masonry and mortar failure below gable capstone
Image courtesy GCA

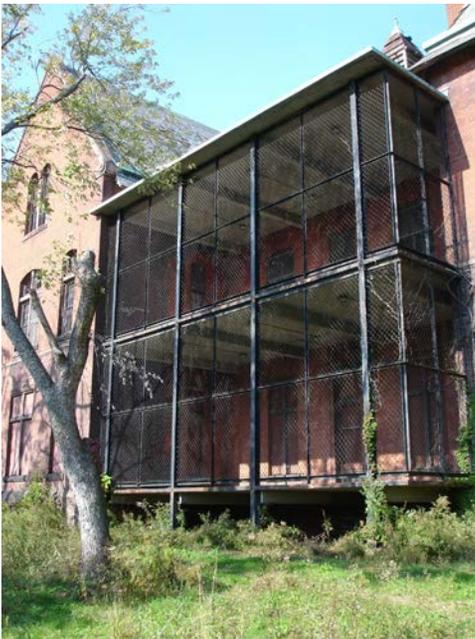
- The iron porches remain on the east and west ends of the south elevation (Fig. I.11). Both are in fair condition with

Fig. I.11 South elevation iron porch
Image courtesy GCA

some rusting of the steel structure, grating and mesh.

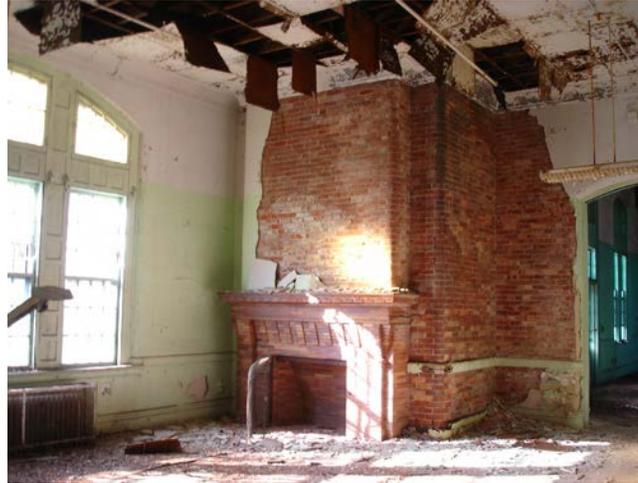
Fig. I.12 Surface finish damage - missing plaster exposing brick, rusted tin ceiling - at fireplace
Image courtesy GCA

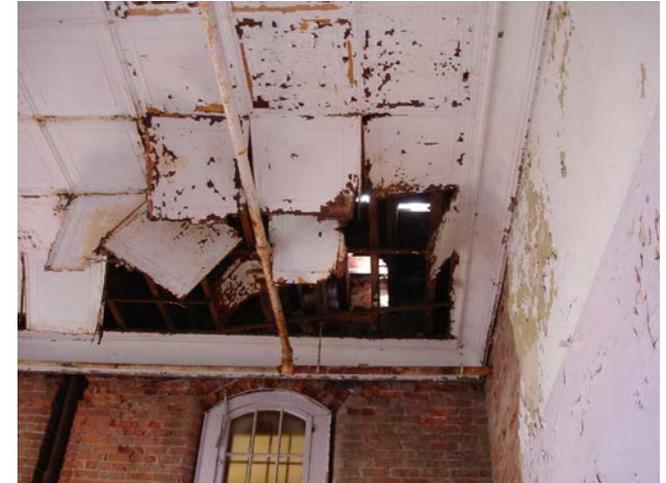
Fig. I.13 Rusted tin ceiling and structural damage
Image courtesy GCA

damage is concentrated in areas of previous and current roof leaks and broken internal downspouts. There is failure and structural instability in rooms at the east and west ends of the building on the first and second floors. Extensive plaster failure has occurred, exposing the underlying brick walls. In all areas there is surface finish damage due to high moisture levels and a lack of ventilation. (Fig. I.12) Paint is generally peeling, tin ceilings are rusted (Fig. I.13), and plaster ceilings are cracked.

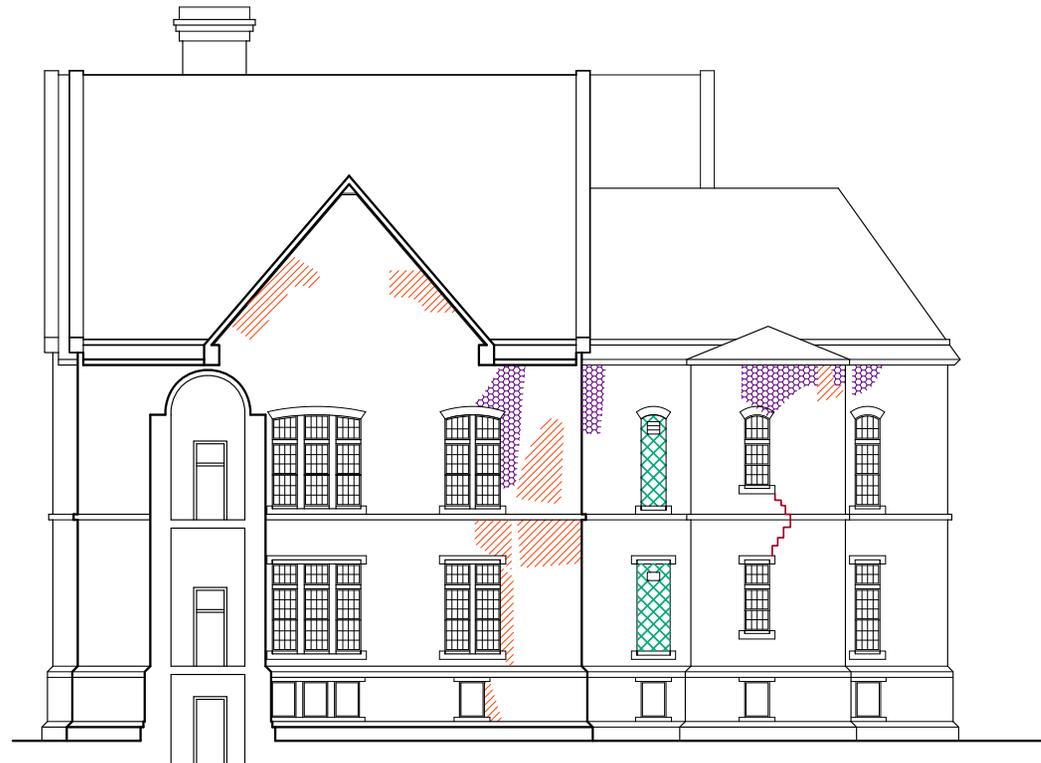
I
2.2

Step Cracking	40% Spalling

Rebuilt Areas	50% Staining

Open Joints / Shifting / Masonry Damage	100% Mortar Erosion

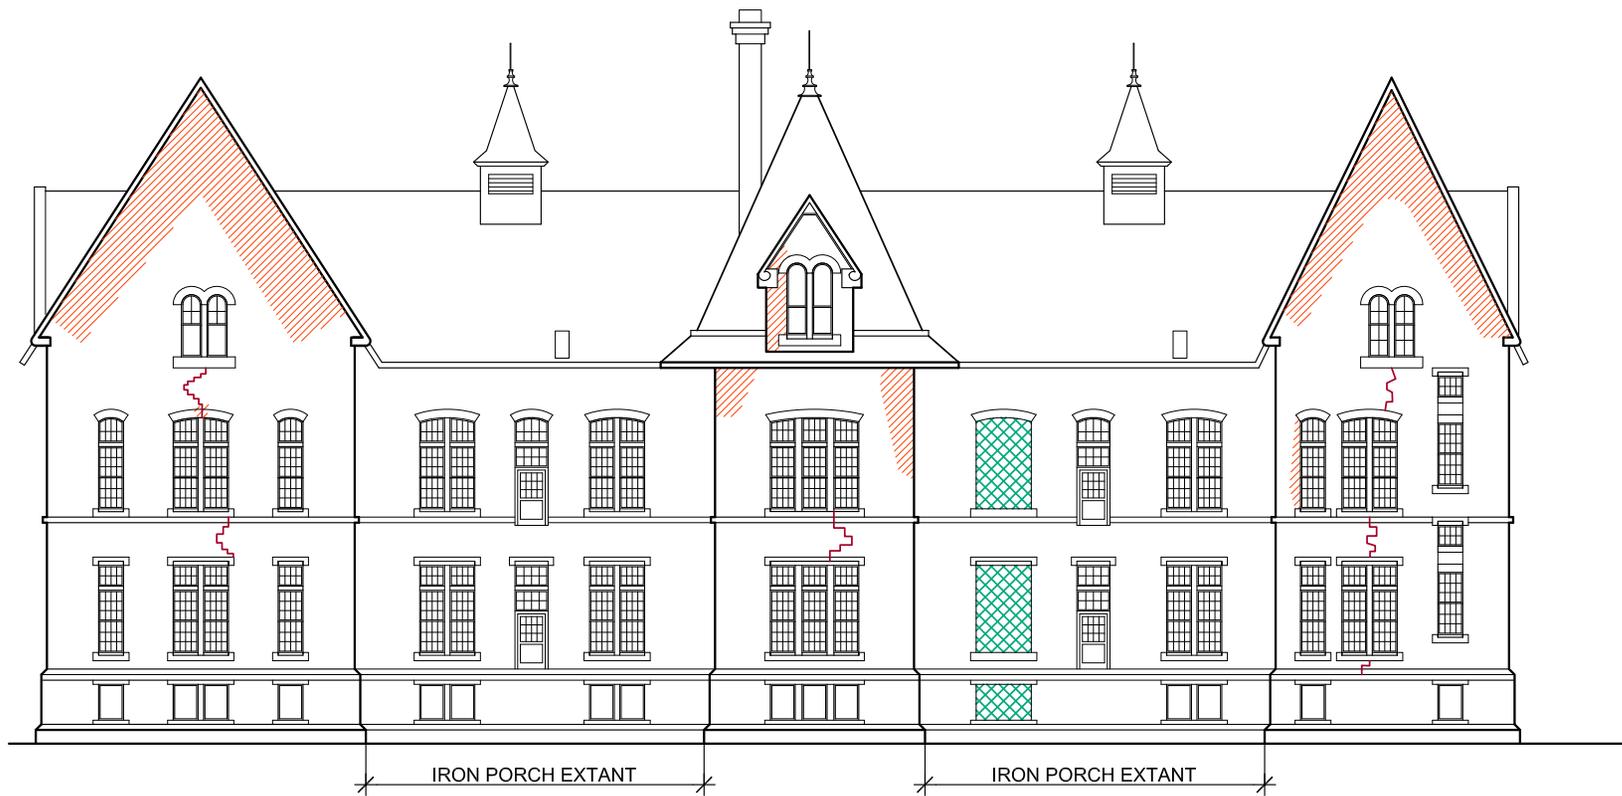
I
2.3 **South Elevation** FEMALE WARD I
These drawings show estimated existing conditions.

Step Cracking	6% Spalling

Rebuilt Areas	19% Staining

Open Joints / Shifting / Masonry Damage	24% Mortar Erosion

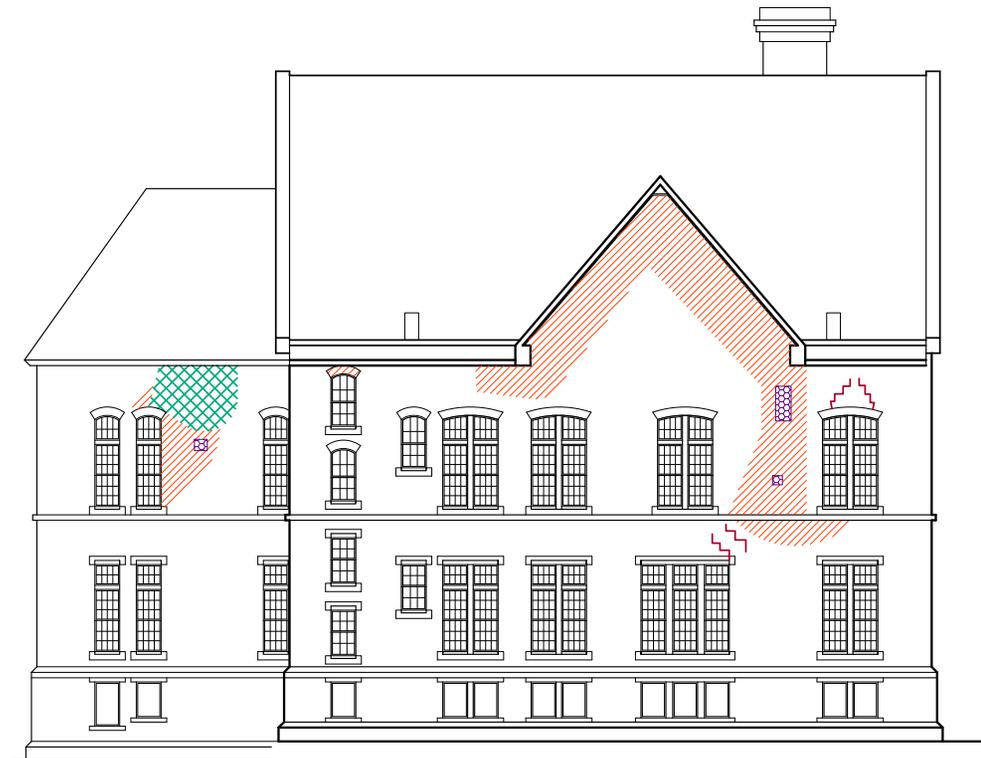
I
2.4

5% Spalling

10% Staining

50% Mortar Erosion

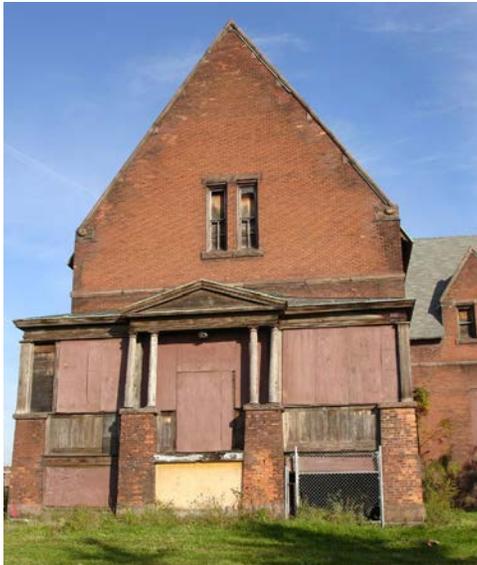
Fig. J.5 **West wall of north wing with wooden porch - area of bulging and previous stabilization efforts**

In general, the brick is in fair condition. The brick on the north and east elevations contain isolated areas of collapse. (Fig. J.3) The brick surrounding the areas of collapse appears, outside the areas of saturation; appear to be in sound condition. There is evidence of previous rebuilding on the north elevation. (Fig. J.4) These areas are still being saturated and are beginning to fail again. The south wall of the north wing contains a bulge outward that has been stabilized with straps in the past. (Fig. J.5)

- An iron porch remains on the east elevation. (Fig. J.7) The steel structure, grating and mesh are of a finer material and profile than the extant porches on the south elevations. This porch may be an example of the materials and scale of the earlier (1890's) porches that were built. It is in poor condition with the steel rusting and collapse of the concrete floor in some locations.
- A wooden neo-classical style porch was constructed on the west elevation, possibly as early as 1900. The porch is in poor condition with wood deterioration and partial collapse. (Fig. J.5)

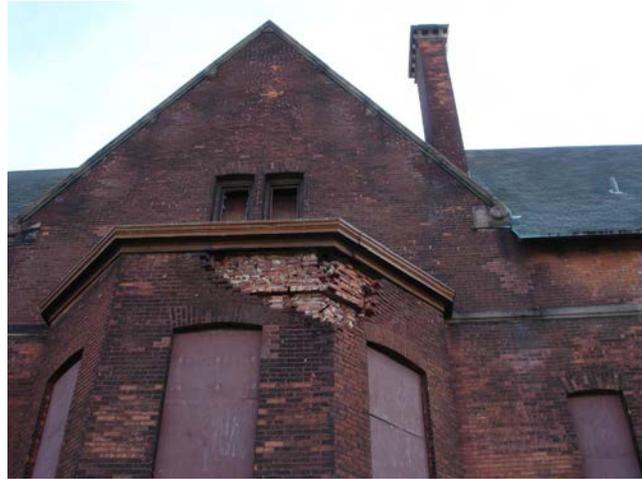
Fig. J.3 **Areas of brick collapse on north elevation**
Image courtesy GCA

- Isolated areas of brick have failed on the north and east elevations of the building. The outer wythe of brick is missing, exposing the brick inner wythes. (Fig. J.3)
- Areas of the brick have been rebuilt on the north elevation at the upper areas of the wall, and at the corners. These rebuilt areas are continuing to be saturated and are deteriorating again. (Fig. J.4)
- In areas of water saturation of the brick (below the gables, at the corners, etc.) there is efflorescence and spalling of the brick (Fig. J.6)

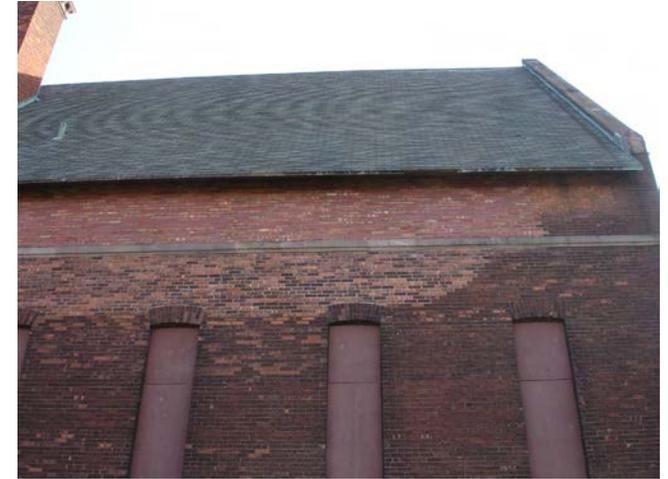
Fig. J.4 **Area of previous brick rebuilding on north elevation**
Image courtesy GCA

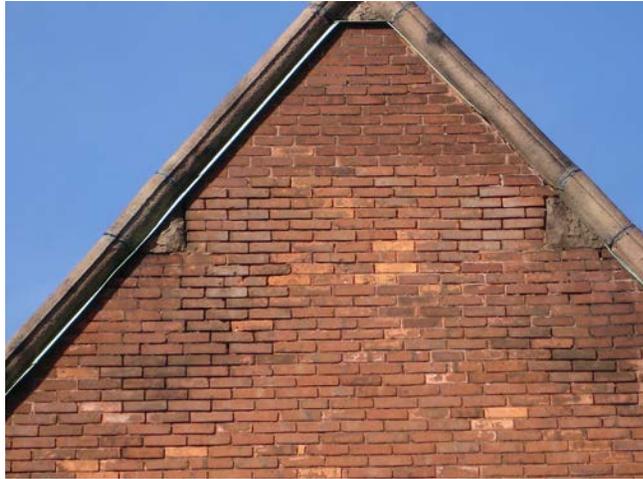
The surface contains spalling of between 5-25%; fairly extensive atmospheric soiling (30-80%); and limited algae growth on the north elevation. (Fig. J.6)

water infiltration and saturation, the mortar (often in the areas of previous repair) continues to deteriorate, affecting the gable ends and eave areas most severely. (Fig. J.6)

Fig. J.6 **Typical soiling, spalling and open joints at brick gables**
Image courtesy GCA

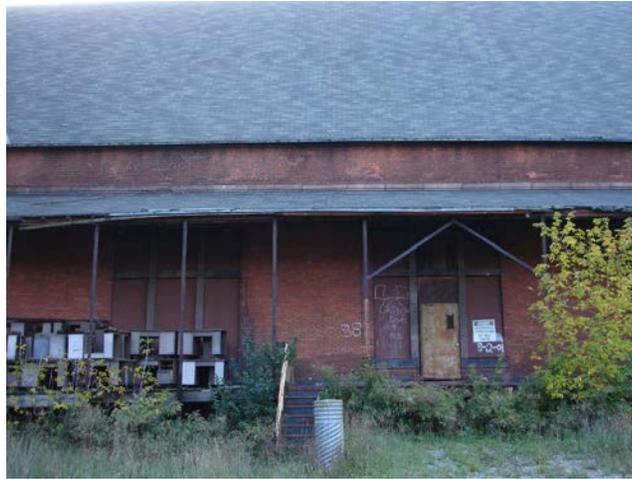
Fig. J.7 **Iron porch on west elevation**
Image courtesy GCA

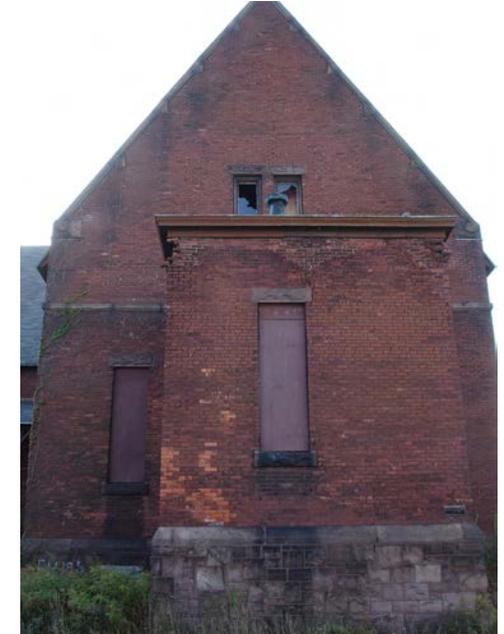
- Areas of step cracking between the windows appear to be due to water saturation and bulging of the brick from the inner wythe. (Fig. J.8)

Fig. J.8 **East elevation showing areas of collapse and step cracking above attic window**
Image courtesy GCA

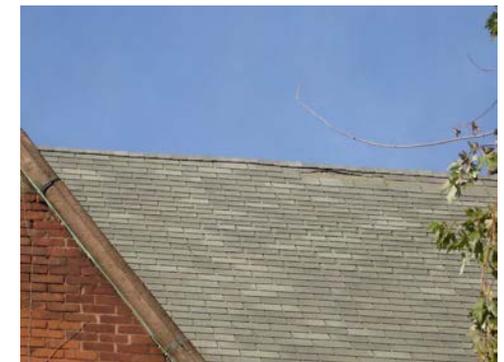
- The roof is covered in asphalt 3 tab shingles, possibly dating to the 1970's or 1980's. It is in poor condition with no open holes and a few areas of missing shingles. The roof was described as in poor condition in the 2002 existing conditions report. (Fig. J.9)
- The original copper valleys and some flashing remain on the roof. The gutter was shingled over to eliminate the problem of broken internal downspouts that were diverting water to the interior of the building.
- Wide, wooden overhanging eave with decorative "rafter tails" projecting out from face of building.

Fig. J.9 **Typical condition of asphalt shingle roof**
Image courtesy GCA

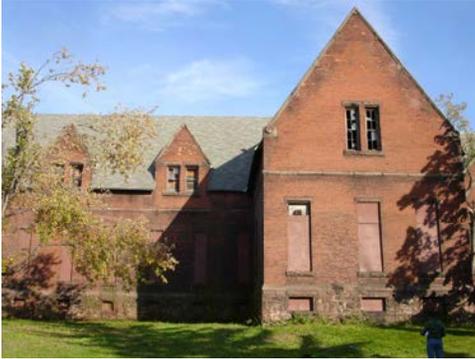
- The basement and first floor windows are covered with plywood. (Fig. J.10)

Fig. J.10 South elevation showing plywood coverings on lower windows and broken panes on attic windows

- The attic windows have no protective covering or bars.
- Most of the window panes are broken.

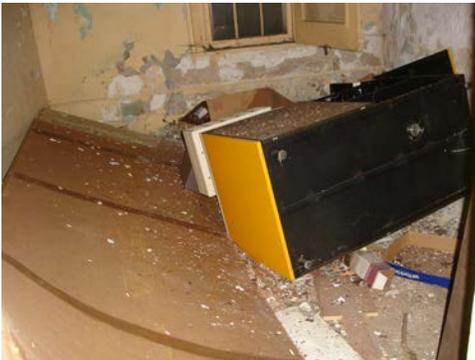
Fig. J.11 Partially collapsed floor in west end
Image courtesy GCA

The interior of the building is in fair condition. The interior damage is concentrated in areas of previous and current roof leaks and broken internal downspouts. There are collapsed floors in the west end of the building. (Fig. J.11) Extensive plaster failure has occurred, exposing the underlying brick walls. (Fig. J.12) In all areas there is surface finish damage due to high moisture levels and a lack of ventilation. Paint is generally peeling, tin ceilings are rusted, and plaster ceilings are cracked. (Fig. J.13)

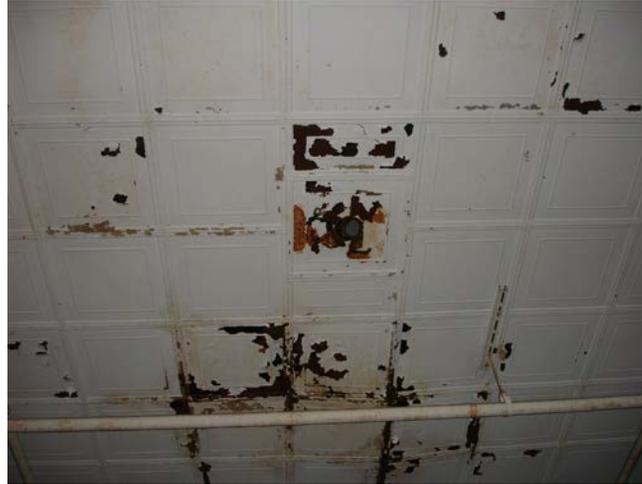
Fig. J.12 Area of water infiltration exposing framing
Image courtesy GCA

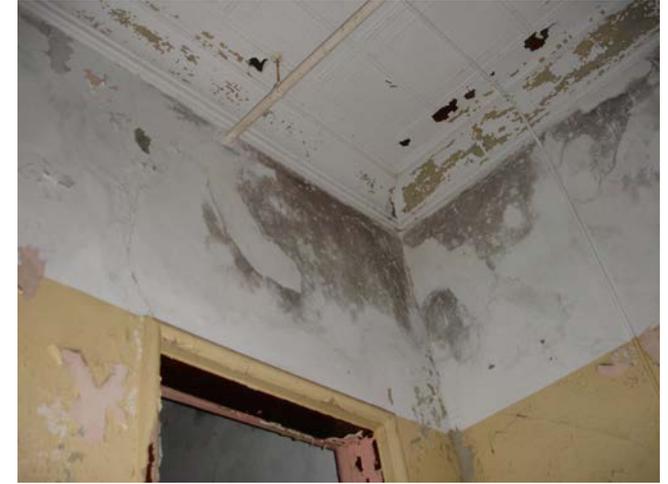
Fig. J.13 Typical condition of surfaces due to moisture - peeling paint, mold, rusted ceilings
Image courtesy GCA

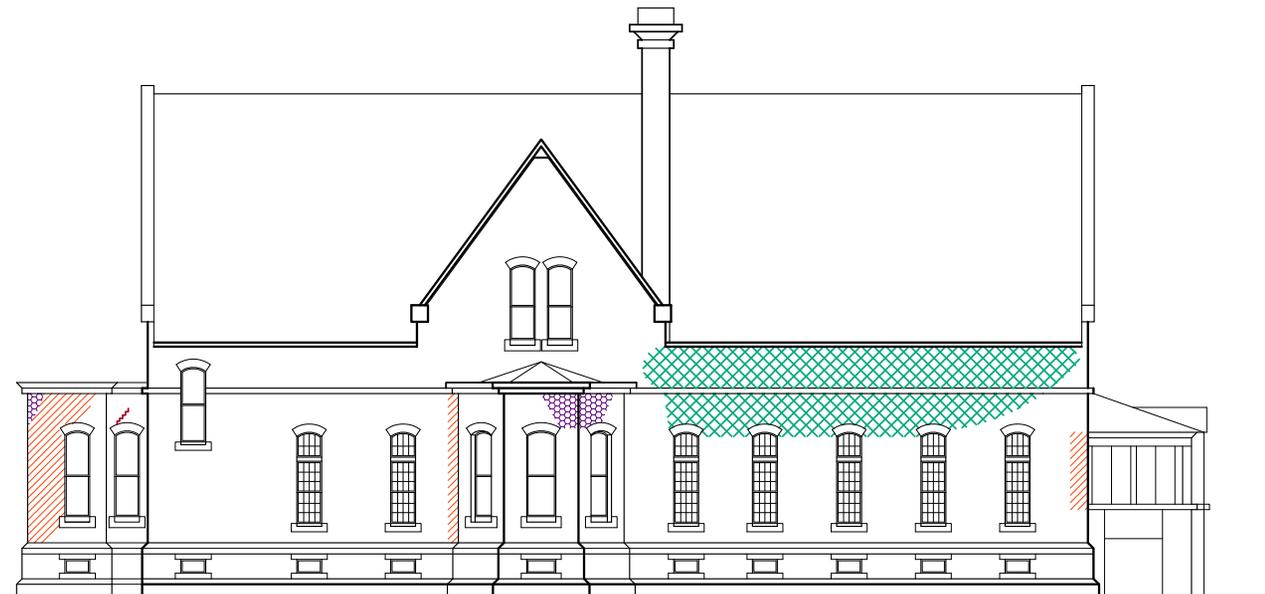
J
2.1

Step Cracking	25% Spalling

Rebuilt Areas	80% Staining

Open Joints / Shifting / Masonry Damage	40% Mortar Erosion

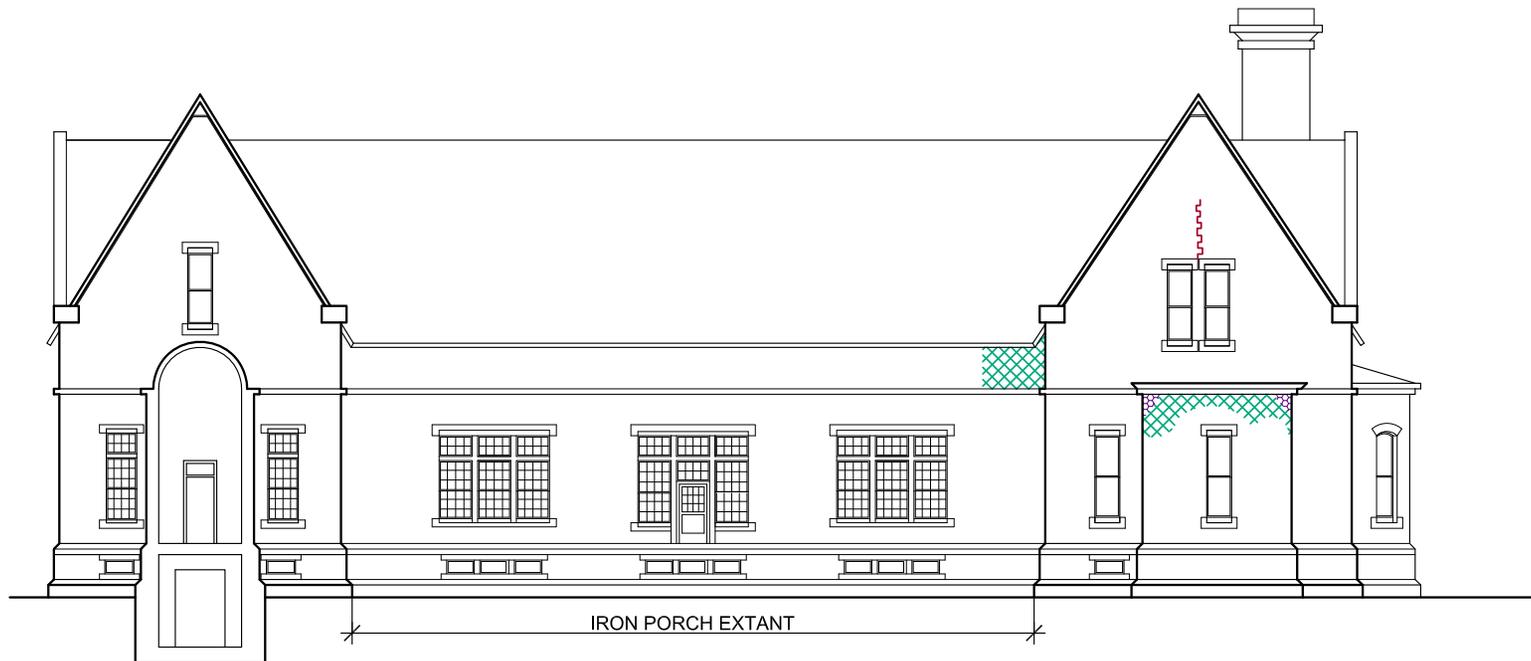
J
2.2 **East Elevation** FEMALE WARD J
These drawings show estimated existing conditions.

Step Cracking	9% Spalling

Rebuilt Areas	29% Staining

Open Joints / Shifting / Masonry Damage	23% Mortar Erosion

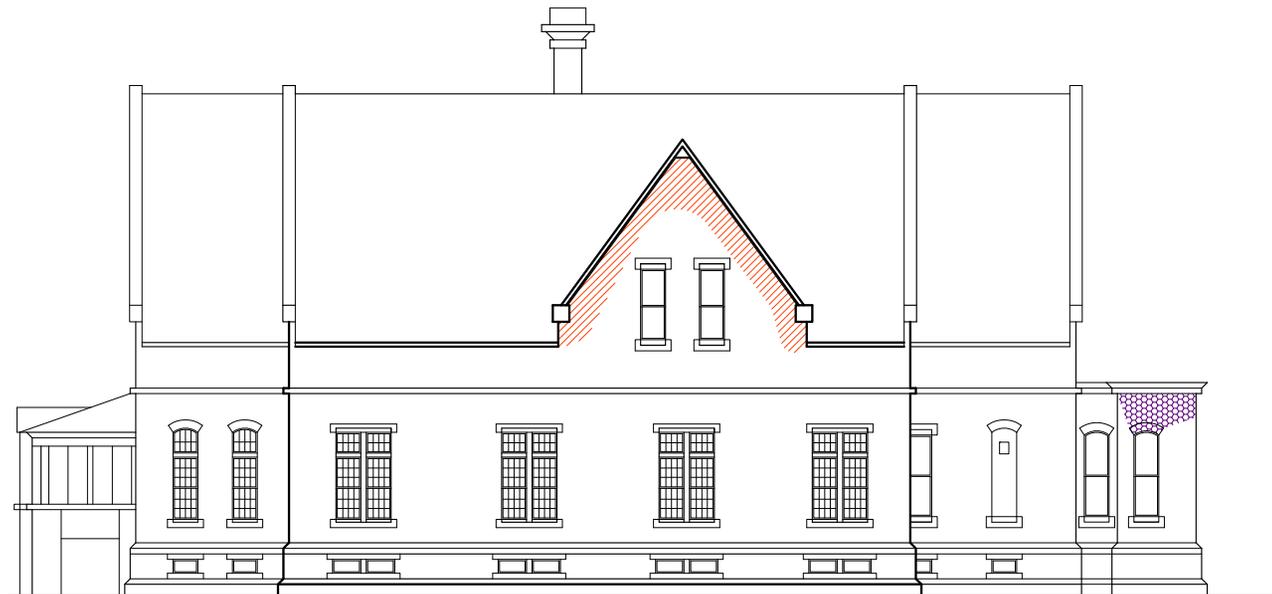
J
2.3

5% Spalling

65% Staining

50% Mortar Erosion

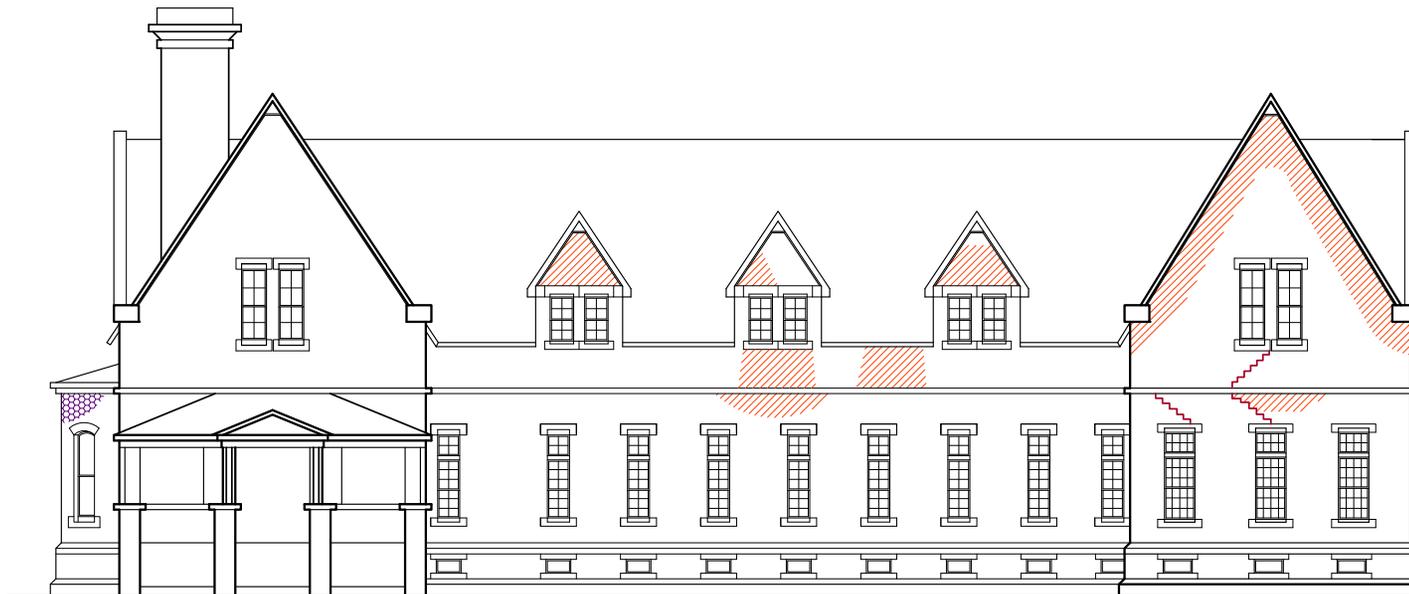
J
2.4 **West Elevation** FEMALE WARD J
These drawings show estimated existing conditions.

Step Cracking	4% Spalling

Rebuilt Areas	49% Staining

Open Joints / Shifting / Masonry Damage	38% Mortar Erosion

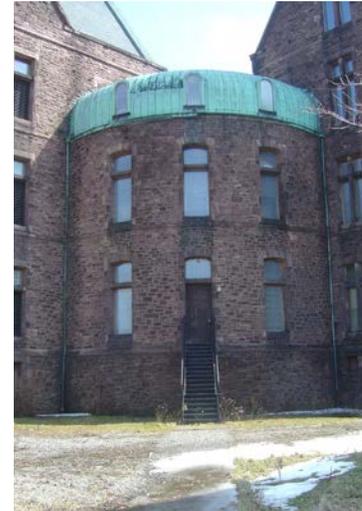
- Historic photos show flat roof at connector. Currently has domed copper roof.
- Vaulted copper with arched windows.
- Aged condition
- Masonry
- Open mortar joints in masonry – 15-20%
- Spalling 15-25%
- Staining 40-50%
- Lots of open joints in central bay b/w windows
- Open joints all along roof cornice

Fig. A-B.2 **Connector A-B North Elevation**
Image courtesy GCA

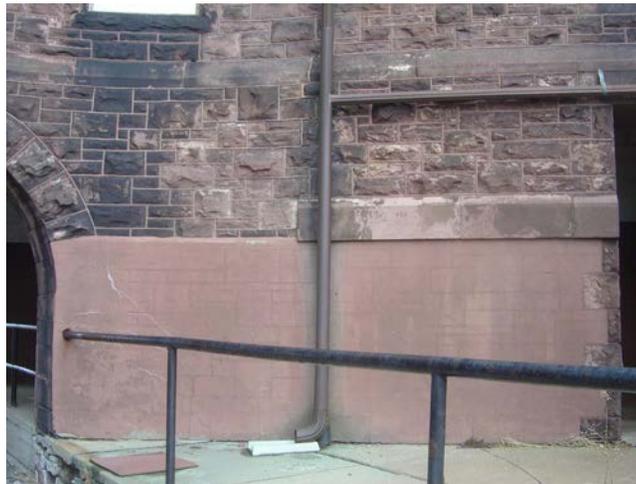
- Open mortar joints in masonry – 10-30%
- Spalling 20-25%
- Staining 50-80%
- Algae in lower level at junction with main buildings
- Open joints along arched entryway
- Step crack at junction with admin bldg (Fig. AB-F.3)
- Previous repair of open joints along roof cornice
- Stucco surface – south elevation at elevator installation

Fig. AB-F.3 **Crack at junction with main building**
Image courtesy GCA

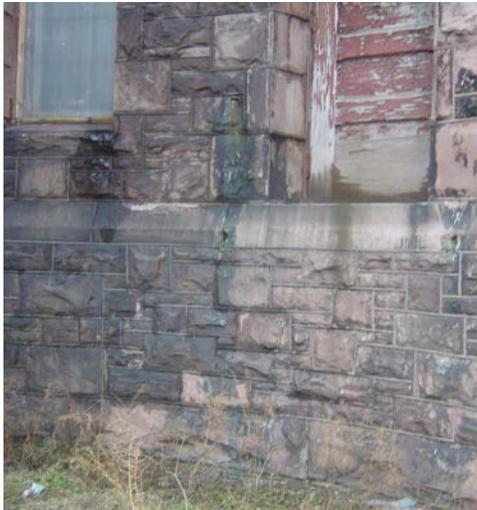
Fig. F-G.3 **North elevation door opening, step crack below**
Image courtesy GCA

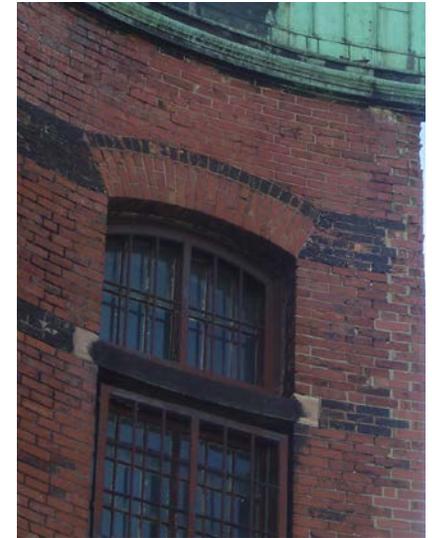
Fig. B-C.3 **Tarred Brick Detail**
Image courtesy GCA
