HISTORIC STRUCTURES REPORT

the RICHARDSON OLMSTED COMPLEX *Buffalo, NY*

July 2008

GOODY
CLANCY

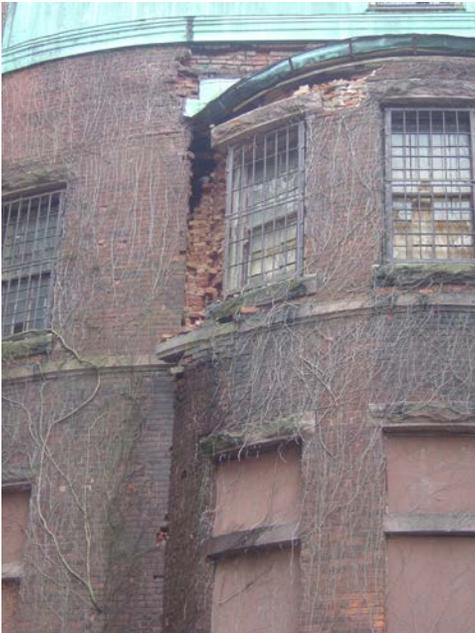
Fig.G-H.3 **Collapsed brick at curved bay to connector**
Image courtesy GCA

- Open mortar joints in masonry – 75-80%
- Spalling 75%
- Staining 75%
- Curved bay on north and south elevations.
- Collapsed brick – through wall at second floor north and south elevations at curved bay to connector joint. (Fig.G-H.3)

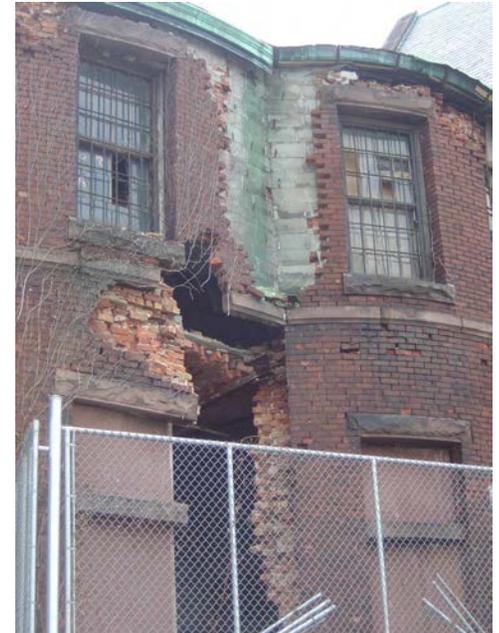
- Open mortar joints in masonry – 75-90%
- Spalling 75%
- Staining 75-100%
- Curved bay on north and south elevations.
- Significant collapse where curved bay meets main building wall. Previous repair with concrete block at second floor. Subsequent collapse since repair. (Fig.H-I.3)

Fig.H-I.3 **Detail of collapse and previous repair**
Image courtesy GCA

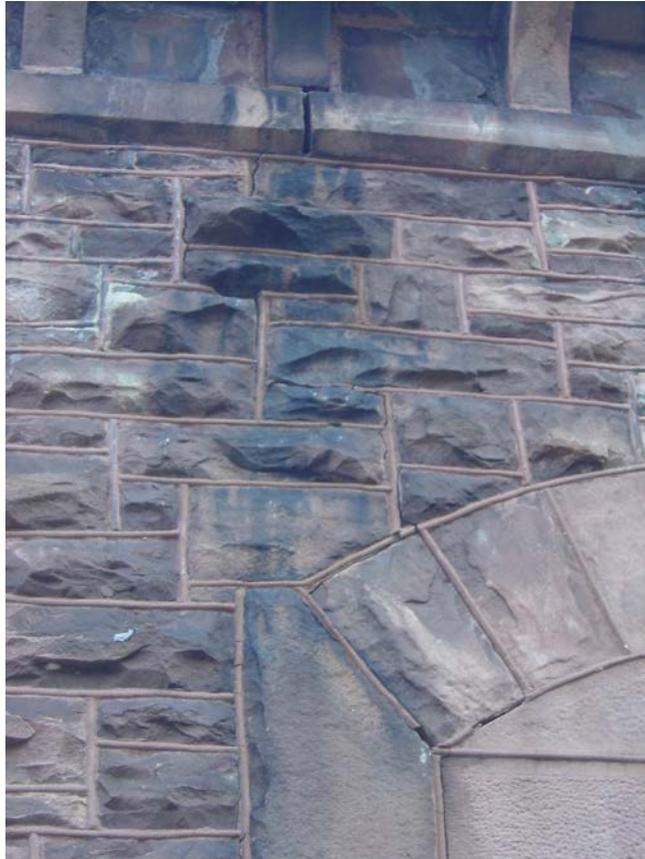
Fig. MK.5 **Step cracking on west elevation**
Image courtesy GCA

Step cracking occurs between the openings (window and door) and the cornice. The stones have not shifted out of plane, but further water infiltration could cause displacement. (Fig. MK.5)

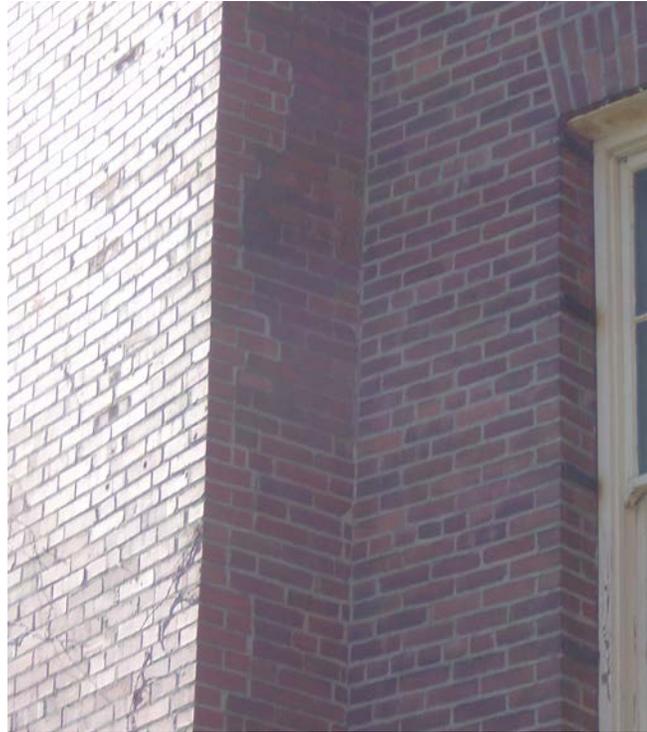
Areas at the corners have been previously rebuilt and continue to deteriorate. (Fig. MDH.3)

Fig. MDH.3 **Area of corner rebuilding**

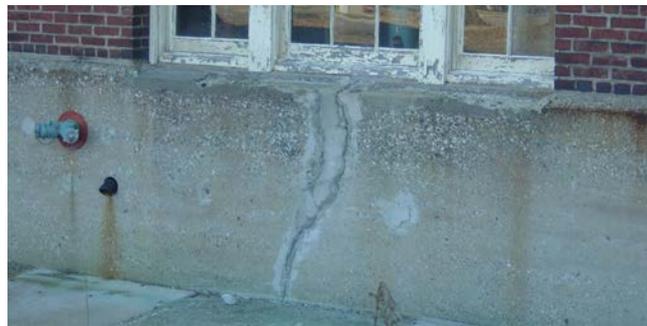
Fig. MDH.4 **Foundation wall crack on east elevation**

There are cracks in the basement concrete foundation wall. These do not appear to be a structural issue and are not a serious concern at this time. (Fig. MDH.4)

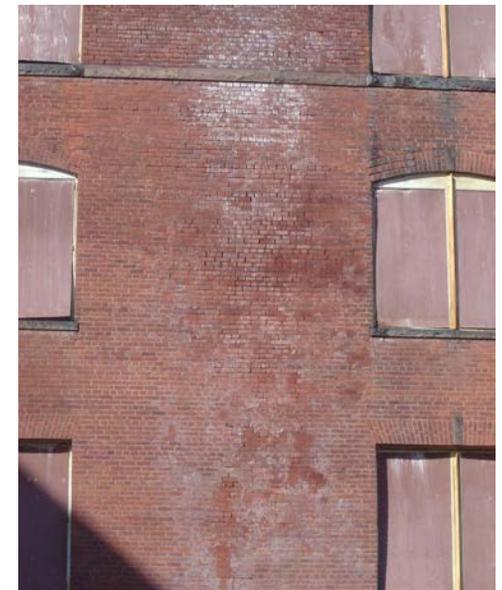
In general, the brick is in good condition. There are areas of water damage under the sills and in the panels between the windows where water saturation has caused mortar erosion, efflorescence and spalling of the brick. (Fig. FDH.4) The surface of the brick contains moderate spalling (25%), atmospheric soiling (50-60%) and no significant algae growth on the building.

Fig. FDH.4 **Area of water saturation showing mortar erosion and efflorescence**
Image courtesy GCA

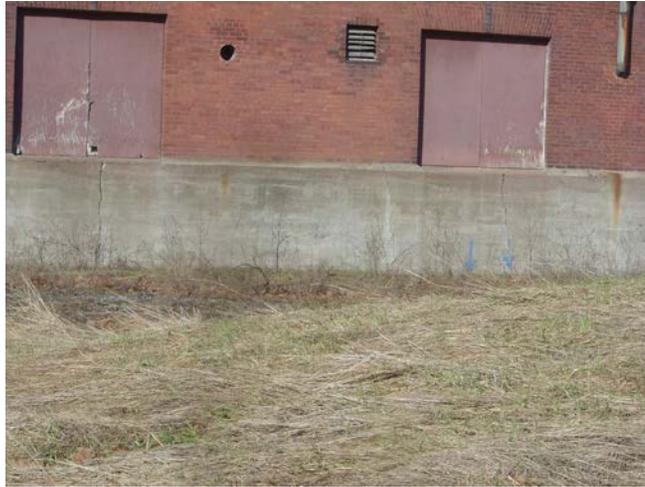
Fig. FDH.5 **Foundation wall crack on east elevation**
Image courtesy GCA

There are cracks in the basement concrete foundation wall. These do not appear to be a structural issue and are not a serious concern at this time. (Fig. FDH.5)

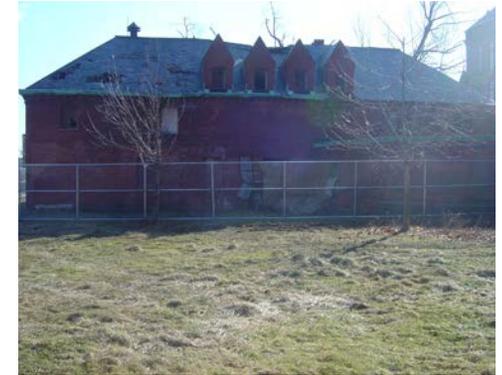
Fig. FK.3 Female Kitchen West Elevation showing sagging roof ridge
Image courtesy GCA

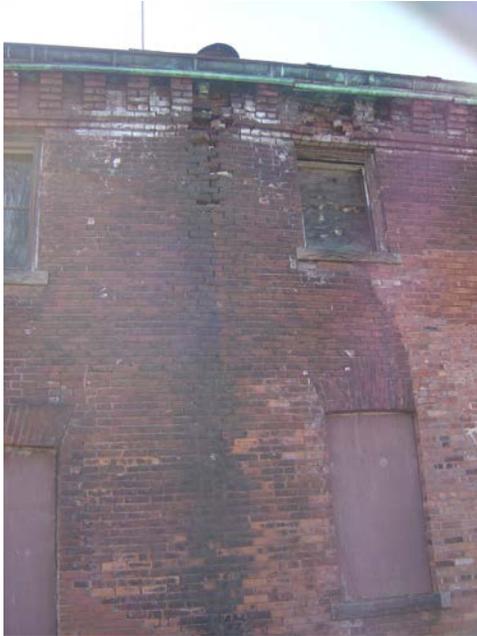
Fig. FK.5 **Brick displacement at cornice and wall**
Image courtesy GCA

brick walls. In some locations, this deterioration is leading to isolated areas of brick displacement, step cracking through the brick joints, and bulging of the wall indicative of future brick displacement and failure. (Fig. FK.5) There is some evidence of previous repairs and blocking off of old openings, but maintenance has not occurred on the building.

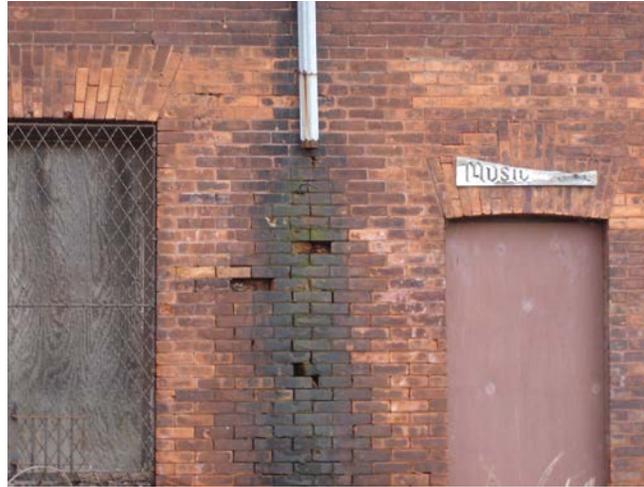
Fig. FK.6 **Typical soiling, spalling and open joints at brick gables**
Image courtesy GCA

The surface contains spalling of between 40-50%; fairly extensive atmospheric soiling (50-75%); and efflorescence in areas of repeated saturation. (Fig. FK.6)

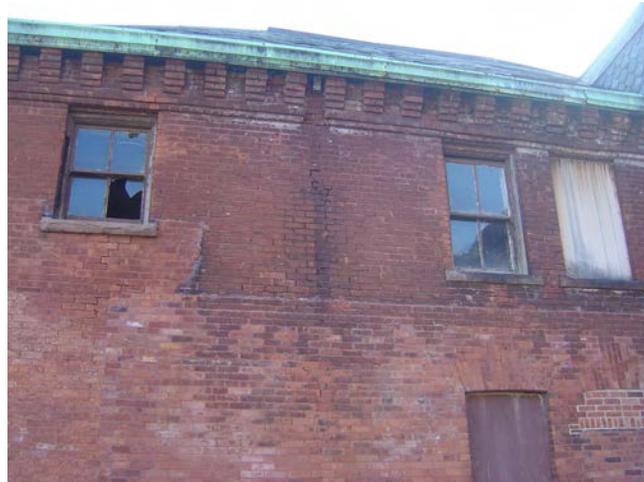
Fig. FK.7 **Missing downspout and resulting masonry deterioration**
Image courtesy GCA

The original slate roof and copper gutters and flashings remain in place. The slate is missing in many areas where ongoing deterioration has formed holes through the wood decking. Due to the lack of maintenance, the deterioration of the roof structure is severe, with sagging of the main roof ridge and imminent collapse of the dormers. The copper gutters are in poor condition, with cracks, holes and missing sections. The downspouts are no longer in place in most locations, directing the water from the gutters to the surface of the masonry. (Fig. FK.7)

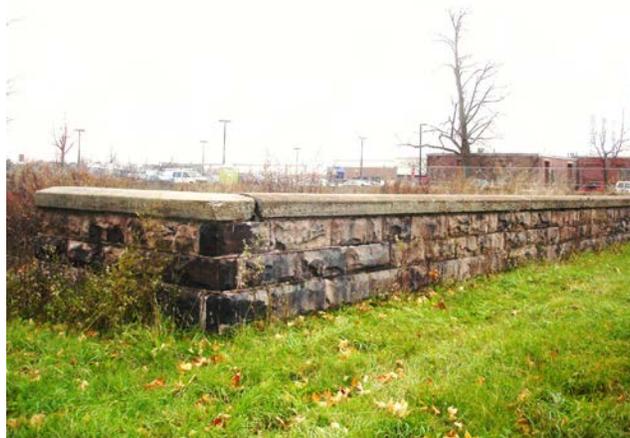
Brief Description: The construction of a Greenhouse as part of the Buffalo State Insane Asylum had always been part of the original Richardson-Olmsted scheme. Yet, it was not constructed until 1888, at which time, while the location of the structure was retained from the original scheme, its design was prepared by the local architect, W.W. Carlin. The constructed building comprised of a cruciform plan with a perimeter Medina sandstone wall approximately 4' in height and 16" thick. Above this was a glazed superstructure with probably cast iron or steel framing. Historic photos of the greenhouse suggest that the superstructure was renovated from its original design to a simplified roof form sometime before 1980. In the late 1980's, it was determined that the superstructure had deteriorated beyond repair and was structurally unsound. Consequently, it was torn down along with interior brick partition walls. A newer basement along the northwest junction of the transept arms was also filled in. The enclosed space within the perimeter walls was landscaped. Currently, the condition of these walls is in fair condition and does not exhibit any evident signs of structural collapse.

Fig. S.3 The remaining perimeter walls of the Greenhouse (GH1)
Image courtesy GCA

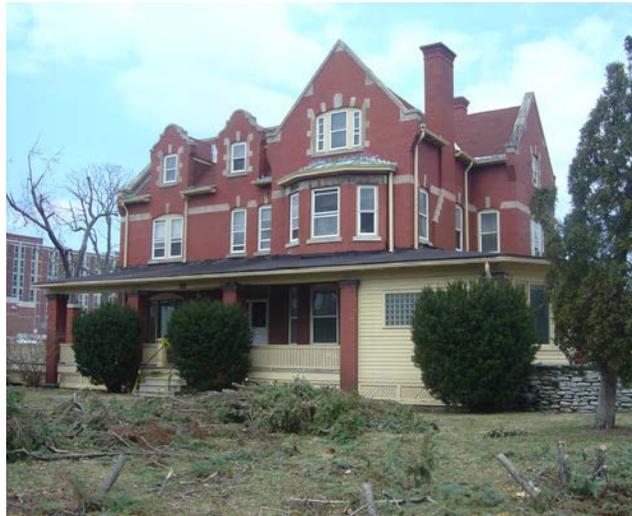
Brief Description: This 2+ story house was constructed as residence for the Superintendent of the Asylum in 1904-05. It's architectural style can be categorized as a Queen Anne - Bungalow hybrid with irregular massing, brick with stone accents, bay windows and projecting chimneys. Originally a porch at the first floor level ran all along the front (south) facade of the house. This was subsequently walled in on the southwest side to create interior space. At present, the condition of the building is fair with some areas in poorer condition - for example, the asphalted porch roof is failing where it meets the brick facade, the protruding gable corners are crumbling in certain areas and there is moderate water damage under window sills.

Fig. S.7 View from the southwest - Superintendent's Residence (SPR)

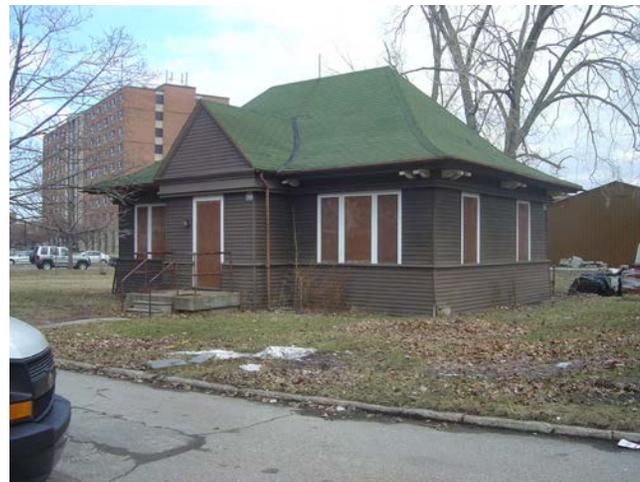
Fig. S.15 View of the Office building (OF) - currently used as utilities shed
Image courtesy GCA

Brief Description: This one-story rectangular wood-frame building was most probably constructed c. 1925 to serve as office space for the Buffalo State Hospital. It has plank siding and a distinctive Chinese-style roof. It is a symmetrical structure with gable end projections on each of its longer facades. It has been previously noted in the developmental history section, that this building could have been a reuse of one of the three summer house pavilions that were constructed c. 1889 due to the similarity in architectural form and proportion (See Fig. S.14 and S.14a.) At present, the building appears to be in fair condition.

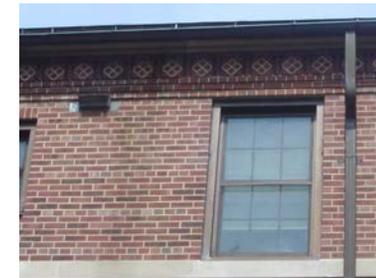
Fig. S.18 Detail of masonry at cornice level-
Nurses Home (NH2)
Image courtesy GCA

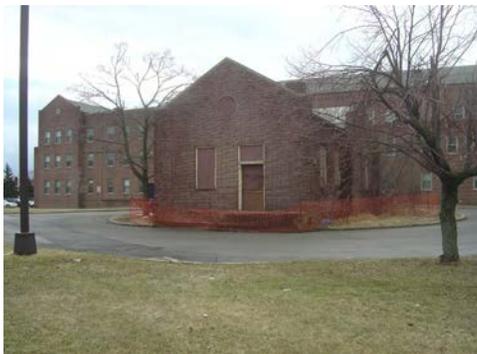
Fig. S.22 View from north- Kitchen building (KN)
Image courtesy Buffalo Psychiatric Center

The Kitchen building is a one-story rectangular building located north of the Reception Building. It is a brick structure with a cross-gable roof. Currently the building is lying vacant and its condition ranges from poor to fair with failing brick masonry at gable ends and signs of damage in the roof.

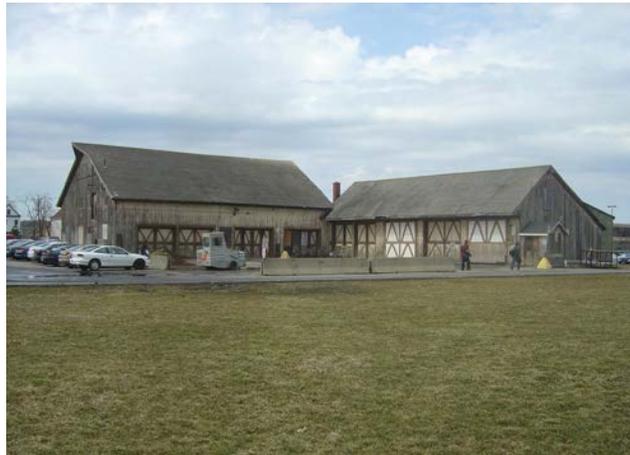
Brief Description: Although this building has a date of construction of 1930 at its present location, it was determined contributing to the NHL period of significance since it contains a board and batten barn which appears to date from c. 1870-1896. It is likely that one of the farm buildings in the northern portion of the site was moved and placed on a concrete foundation ca. 1928-30 to create this wagon shed. It is not known if the wings are old and were also moved from elsewhere or were built here in 1928-30 to offer additional space. At present the condition of the building ranges from poor to fair.

Fig. S.24 View from southeast - Wagon shed (WAG)
Image courtesy GCA

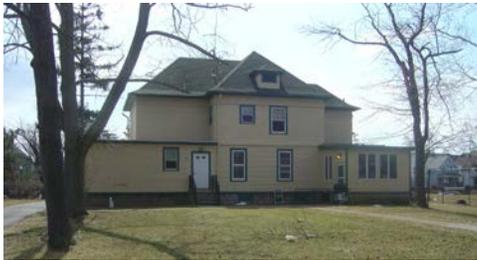
Fig. S.28 **View from north-Staff Residence (R2)**
Image courtesy GCA

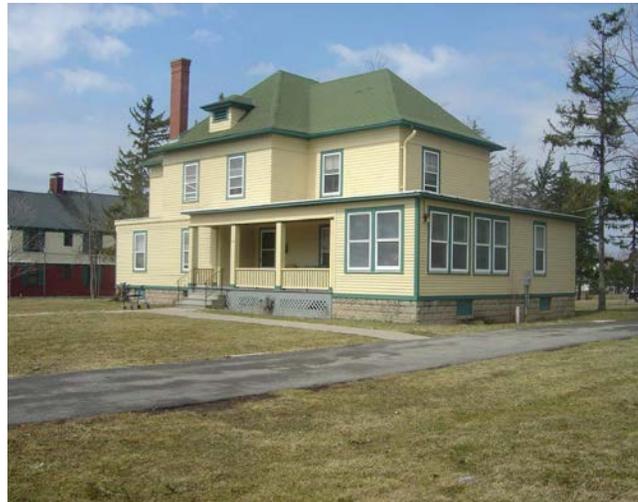
Fig. S.30 **View from south- Staff Residence (R2)**
Image courtesy GCA

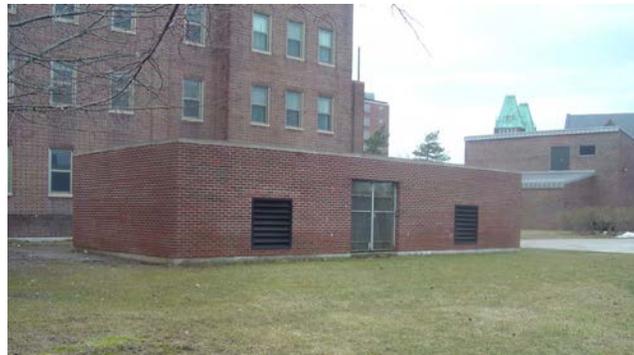
These two structures for housing air-conditioning equipment are located in the north-east portion of the site adjacent to the Rehabilitation Center and the Reception building. Both structures are simple, rectangular buildings and appear to be in good condition.

Fig. S.38 **View of AC1**
Image courtesy GCA

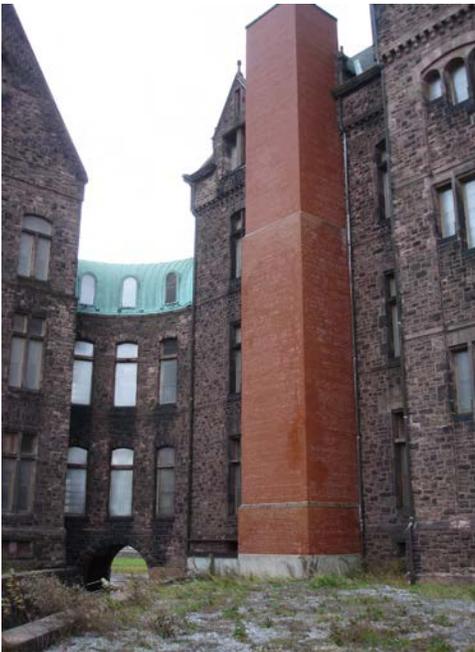
Fig. T.1 **Incompatible elevator addition on west facade of Administration Building**

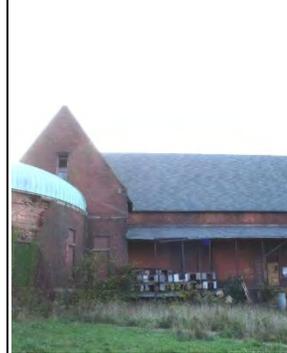
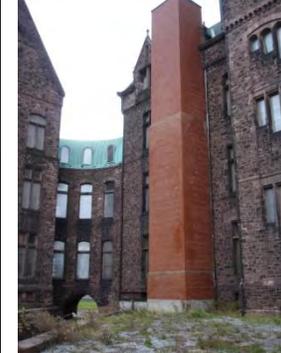
Feature	Description	Significance	Condition	Integrity	Deficiency	Recommendation
E1a.	Footprint: Ward buildings- T & H shapes ; Admin. building- roughly square	All ward buildings in the 'V' cluster have a shape that can be described as a combination of the letters 'T' and 'H'- unique from other Kirkbrides in having an additional central arm; Admin Bldg is roughly square to suit interior program & distinguish from wards.	Contributing	Fair	Fair	Addition of porches/ brick additions on principal façades beginning in 1906 slightly altered original building footprints.	1. Except for elevator shaft and brick addition on first floor of Ward B, all other additions date from the period of significance (POS) (before 1969) and should be evaluated depending on reuse program for retention. The metal chain-link porches date from c. 1945 – porches were first added at these locations in 1906-1916, but were of a simpler, more open design. Since the current porches are a later revision and significantly obscure the masonry and overall appearance of the ward buildings, the HSR recommends that they may be removed -retention of representative examples at some locations may be considered in this approach. 2. In future redevelopment, avoid any direct additions to historic buildings so as not to alter their shape; where necessary use free-standing connectors, etc. to attach to existing building.

<i>Rear addition (c .1918) on AB</i>	<i>Porch/staircase on south façade (c.1945) on Wards B,F,G,H and I.</i>	<i>Brick addition on first floor, south façade of Ward B (date unknown)</i>	<i>Porch addition (c.1894-95) on west façade of Ward J</i>	<i>Porch addition (c.1900) on east façade of Ward J</i>	<i>Elevator shaft addition (c.1992) on west façade of Administration Building</i>

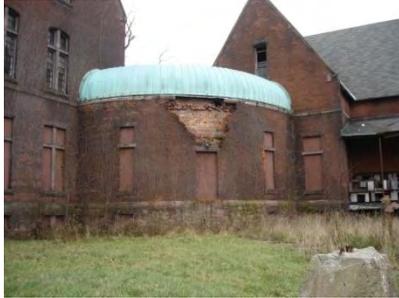
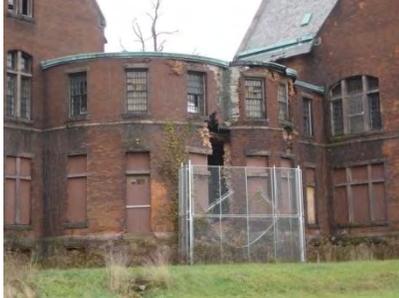
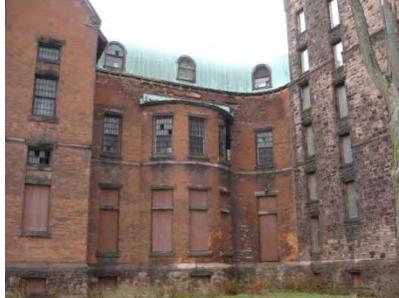
<i>Connector I-J</i>		<i>Connector H-I</i>		<i>Connector G-H</i>

Feature	Description	Significance	Condition	Integrity	Deficiency	Recommendation
E1b	Footprint: Connectors – quarter-circle profile	Connectors quadrant shaped – unique from other asylums (curved shape was instrumental in discouraging their use as wards)	Contributing	Poor	Good	Structural damage in brick connectors may lead to potential loss of profile	<ol style="list-style-type: none"> 1. Rebuild collapsed and shifted areas of the brick walls using brick that matches surrounding brick in color, texture and composition. Reuse as much of the original brick as possible. 2. Avoid any direct additions to historic structure so as not to alter its shape; where necessary use free-standing connectors, etc. to attach to new building.
I N S T A N C E S

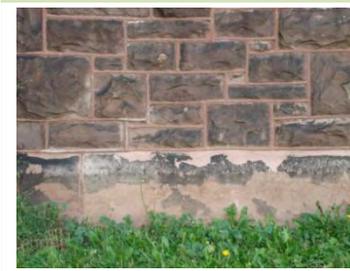
Note minor spalling on base course

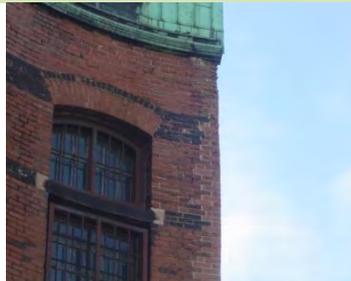
<i>Typical brick masonry used in Wards H, I and J & Female Kitchen (FK)</i>	<i>Brick used on vaulted ceiling of entrance porch, Administration building.</i>	<i>Missing area of brick wall caused by water infiltration</i>	<i>'Peeling' of brick wythes due to water infiltration</i>	<i>ConnectorB-MDH that has the only surviving tarred brick.</i>

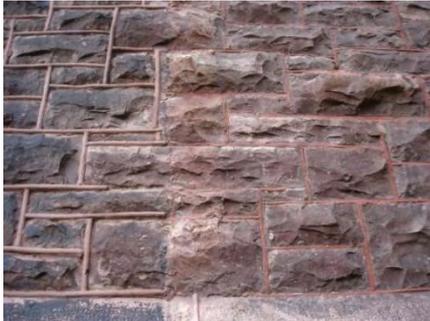
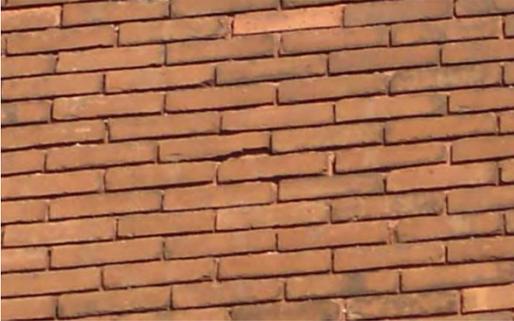
<p><i>In left portion of photo is the typical mortar (applied in 1990's) that exists on Admin Bldg and wards A, B,F and G. In the right portion are remains of historic reddish mortar .</i></p>		<p><i>Typical mortar on brick buildings- Wards H, I and J.</i></p>

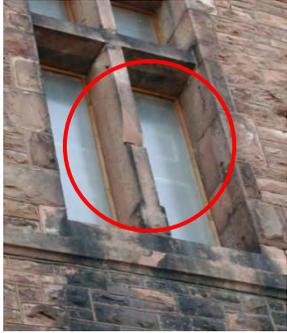
<p data-bbox="306 987 947 1040"><i>Typical cross shaped stone mullions & transoms on the Administration Building and all ward buildings. Note the spalled stone.</i></p>

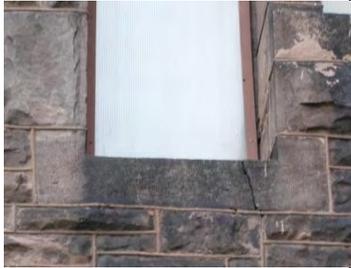
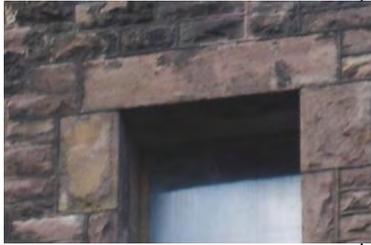
<i>Typical sill detail in stone buildings. Note crack in stone in this instance</i>	<i>Typical lintel detail in stone buildings</i>

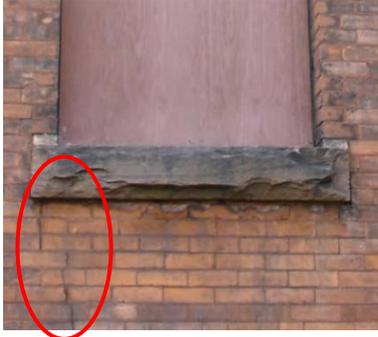
<i>Typical sill detail in brick buildings. Note masonry cracking in masonry at junction of sill stone.</i>

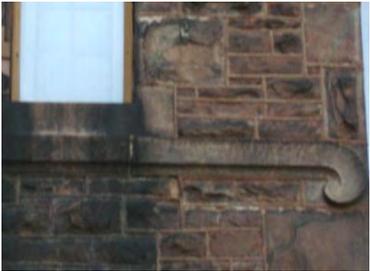
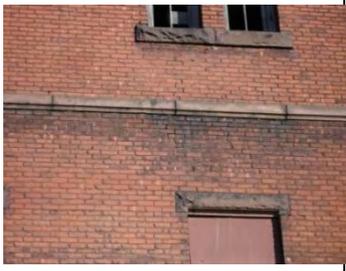
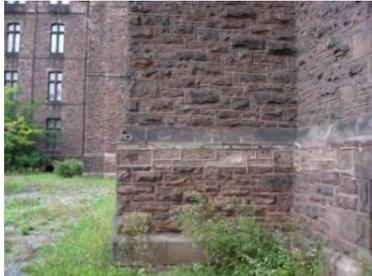
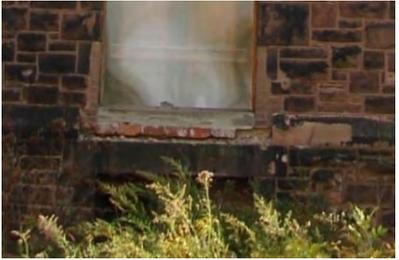
<i>Scrolled-end cornice where belt course meets window opening. Found only on wards A,B,F.</i>	<i>Typical cornice at floor level on all wards and Administration Building</i>	<i>Typical cornice profile at water table in all wards and Administration Building</i>	<i>Instance on Ward A where original cornice was cut leading to spalling of the original stone.</i>

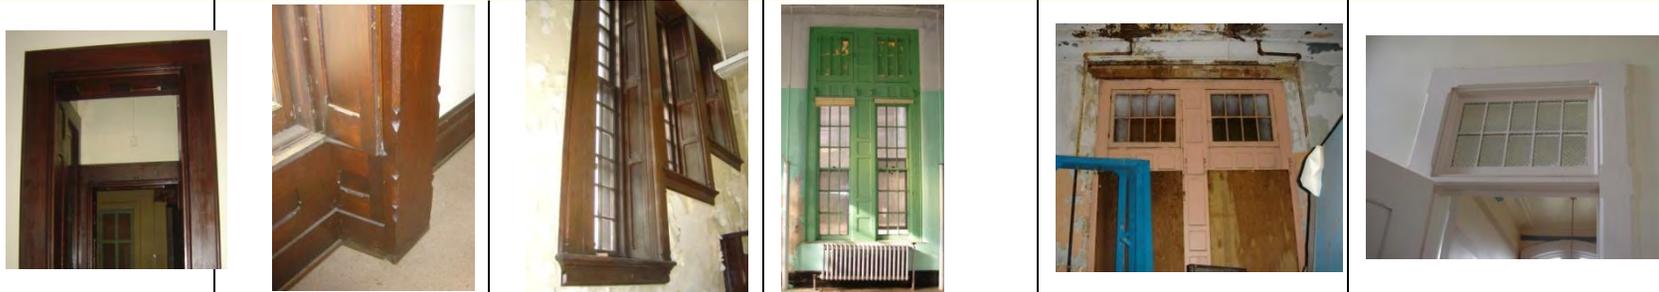
Feature	Description	Significance	Condition	Integrity	Deficiency	Recommendation
I2c.	Casework	Wide wood casing around doors/ windows - chamfered-edge detail; originally unpainted varnished wood finish , painted in modern renovations.	Contributing	Fair	Good	In areas of water infiltration, the casing may be rotted, though it is overall in good to fair condition.	The casing is important in defining historic character in the buildings and should be restored or replaced-in-kind as appropriate.

<p><i>Un-painted wood casings in Admin Bldg.</i></p>			<p><i>Typical painted wood casing in Male & Female wards</i></p>		<p><i>Renovated wood casing in Male Ward A</i></p>

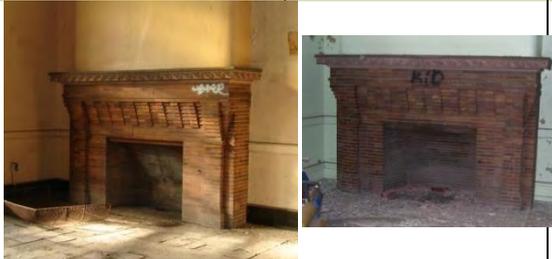
Feature	Description	Significance	Condition	Integrity	Deficiency	Recommendation
12e.	Fireplaces	Historic stone and exposed brick fireplaces with minimal naturalistic ornament were built in public recess on each floor of Female wards; stone fireplaces in Admin Building – important feature in historic intent of providing a ‘home-like’ feel to the interiors.	Contributing	Fair	Good	Common problems are minor physical damage (spalling, soiling), graffiti in certain areas and paint schemes that are inappropriate with historic character.	Restore all fireplaces to match historic appearance in size, proportion, material, finish and color. Remove non-historic paint and graffiti using gentlest methods possible. Avoid sandblasting to minimize damage to existing material.

<i>Fireplace in Female Ward F</i>	<i>Detail of fireplace frieze - Female Ward G</i>	<i>Fireplace in Admin Bldg</i>	<i>Exposed brick fireplaces in Female Wards G & H resp. note graffiti</i>	<i>Fireplace in Female Ward F- painted over</i>

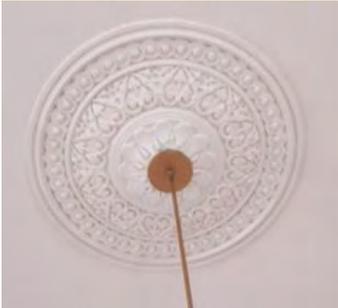
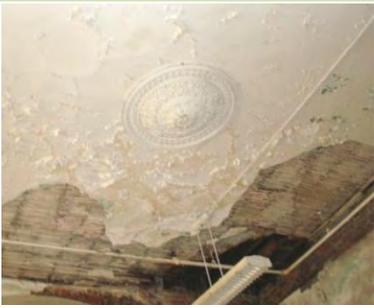
<i>Renovated ceiling medallion in Male Ward A</i>		<i>Damaged ceiling medallion in Male Ward B</i>

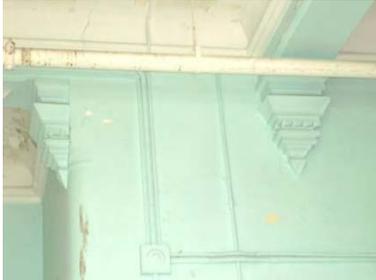
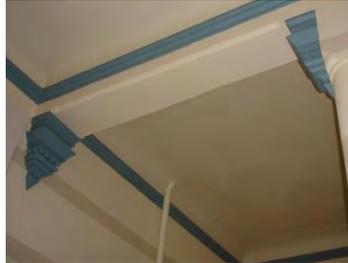
Feature	Description	Significance	Condition	Integrity	Deficiency	Recommendation
12h.	Brackets	Plaster coated brick brackets with saw-tooth motif (typically Richardsonian pattern) located at ceiling level at corridor intersections in Admin Bldg. and Male Wards	Contributing	Good	Good	Plaster and finishes are damaged at areas of water infiltration	Restore appearance to match historic examples in material, composition, color, design and profile. Reconstruct profile if needed. Do not conceal as a result of new interior additions, finishes etc.
I N S T A N C E S

<i>Brackets in Male Ward B</i>		<i>Detail of bracket showing saw-tooth motif</i>		<i>Renovated brackets in Male Ward A</i>		
	Feature	Description	Significance	Condition	Integrity	Deficiency	Recommendation
12i.	Ventilation grilles	Metal grilles featuring various patterns installed on corridor walls, slightly above floor level and/or above lintel level, to conceal passive ventilation channels- also play an aesthetic role.	Potentially Contributing	Fair	Good	Common problems include whole missing units and broken parts.	It is recommended that these grilles be retained where intact and re-installed where missing or broken. They may be removed at instances, depending upon the rehabilitation program but representative examples should be retained in any approach.

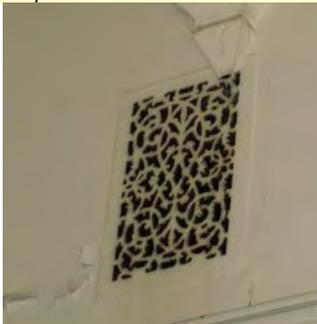
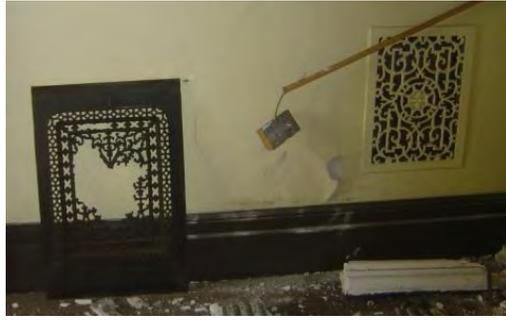
<i>Typical grill above lintel level</i>		<i>Installed and detached/broken metal grills in Admin Bldg.</i>

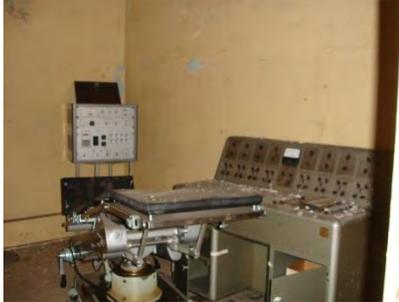
<i>Sawtooth motif detail of cabinet</i>							
	Feature	Description	Significance	Condition	Integrity	Deficiency	Recommendation	
I2k.	Treatment equipment	Very little of the historic equipment used for treatment of illness survives- a couple of treatment machinery (probably 15-40 years old) was found in Female Ward J	Potentially contributing	Fair	Fair	--	This equipment may be preserved for use as interpretive media, depending on the rehabilitation program for the complex.

<i>Treatment equipment lying in Female ward J</i>

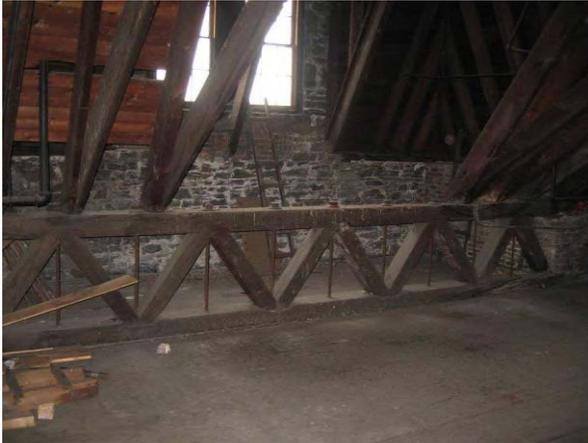
Timber Truss typical in Male Wards A & B

Feature	Description	Significance	Condition	Integrity	Deficiency	Recommendation
I3a	Timber Trusses	Two main types: Wards A & B- field constructed scissor trusses; 2 x 12 framing Wards F to J – timber trusses supporting 6 x 8 wood purlins with 2 x 6 rafters	Contributing	Varies	Good	In areas of water infiltration, there is some wood deterioration.	Repair in kind. If attic is used as habitable space, make attempts to keep the trusses exposed as they are – do not cover with false ceiling panels, etc.

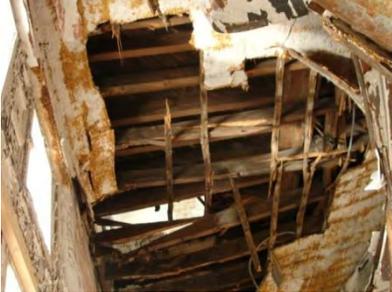
Feature	Description	Significance	Condition	Integrity	Deficiency	Recommendation
13b.	Counter-ceiled floor/ceiling structure	The floor structure of the wards was designed to be “counter-ceiled”, consisting of two overlapping layers of wooden joists, the upper supporting the floor above, the lower upholding the ceiling below, with insulation in between for purposes of ‘deafening’ – this system was defined in the Kirkbride Plan.	Contributing	Good to Fair	Good	In areas of water infiltration, there is some wood deterioration.	Repair in kind wherever possible. When extent of damage necessitates reconstruction, base reconstruction of original system on extant examples in adjacent areas.
I N S T A N C E S

<p><i>Exposed ceiling / floor system in an exposed area of damage</i></p>

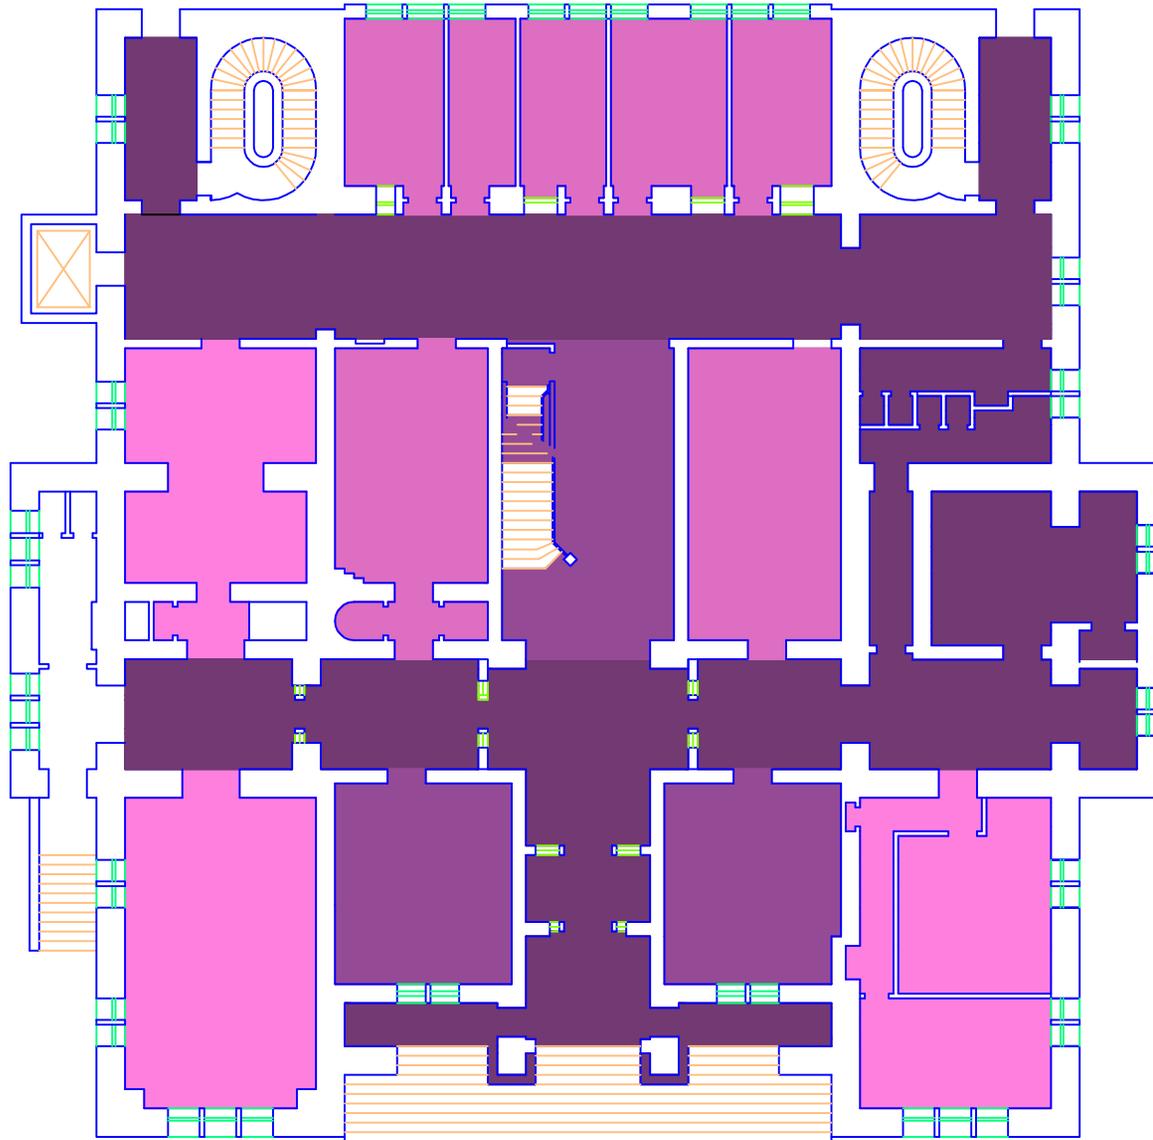
AB **First Floor Plan** ADMINISTRATION BUILDING
1.1 the RICHARDSON CENTER COMPLEX

The attached building floor plans show the calculated live load capacities for different floor areas in each building. The calculated live load capacities have been broken down into ranges that are based on typical code required live loads for new construction. The actual code-required live loads for the buildings will need to be determined based on the applicable code at the time of construction and the proposed uses. The following are the live load ranges that we have used in our presentation and the typical uses associated with them. Please note, as stated above, the calculated live load capacities shown in these plans do not reflect the possible reductions in strength to due deterioration.

We recommend that areas that do not have a calculated live load capacity of at least 40 psf be studied in further detail, as this lack of live load capacity appears to be anomalous within the complex and may be the result of inaccurate framing configuration assumptions for those areas.

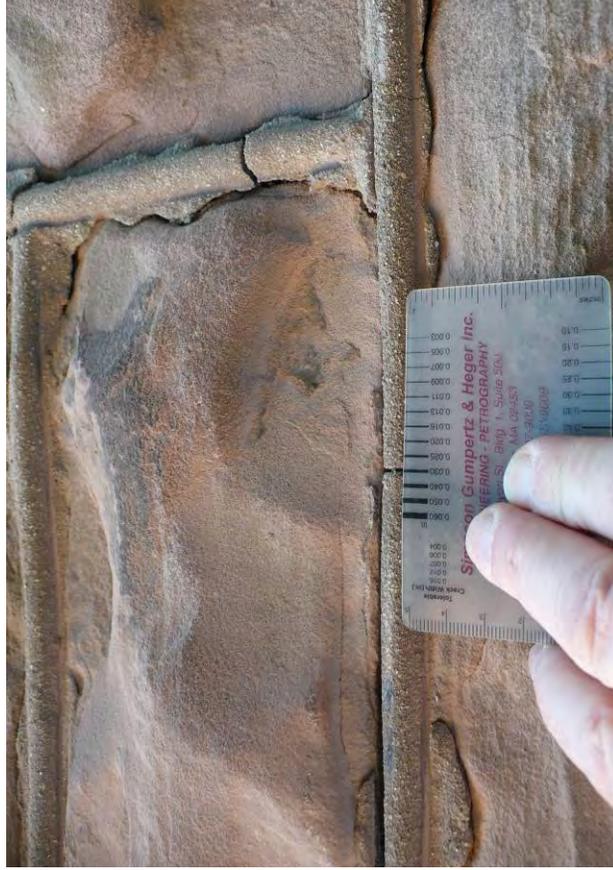
Photo 3

- Some mortar joints exhibit cracking with cracks typically measuring from 0.025 in. to 0.05 in. wide (Photo 3).
- In numerous cases on double and triple windows with intermediate stone mullions, the vertical stones at the intermediate mullions have vertical cracks that align with the joint between horizontal stones. Cracks typically extend into the stones above and below the joint in the horizontal stones (Photo 4).
- Some of the stones at the window jambs and sills are cracked or spalled at embedded fasteners (Photo 5).

Typical cracking of mortar joints of stone masonry (Building G shown in photo)

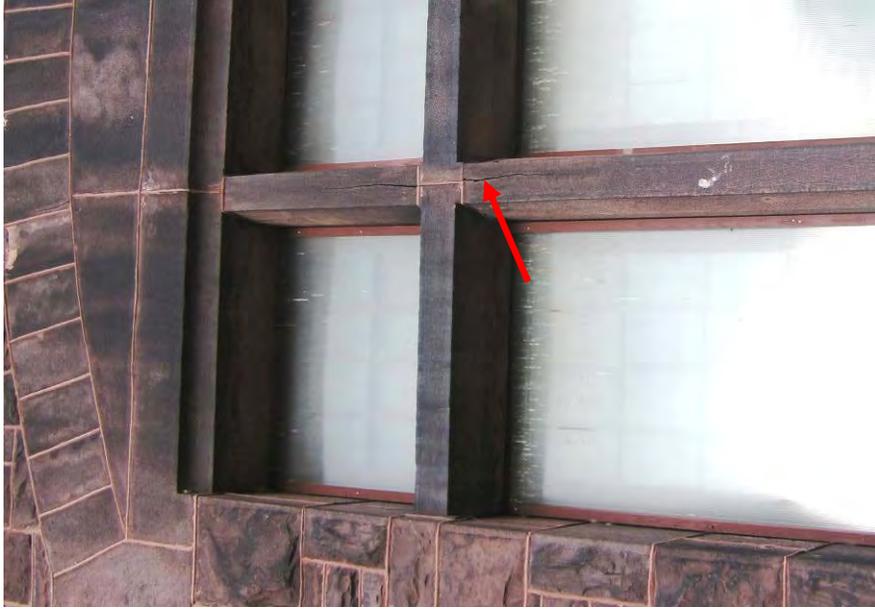
Photo 4

Typical cracking (arrow) of vertical intermediate mullions.

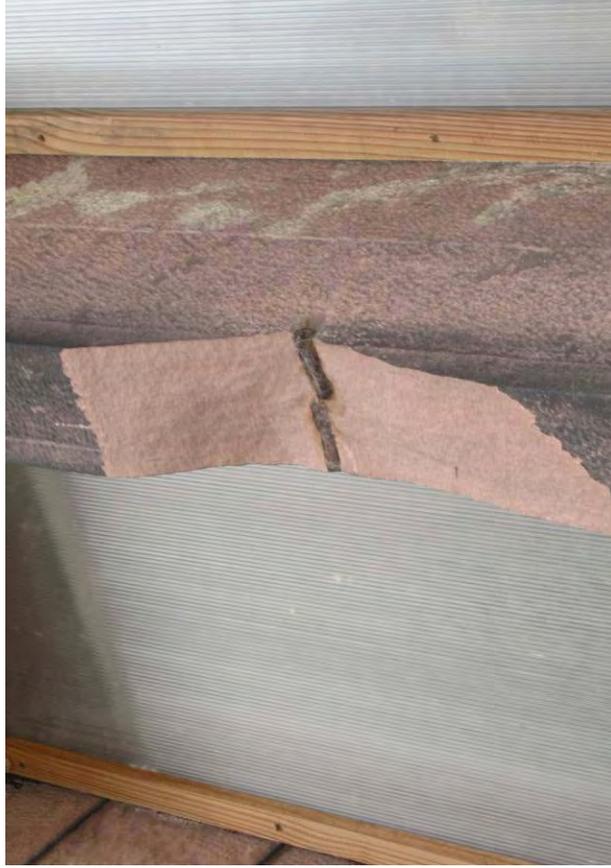
Photo 5

Spalled stone at window mullion at location of fastener.

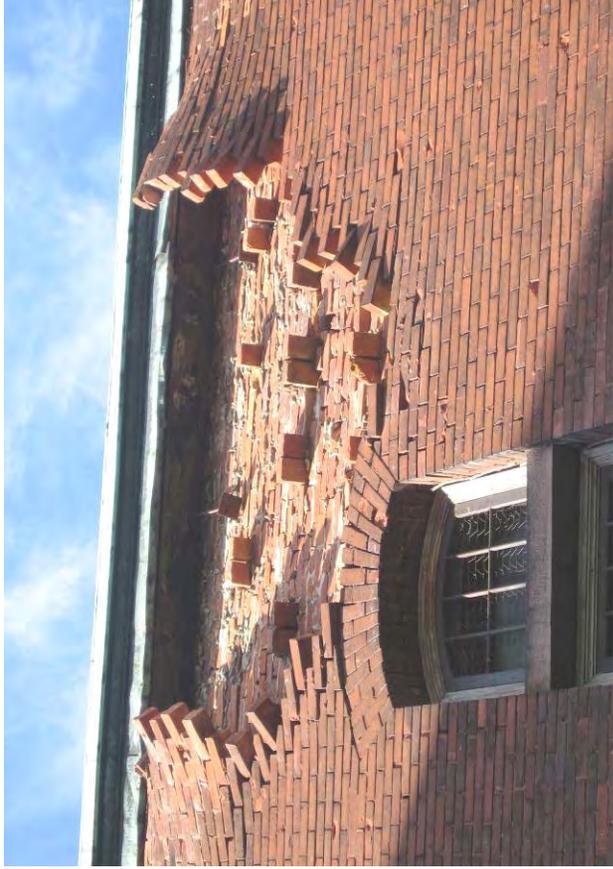
Photo 7

Typical area of severe deterioration of brick masonry. Brick appears to be “peeling” away from the building.

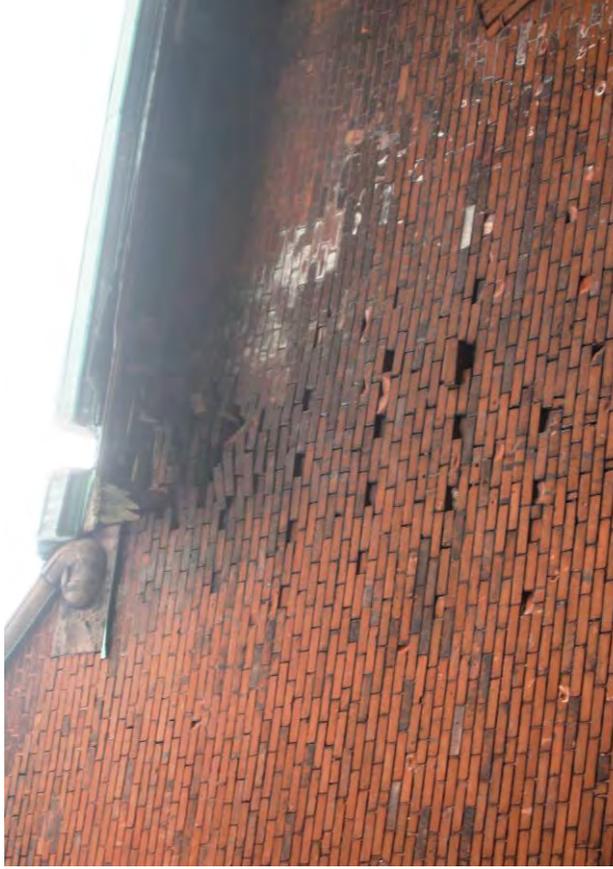
Photo 8

- Outward displacement (“bulging”) of the exterior brick is visible in some localized areas where the header bricks are now recessed from the outermost plane of the brick facade (Photo 8). In these areas, it appears that the headers have remained in place, while the outer wythe(s) has moved outward. These areas appear to be in the early stages of deterioration and displacement that will ultimately lead to the collapsed areas observed elsewhere and described above.

Recessed header bricks indicate outward displacement (“bulging”) of the exterior brick.

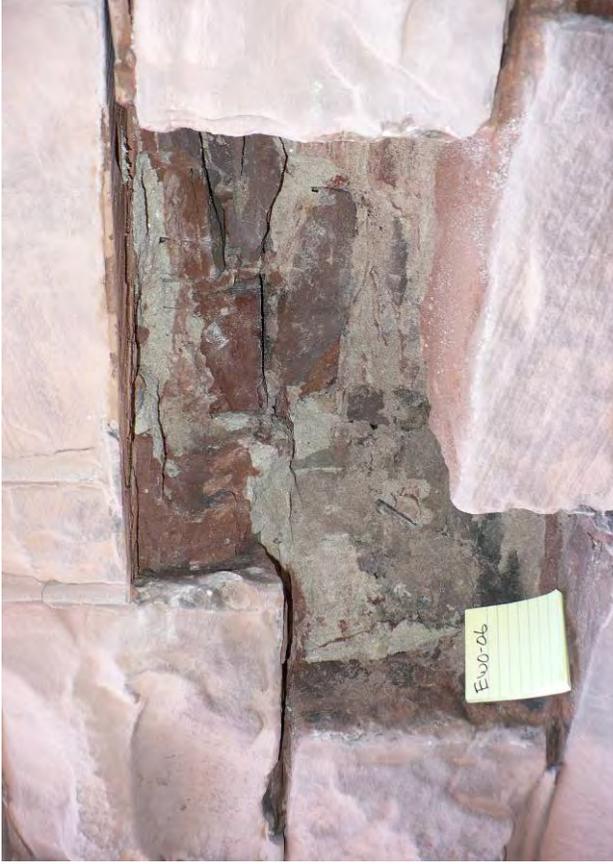
Photo 9

- **Building G:**
 - **Exploratory Opening EWO-06:** Opening made at the first floor of the west elevation at an area of observed water damage at the interior. The wall construction is typical, with the rubble wall consisting of a mixture of brick and stone with mortar (Photo 9). Removed stones are 8 in. deep, while the blocks at the jambs are 6 in. deep. The original pointing mortar is light brown with a raised square bead at the center of the joints. The majority of the mortar joints appear to have been repointed using a light-brown mortar with a grapevine profile (round bead of mortar at the center of the joint). The bedding mortar at the outer face of the stone is colored red, while the bedding mortar at the interior of the stone is white.

Exploratory Opening
EWO-06 in stone masonry
wall of Building G.

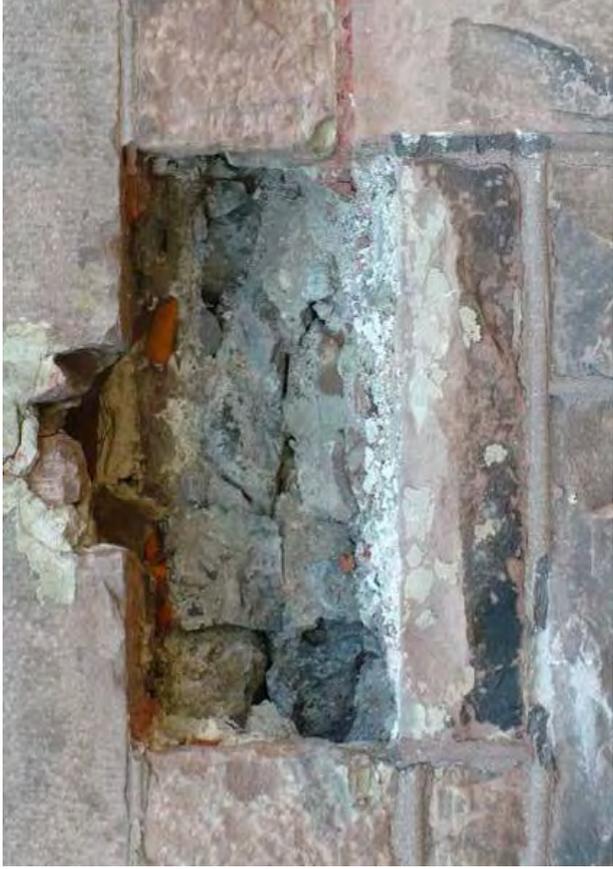
Photo 11

- **Exploratory Opening EWO-09:** Opening in south elevation, west of EWO-08 (Photo 11). Typical wall construction with a rubble brick, stone, and mortar backup wall. The bedding mortar at the face of the masonry is colored red.

Exploratory Opening
EWO-09 in stone masonry
wall of Building F.

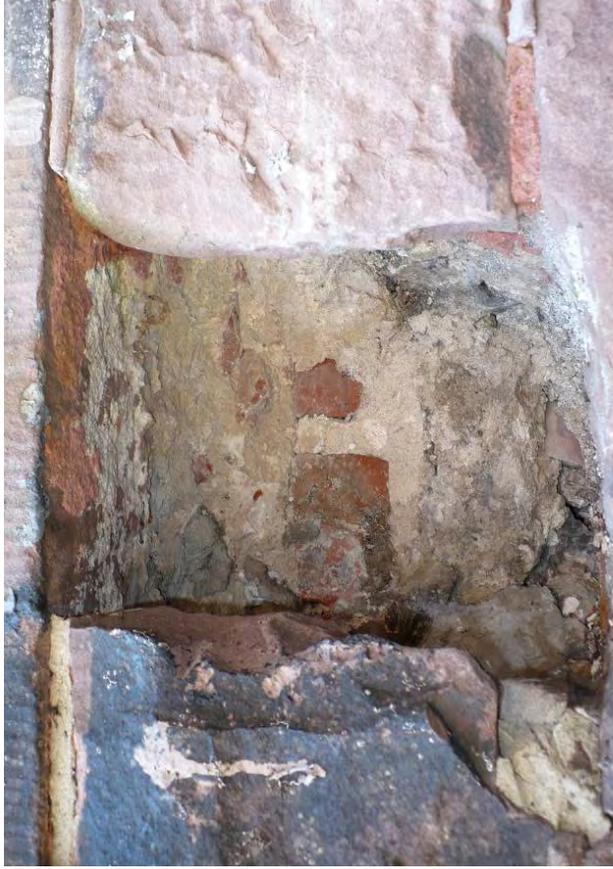
Photo 12

- **Exploratory Opening EWO-10:** Opening in east elevation (Photo 12). Typical wall construction. At the north side of the opening, the bedding mortar is colored red, and at the south side of the opening (not originally sheltered by the porch), the bedding mortar is white.

Exploratory Opening
EWO-10 in stone masonry of
Building F. The bedding
mortar at the face stones at
the north side of the opening
is white (as seen in the upper
left corner of the photo),
while the bedding mortar at
the south side of the opening
is red (as seen in the lower
left corner of the photo).

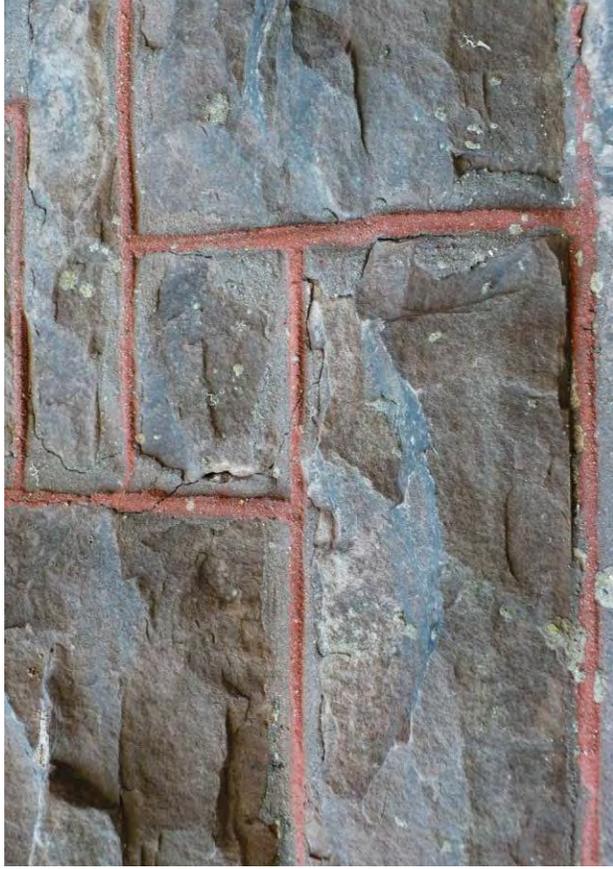
Photo 13

- **Building AB – Administration Building:**
 - **Exploratory Opening EWO-7:** Opening at third-floor level east of the tripartite window. Typical wall construction. Original pointing mortar is dark brown/black with a raised square bead, colored red at the center of the mortar joints (Photo 13). The majority of the masonry appears to have been repointed using a light-brown mortar with a raised square bead at the center of the joints. The bedding mortar is white.

Original pointing mortar of
Building A is colored black
with a raised square bead
colored red at the center.
Original pointing mortar at
Building AB is similar.

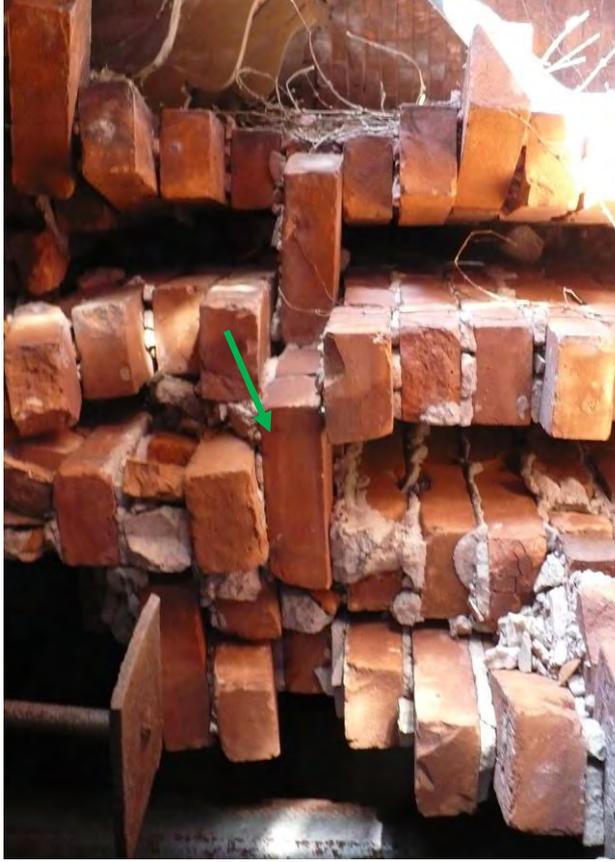
Photo 14

Typical wall construction at brick buildings (photo taken at area of severe damage). Outer two wythes (though the outermost wythe is delaminating from the second wythe in the photo) are tied to the inner two wythes (left side of photo) by header bricks that span the cavity (arrow).
