HISTORIC STRUCTURES REPORT

the RICHARDSON OLMSTED COMPLEX *Buffalo, NY*

July 2008

GOODY
CLANCY

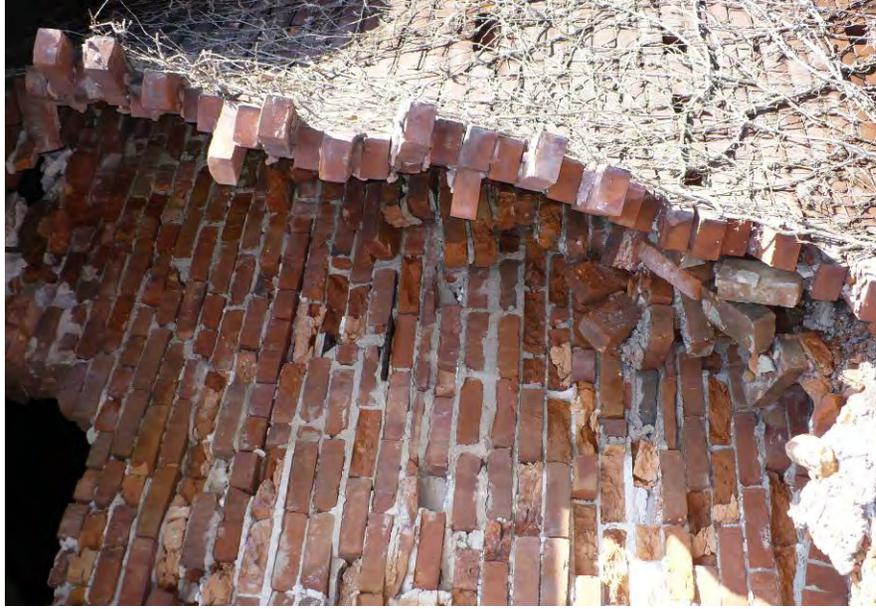
Photo 15

- **Building I:**
 - **Exploratory Opening EWO-01:** Opening at area of partial collapse of the wall at the second floor of the east elevation (Photo 15). The wall construction is typical.

Exploratory Opening EWO-01 in collapsed brick masonry of Building I.

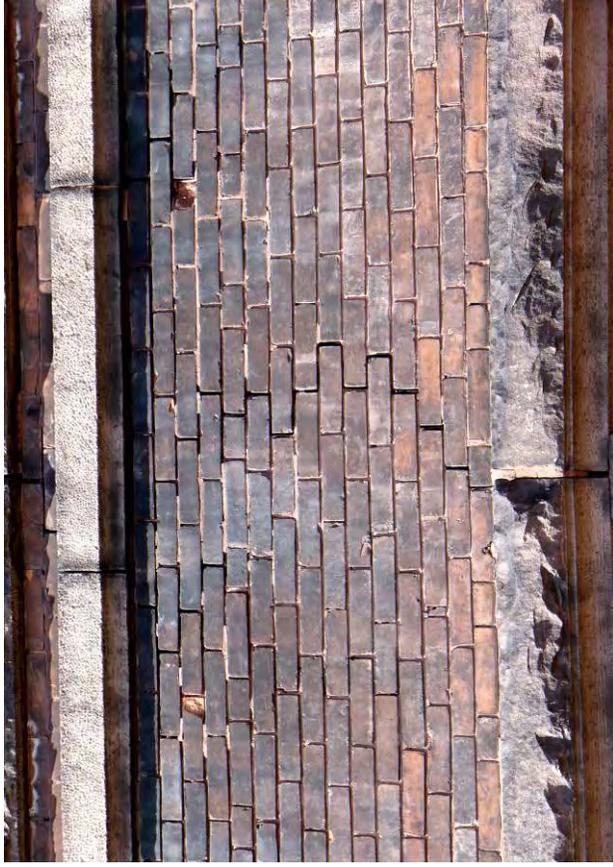
Photo 17

- **Exploratory Opening EWO-11:** Opening at area of wall with erosion of mortar from several head joints that appear to form a “vertical crack,” but it is otherwise intact (Photo 17). The vertical crack, measuring approximately 1/4 in. wide, extends from the head of the first-floor window to the second-floor belt course. We did not observe evidence of lateral wall movement on either side of the window or open joints or cracked brick on either side of the vertical crack. The head joint in the two-part window sill above the crack is missing mortar, and the head joint in the belt course above the crack has partial mortar loss. The wall construction is typical.

Exploratory Opening EWO-11 at cracked masonry of Building I. Vertical crack in masonry between the head of the first-floor window and the bottom of the second-floor belt course. The crack only travels through the mortar joints as none of the brick are cracked.

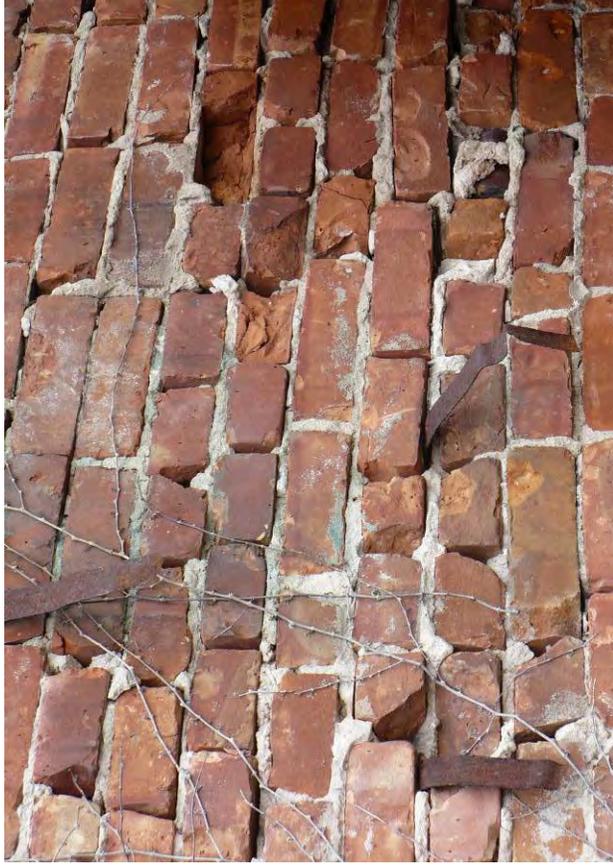
Photo 18

- **Exploratory Opening EWO-A:** Opening at connector corridor between Buildings I and J at area of partial collapse of the wall. The wall construction is not typical and consists of one outer wythe of brick, a cavity, and two inner wythes of brick. Metal straps are used to tie the outer wythe of brick to the two inner wythes of brick. At the area of the opening, the metal straps typically are corroded (Photo 18).

Exploratory Opening EWO-A in the connector corridor between Buildings I and J. Metal ties used in place of brick to span the cavity and tie the outer brick to the inner brick. The metal ties are typically corroded.

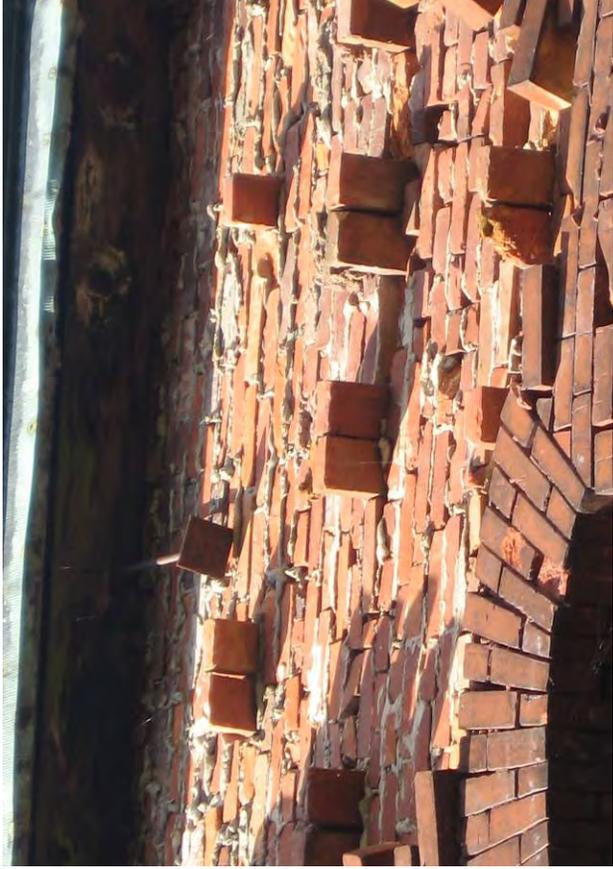
Photo 19

- **Exploratory Opening EWO-B:** Opening at the east elevation. Typical wall construction with header courses spaced seven to eight courses apart. The brick that span the cavity between the inner and outer wythes are paired (Photo 19).

Exploratory Opening EWO-B at area of collapsed brick masonry at Building I. Bricks that span the cavity between the outer wythes and inner wythes are paired (outer wythe bricks not seen in photo).

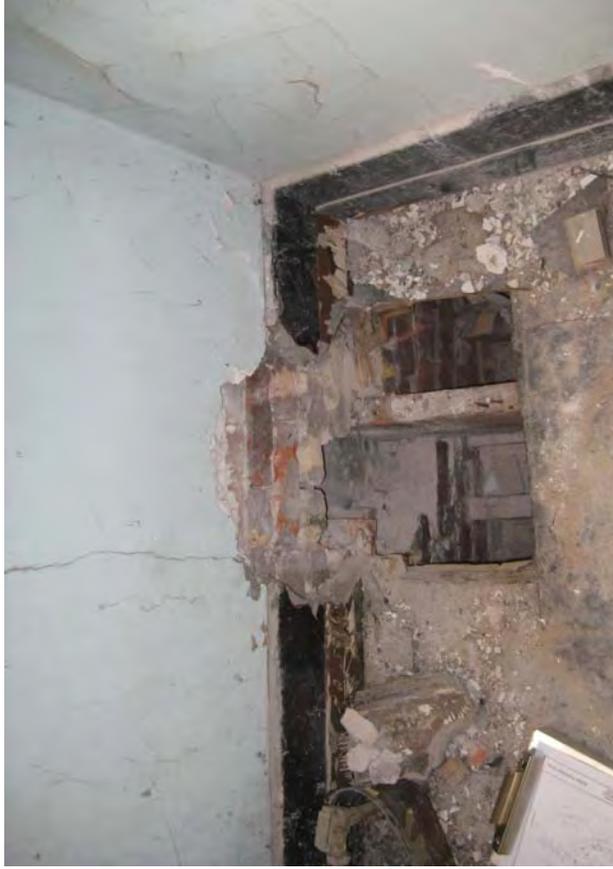
Photo 20

- **Exploratory Opening EWO-12:** Opening at the second-floor level in an area well protected below a porch roof (Photo 20). The wall construction is typical. The bedding mortar is colored red.
- **Exploratory Opening EWO-C:** Opening at the second floor of the south elevation of the connector corridor between Buildings G and H. Wall is partially collapsed at area of opening. The wall construction is typical.

Exploratory Opening EWO-12 in area of brick masonry well protected below a porch roof.

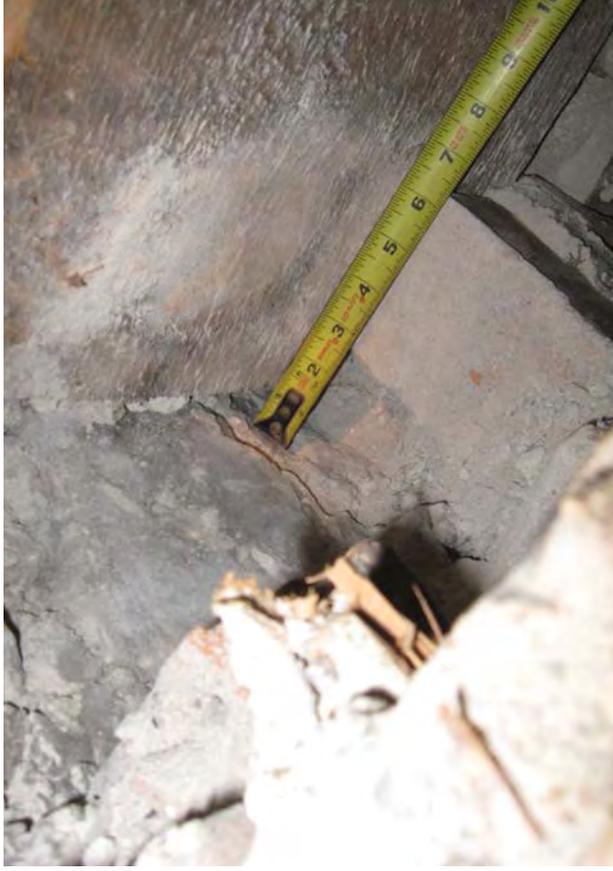
Photo 21

- **Exploratory Opening IWO-01:** Exploratory opening at floor/wall intersection at the third-floor level on the south elevation to observe the floor joist bearing condition at the exterior wall (Photo 21). The floor framing consists of 2 in. x 11-1/2 in. floor joists, spaced at approximately 16 in. o.c. At this opening, the brick wall is built tightly around the joists, and the joist ends are square cut, not firecut. The joist that we observed had approximately 5-1/4 in. bearing on the brick masonry wall below (Photo 22). The top of the 2 in. x 8 in. ceiling joist for the second-floor level are located 2 in. below the bottom of the floor joists; they are also spaced at 16 in. o.c. The wall construction at the location of bearing consist of one wythe of brick masonry on the interior face, approximately 2-1/2 in. of miscellaneous brick and stone masonry, and then stone masonry on the exterior face.

Exploratory Floor/Wall Opening IWO-01 in the third floor of Building B.

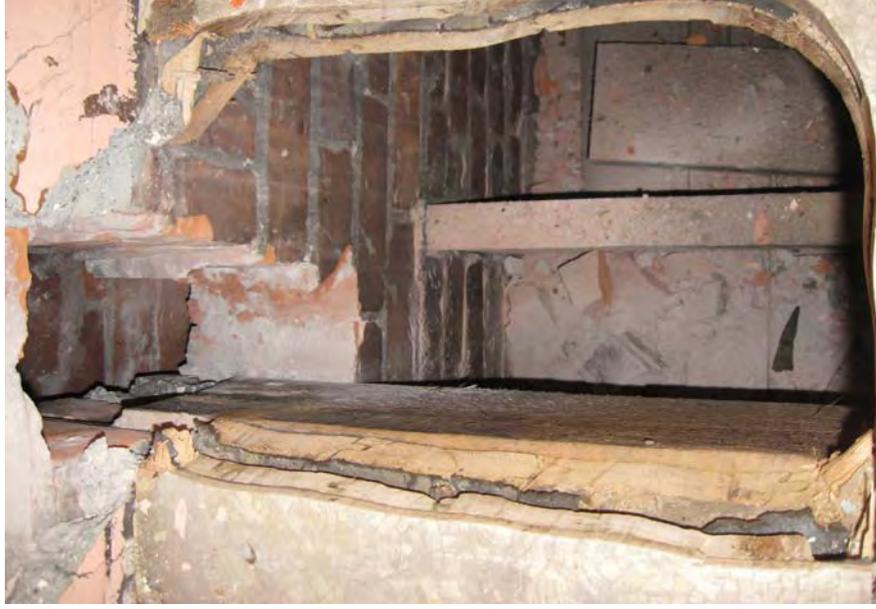
Photo 22

Exploratory Floor/Wall
Opening IWO-01 in the third
floor of Building B. The floor
joists are bearing
approximately 5-1/4 in. on
the masonry below.

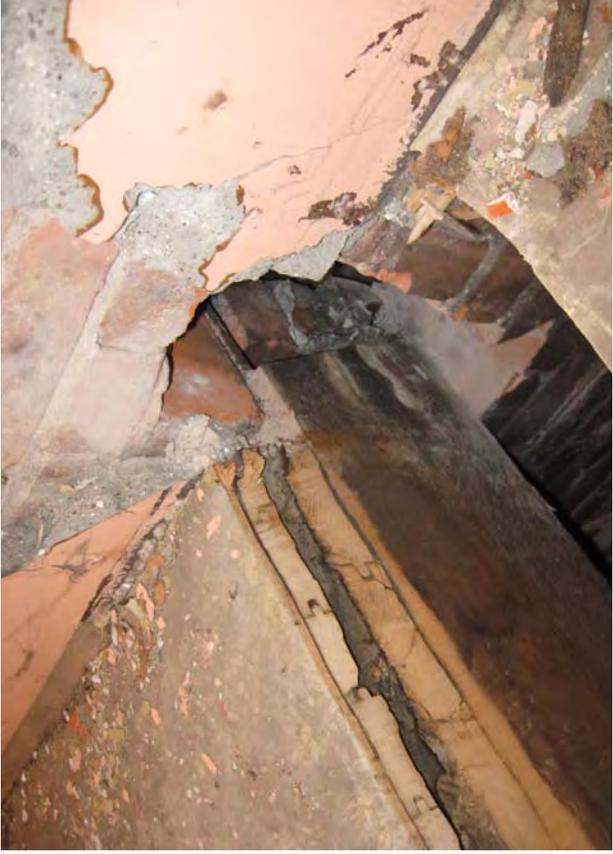
Photo 23

- **Exploratory Opening IWO-02:** Exploratory opening at the floor/wall intersection at the second-floor level on the west elevation to observe the bearing condition at an exterior wall (Photo 23). The floor framing consists of 3 in. x 10 in. firecut floor joists, spaced at 16 in. o.c. (Photo 24). The joist we observed had approximately 5-1/2 in. bearing on the brick masonry wall below (Photo 25). The top of the 2 in. x 10 in. ceiling joist for the first-floor level are located 5 in. below the bottom of the second-floor joists. They are also spaced at 16 in. o.c. The wall construction at the location of bearing consists of two wythes of brick masonry on the interior face, a 4 in. gap, and then two wythes of brick masonry forming the exterior face.

Exploratory Floor/Wall
Opening IWO-02 at an
exterior wall in Building H.

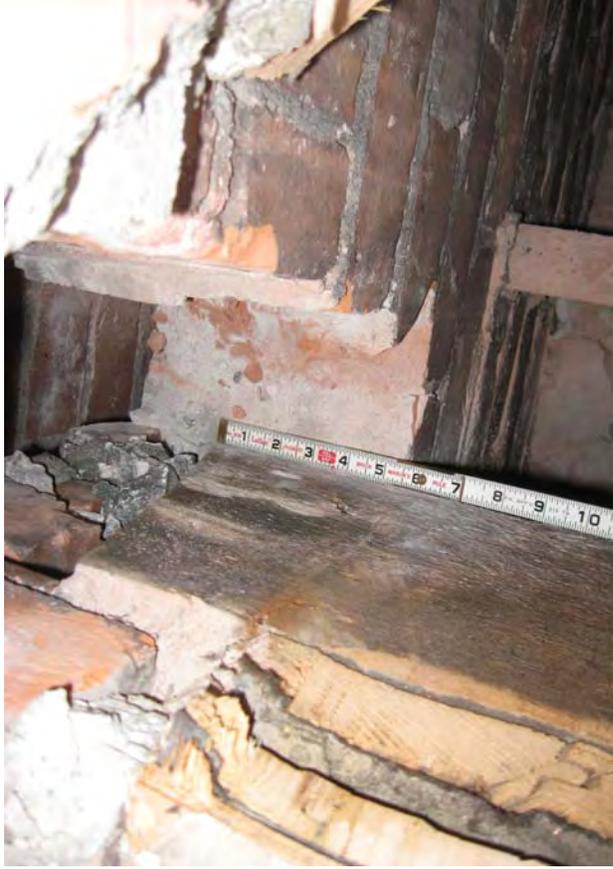
Photo 24

Exploratory Floor/Wall Opening IWO-02 at an exterior wall in Building H. This shows the firecut floor joists.

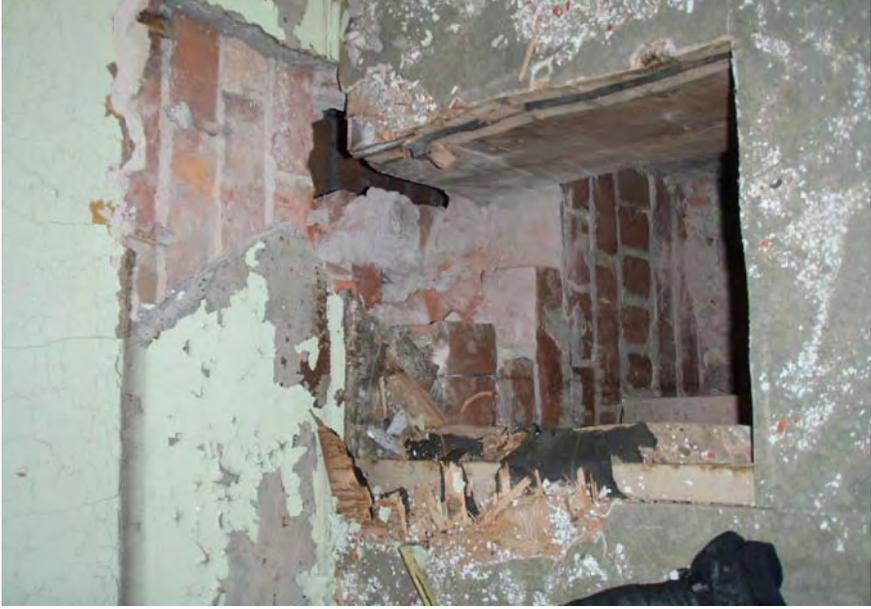
Photo 25

Exploratory Floor/Wall Opening IWO-02 at an exterior wall in Building H. The floor joists are bearing approximately 5-1/2 in. on the masonry wall below.

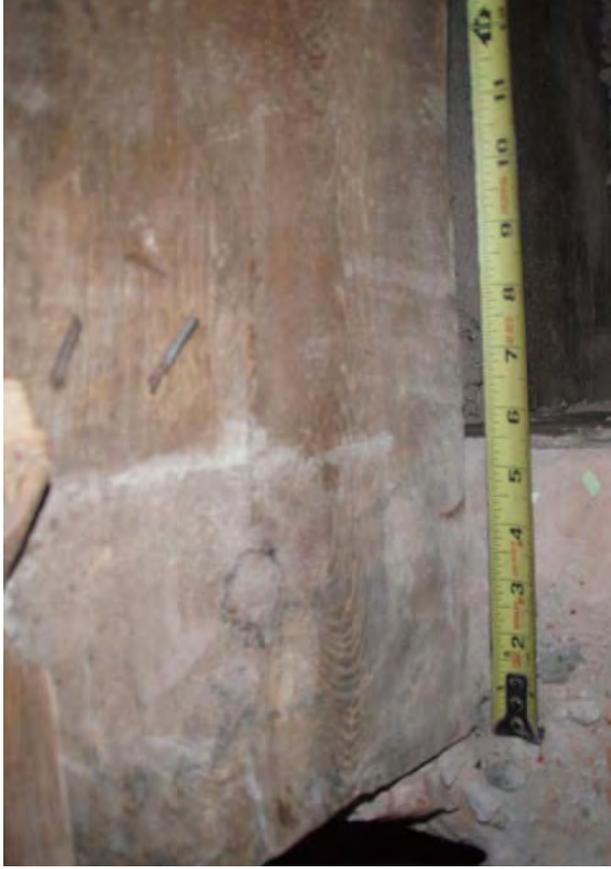
Photo 26

- Exploratory Opening IWO-03:** Exploratory opening at the floor/wall intersection at the second-floor level to observe the bearing condition at an interior wall (Photo 26). The floor framing consists of 3 in. x 10 in. floor joists, spaced at approximately 16 in. o.c. At this opening the floor joists are not firecut. The joist that we observed had approximately 5-1/2 in. of bearing on the brick masonry wall below (Photo 27). The top of the 2 in x 10 in. ceiling joists for the first-floor level are located 6-3/4 in. below the bottom of the floor joists. They are also spaced at 16 in. o.c. The wall construction at the location of bearing consists of two wythes of brick masonry, a 9 in. gap, and then two wythes of brick masonry on the other face.

Exploratory Floor/Wall
Opening IWO-03 at an
interior wall in Building H.

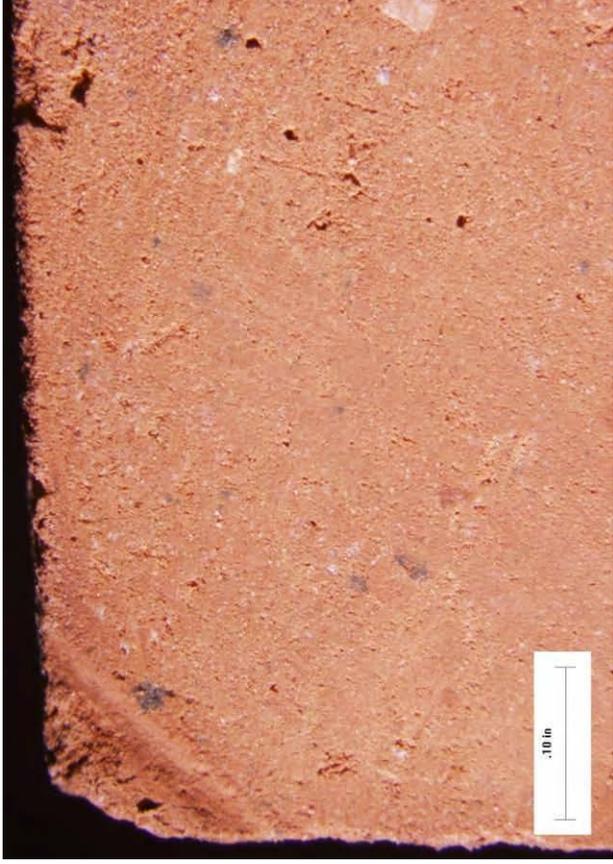
Photo 1

A cut corner of Sample 1 at 6X, showing small voids and a dense structure. Voids do not appear to be interconnected.

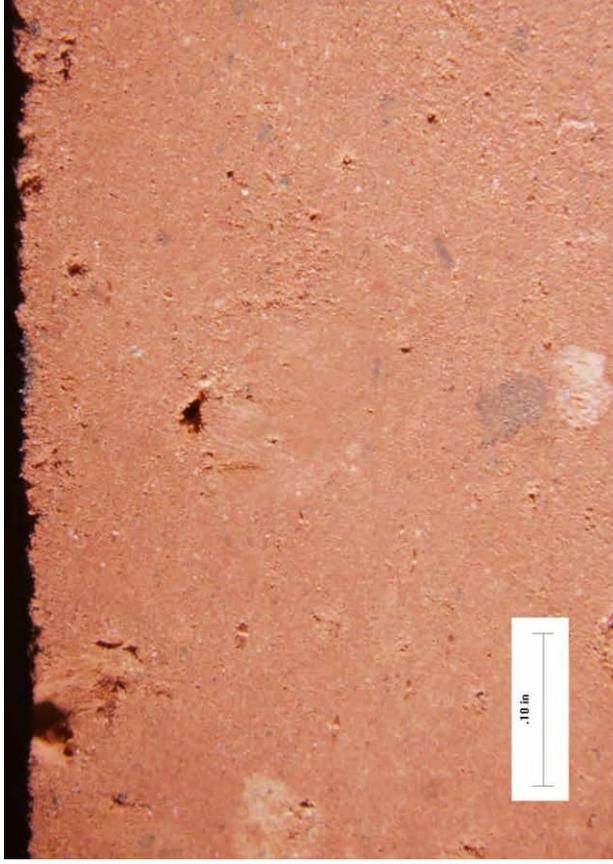
Photo 2

General photo of Sample 1 at 6X, showing average void distribution and size. Voids do not appear to be interconnected.

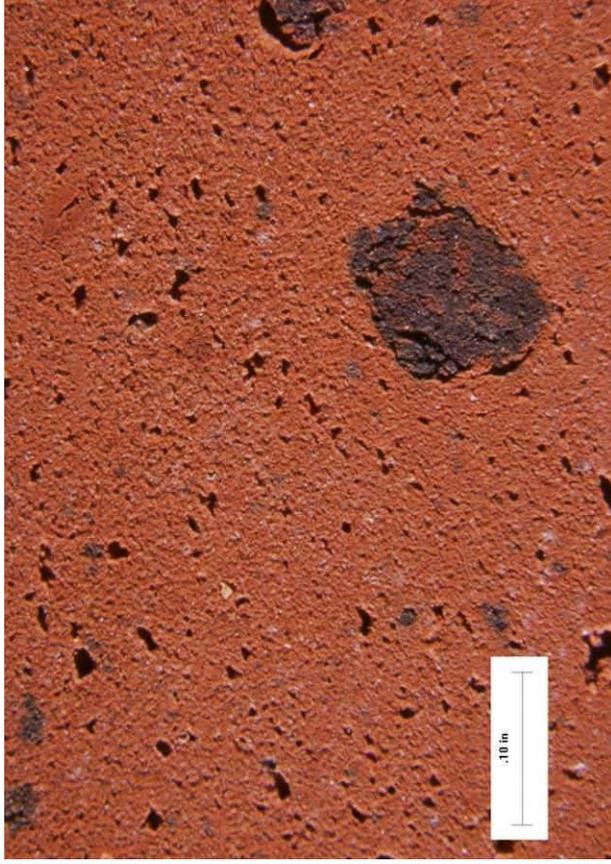
Photo 3

Sample 2 at 6X exhibits more voids than Sample 1.

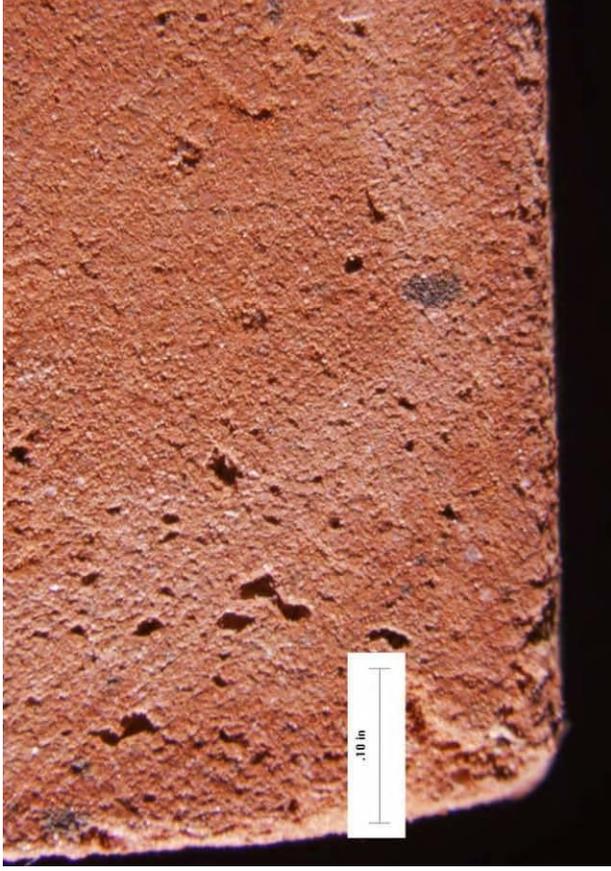
Photo 4

A cut corner of Sample 2 at 6X, showing less-frequent air voids near the edge of the brick. In this area, voids do not appear to be interconnected.

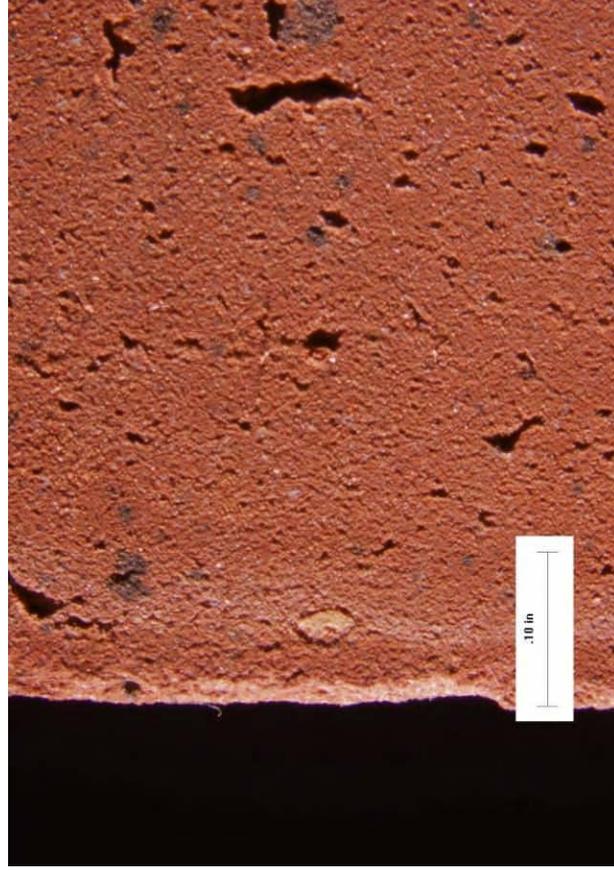
Photo 5

The bricks show increasing porosity toward the center of the brick, but few to no voids near the edges. This is exhibited especially clearly in Sample 2.

Sample 2 at 6X. Note the absence of voids close to the edge of the brick, and increasing frequency of voids deeper inside the brick.

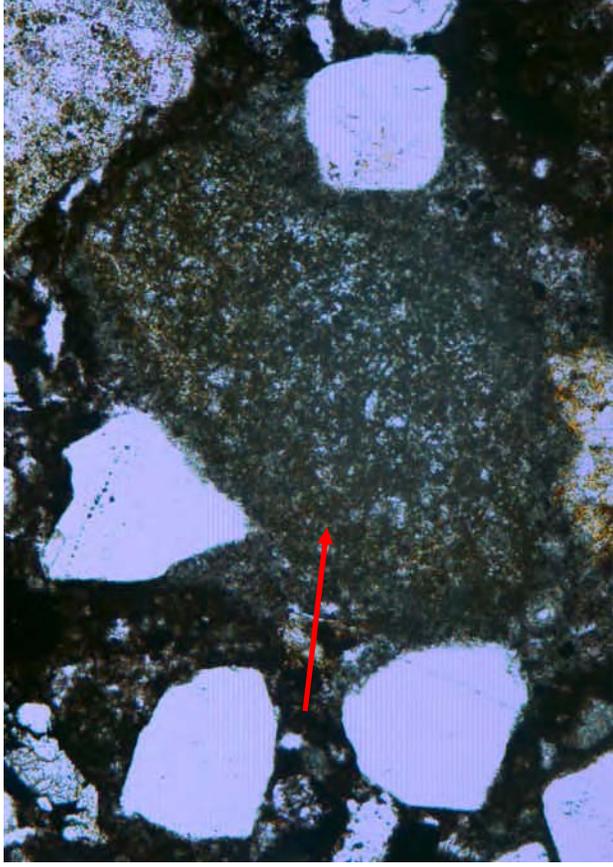
Photo 7

- The mortar contains particles of natural cement as well as lime (see photos 7 – 9).
- The mortar contains a natural sand that is primarily composed of quartz with lesser amounts of feldspar, micas, and limestone (see photo 10).

Natural cement particle at 100x, Sample 7A.

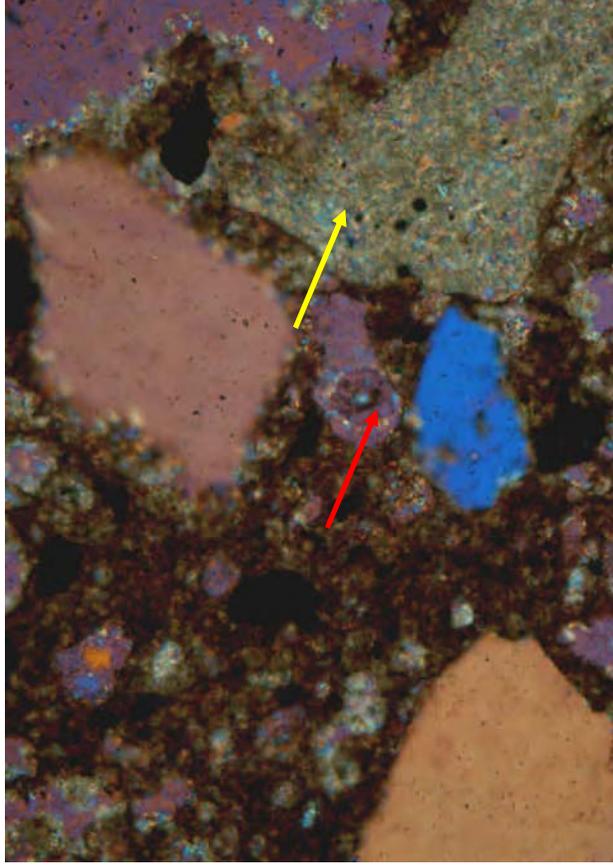
Photo 8

Small particle of quartz (red arrow) in natural cement (yellow arrow) located adjacent to limestone in the paste of sample 7A, at 200x.

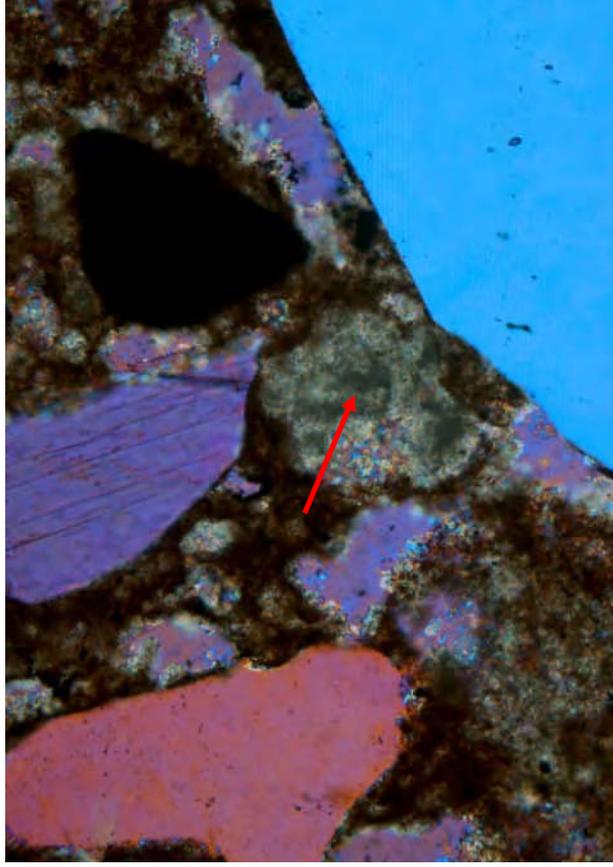
Photo 9

Lime mass surrounded by calcium hydroxide in matrix of sample 7A, 200x.

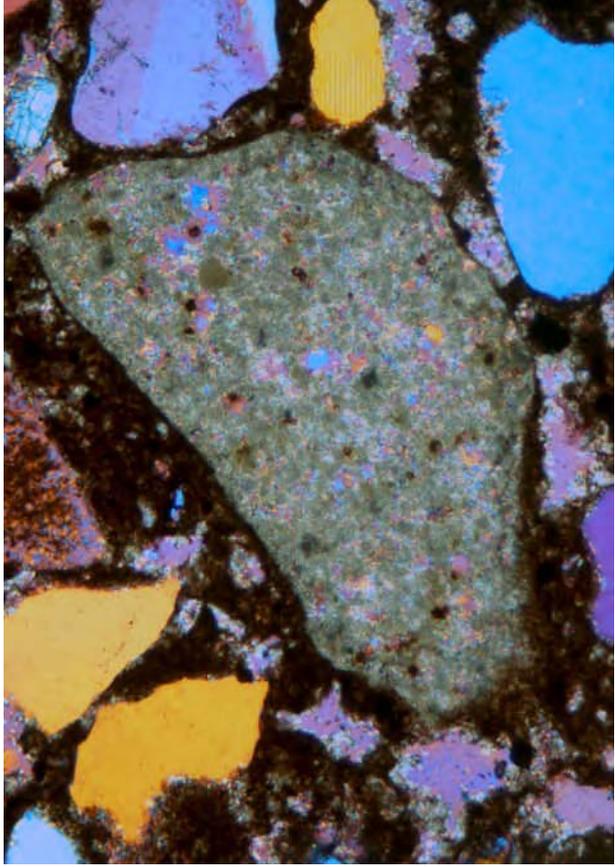
Photo 10

A particle of limestone, as compared to the lime mass shown in photo 9, 100x.

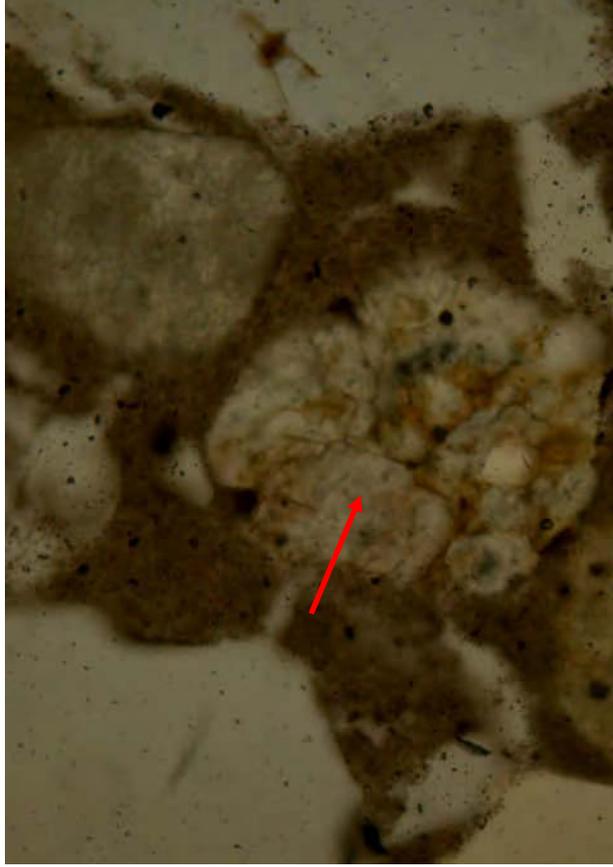
Photo 11

- The mortar exhibits a uniform brick red color.
- The mortar contains particles of natural cement as well as lime (see photo 11).
- The mortar contains an integral, iron oxide coloring pigment, not brick dust. We observe areas within the mortar that exhibit a light grey color due to the absence of coloring pigment.
- The sand fraction of the mortar is a natural sand that is primarily composed of quartz. We also observe lesser amounts of feldspar, micas, and limestone.
- The limestone particles comprise approximately 20% to 25% of the sand fraction, by volume.
- The mortar contains pieces of burnt wood or coal (see photo 12).

Particle of natural cement in the matrix of sample 9, 200X.

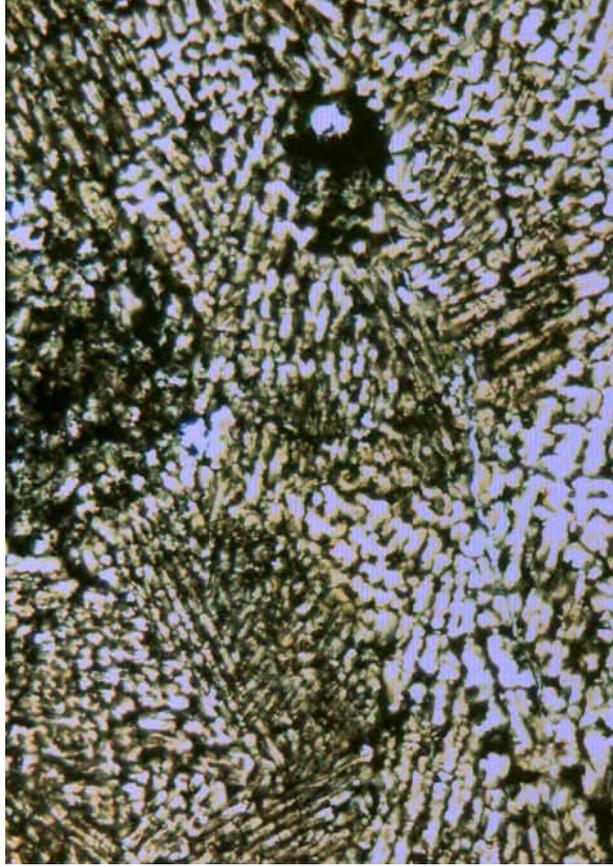
Photo 12

Cellular structure of burnt wood in the matrix of sample 9, 100x.

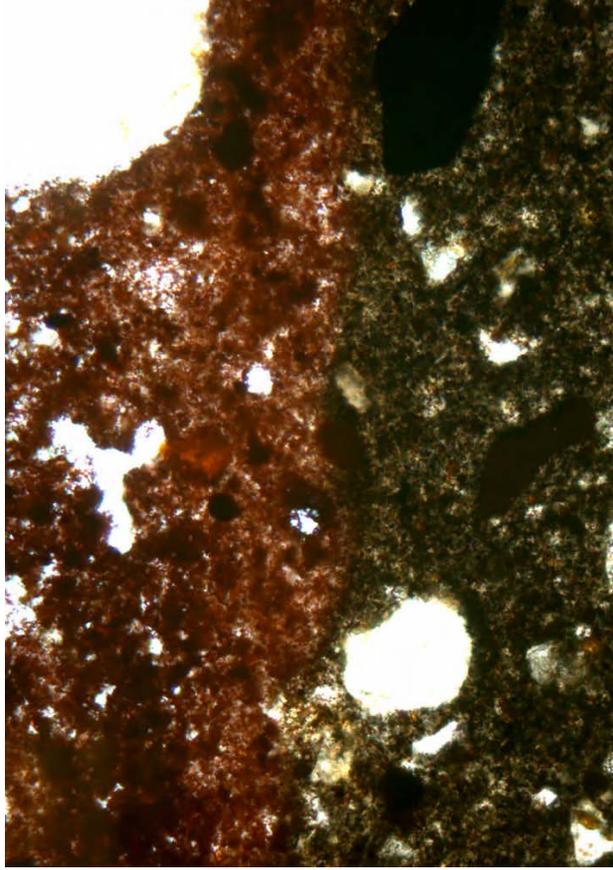
Photo 13

- The black mortar in sample 12 is similar to sample 8, and contains an integral, black carbon, coloring pigment.
- The red “stripe” of mortar in sample 12 is similar to the mortar in sample 7A. It was applied in a separate layer on top of the black mortar evidenced by a distinct, as the boundary between the two different colored mortars which is clearly visible (see photo 13).

Boundary between red and black mortars in sample 12, 200x.
