**RICHARDSON OLMSTED CAMPUS
BUILDING CONDITIONS ASSESSMENT**

BUFFALO, NY

PREPARED FOR: RICHARDSON CENTER CORPORATION

JANUARY 2023

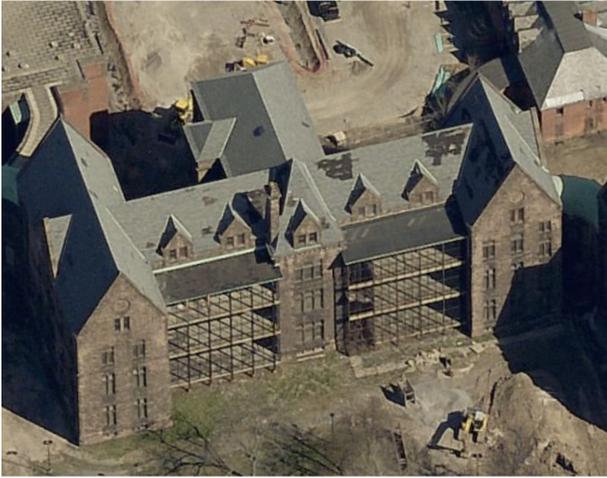
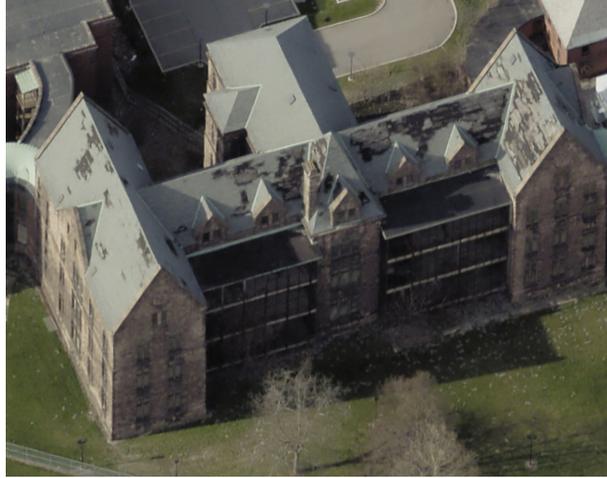
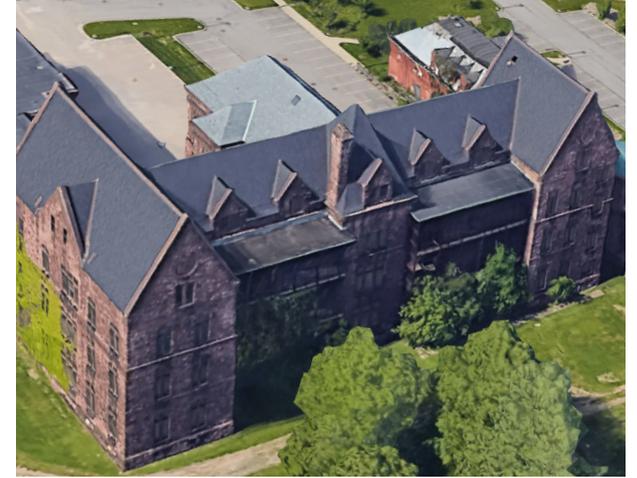
BUILDING 42

2016 >>>> 2020 >>>> 2022

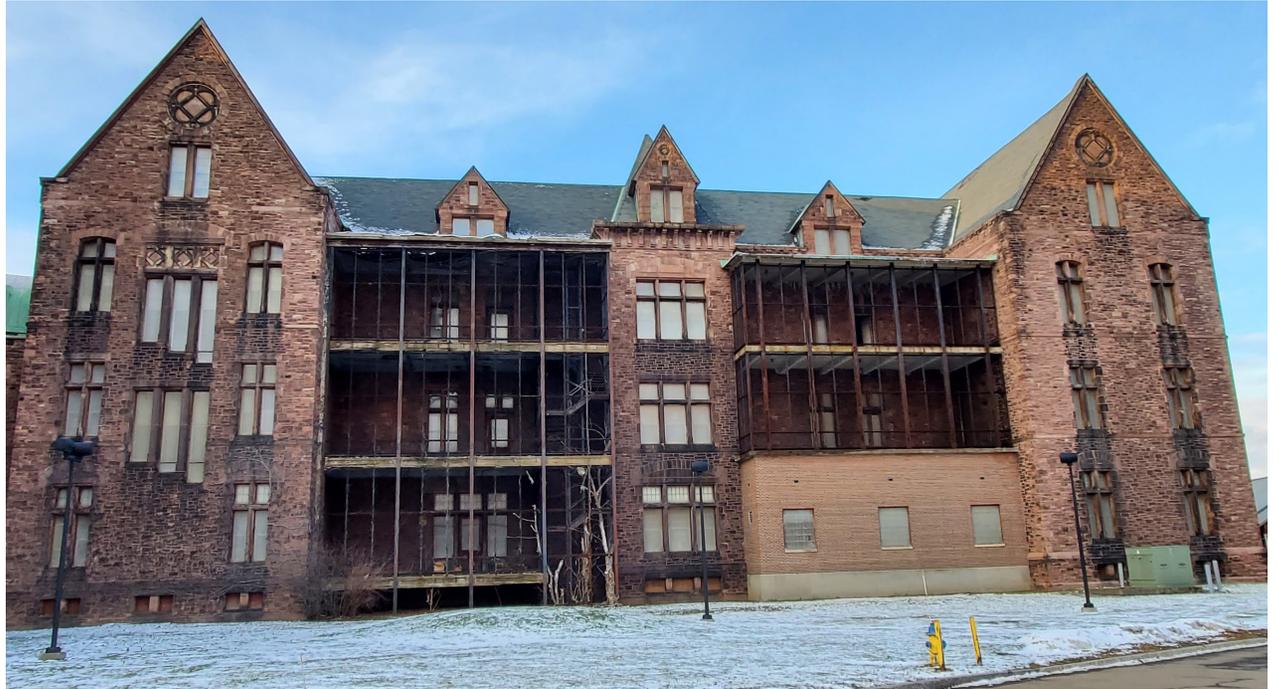
South Elevation of Male Ward B (Building 9)

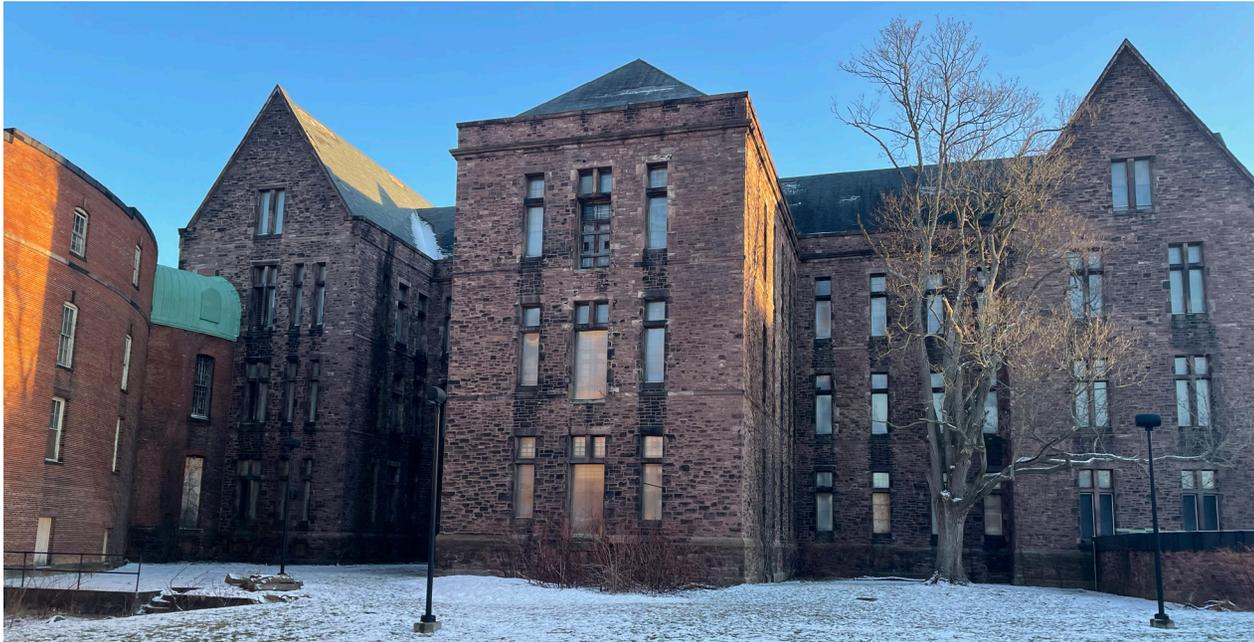
North Elevation of Male Ward B (Building 9)
Detail of Stabilization on North Elevation

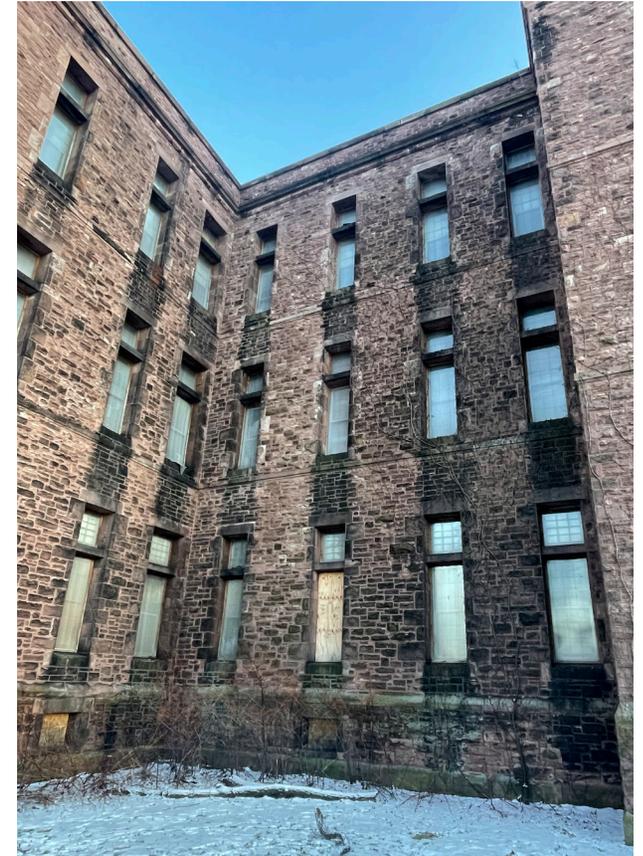
All of the basement windows have been covered with plywood. The remainder of the windows are covered with plastic sheet material, and in some locations plywood.

View Showing Location where Windows have been Covered for Protection

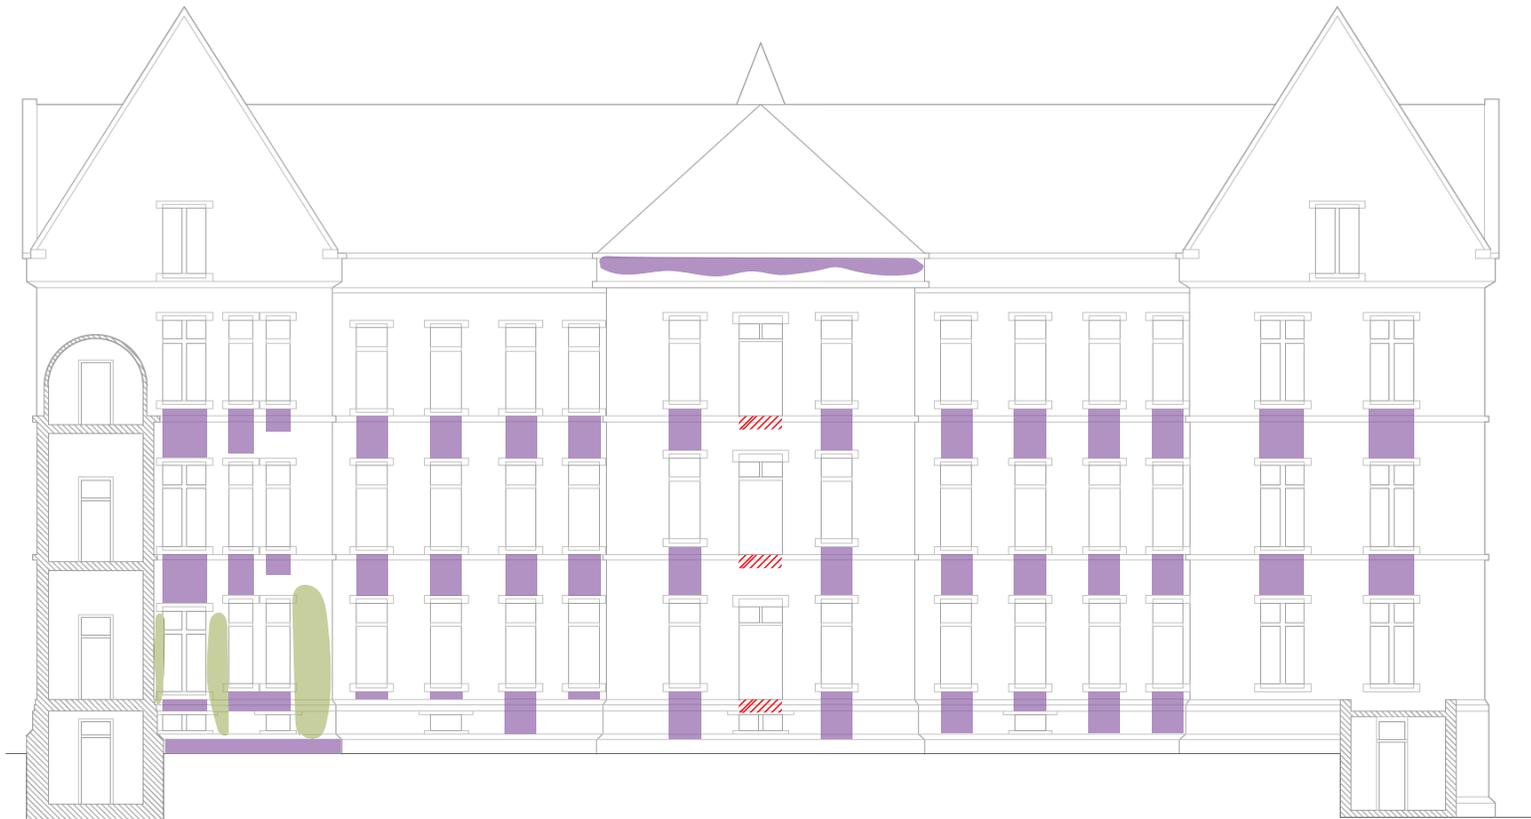
BUILDING 9 (MALE WARD B)
NORTH ELEVATION PLAN

The stone is generally in good condition, with some minor spalling. The north and west elevations show more extensive spalling, as expected given these are areas of greater water infiltration. Spalling is also noted in some locations where the pin fasteners from the iron bars at the window openings have rusted and large pieces of stone have spalled. No significant algae growth was observed on the building. Some atmospheric soiling is observed on all elevations.

The mortar joints are generally sound. Deterioration is noted in locations where ongoing water infiltration and saturation is occurring. Buff colored and red mortar were evident, indicative of several repointing campaigns.

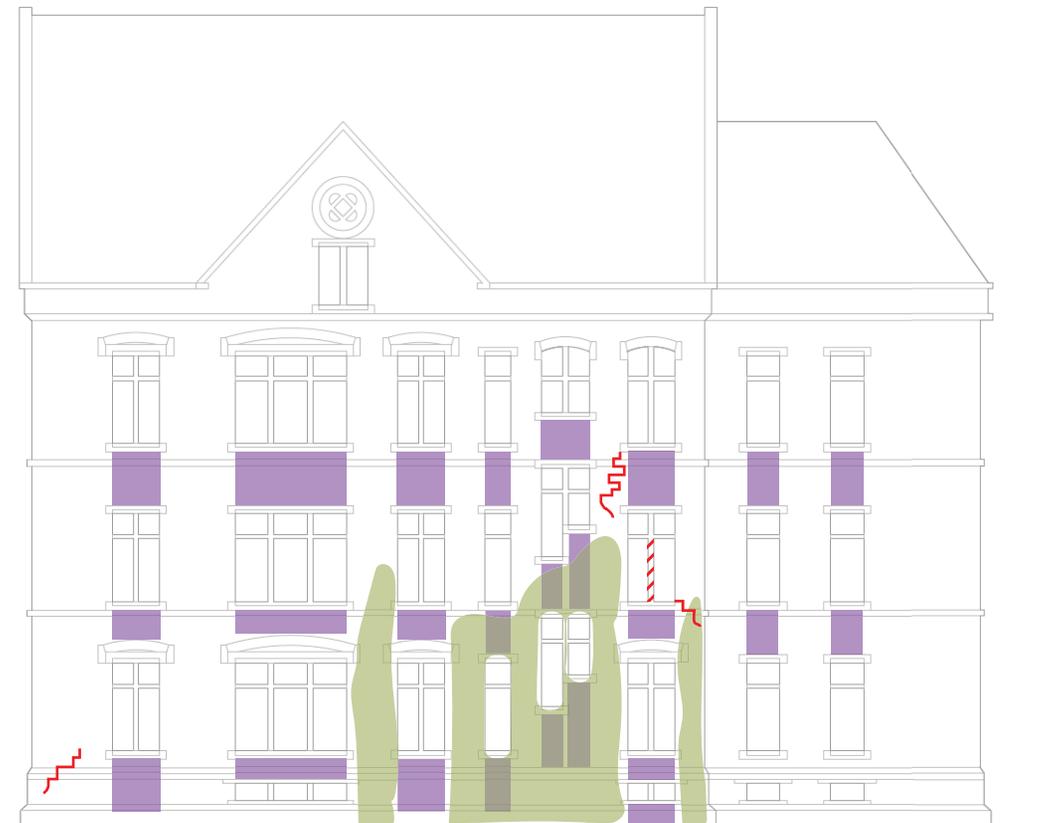
BUILDING 9 (MALE WARD B)
EAST ELEVATION PLAN

Step cracking is observed on the south and east elevations, primarily between the windows.

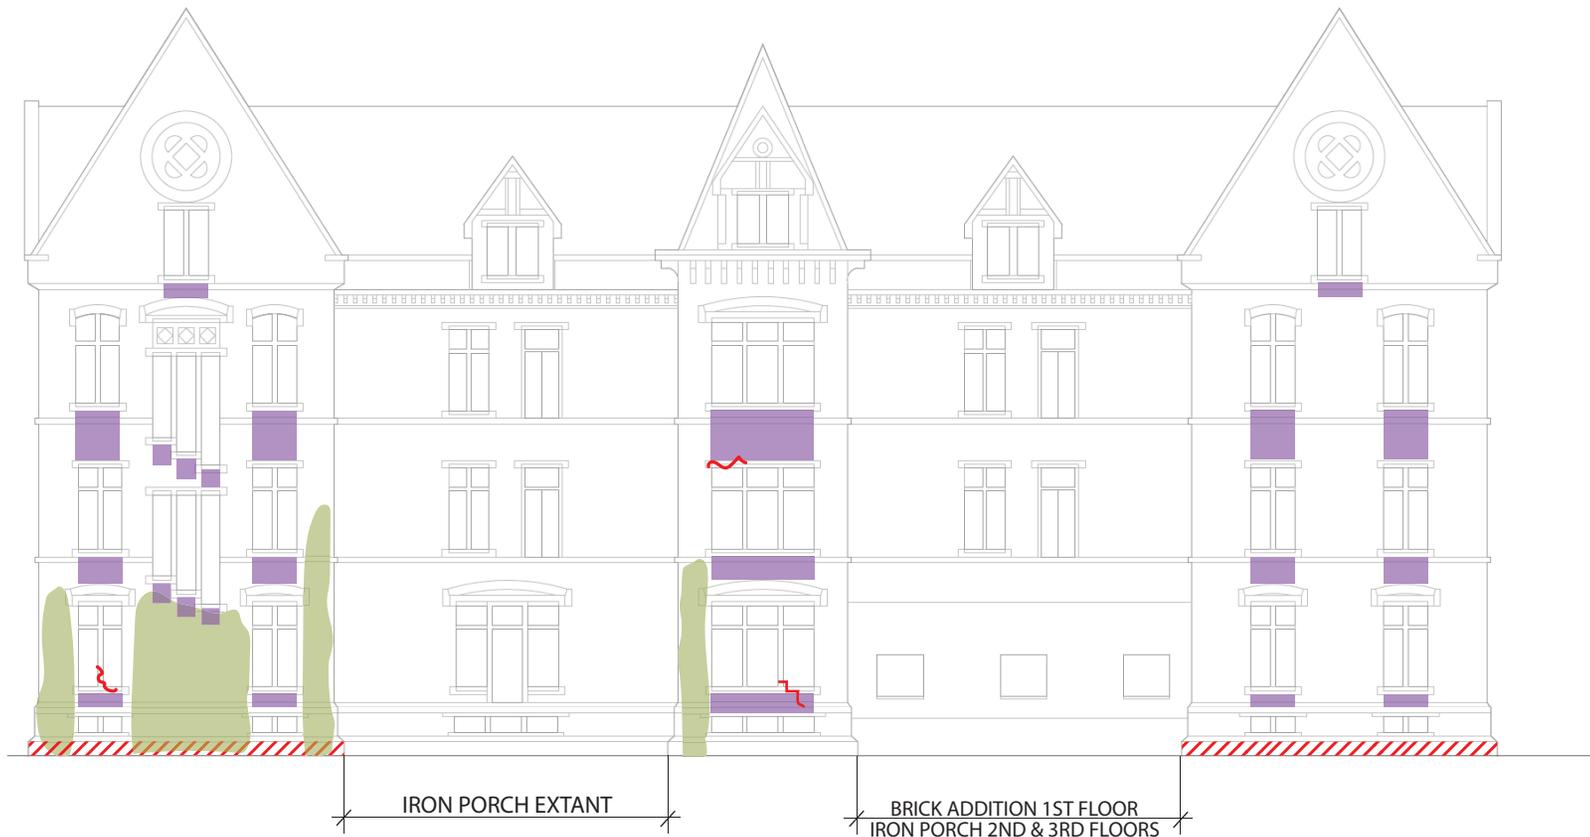
BUILDING 9 (MALE WARD B)
SOUTH ELEVATION PLAN

The porches on the east and west sides of the south elevation are in poor condition. The concrete is spalling, and the steel is rusting. The roof of the porches have deteriorated, and water is infiltrating the building at the flashing.

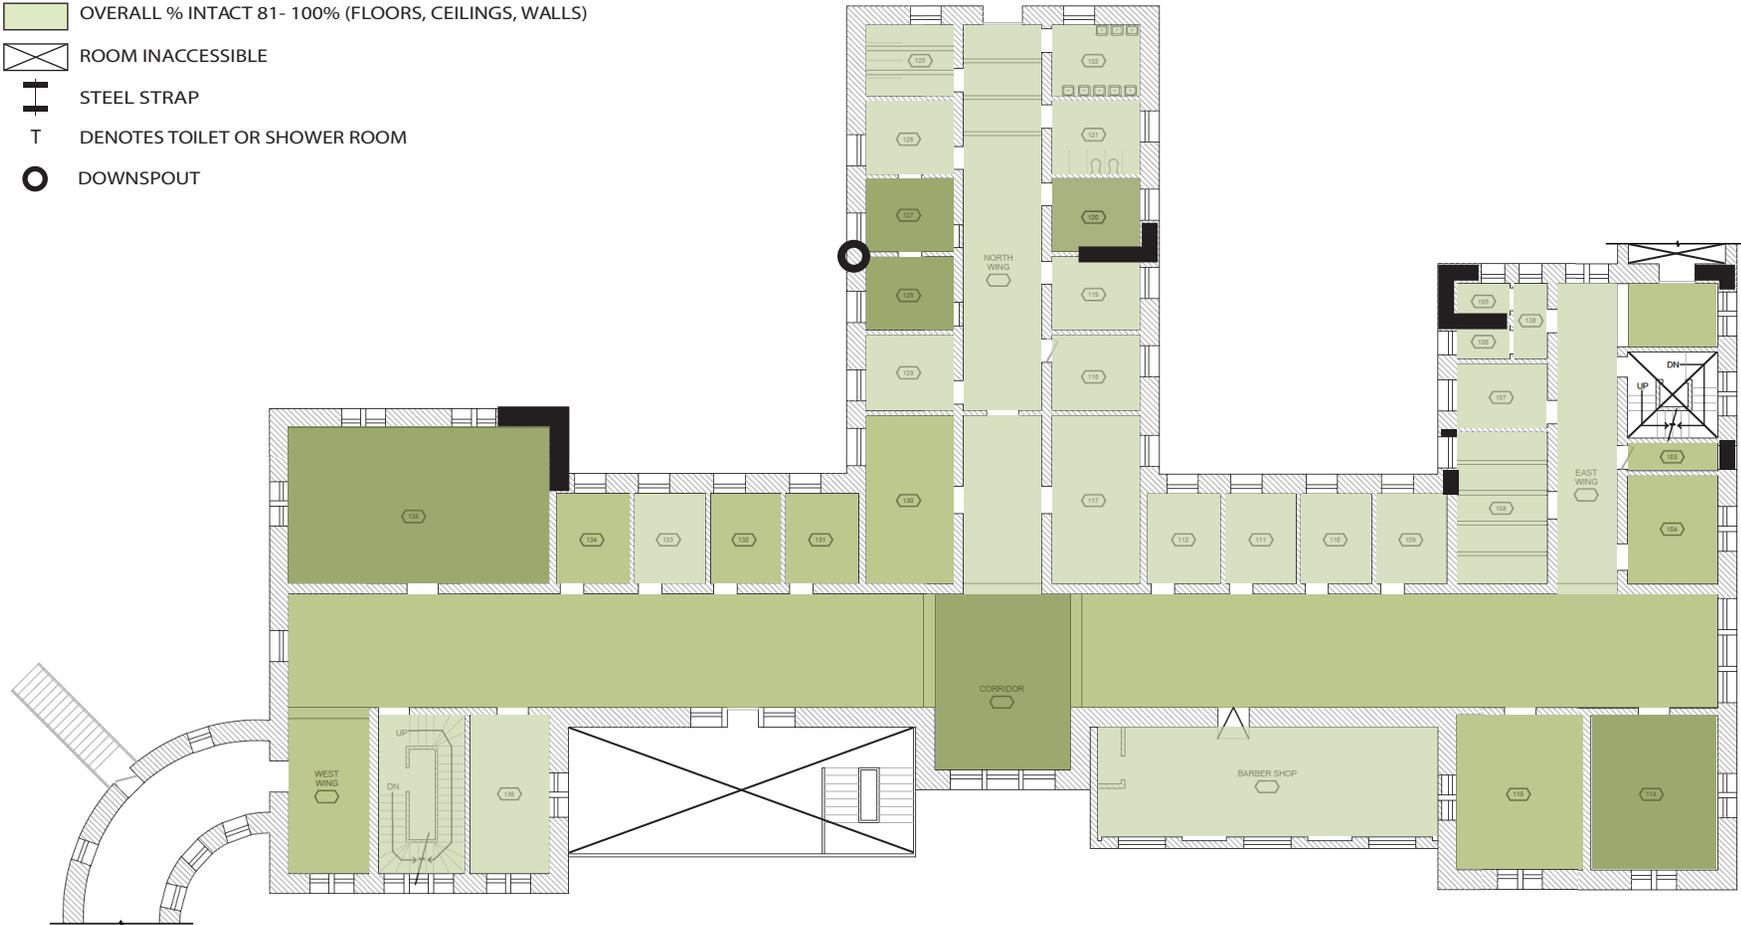
BUILDING 9 (MALE WARD B)
FIRST FLOOR PLAN

The interior of the building features hardwood floors covered with linoleum, and wood doors, window sash, and casing. The building is in fair to poor condition. The majority of the deterioration can be attributed to water infiltration from previous or current roof leaks and broken internal downspouts. This deterioration includes deteriorated and failed plaster ceilings and walls, exposed brick masonry, and deteriorated or failed floor structure. The high moisture levels and lack of ventilation have resulted in peeling paint, cracks in the plaster, and deterioration of the finish plaster coat.

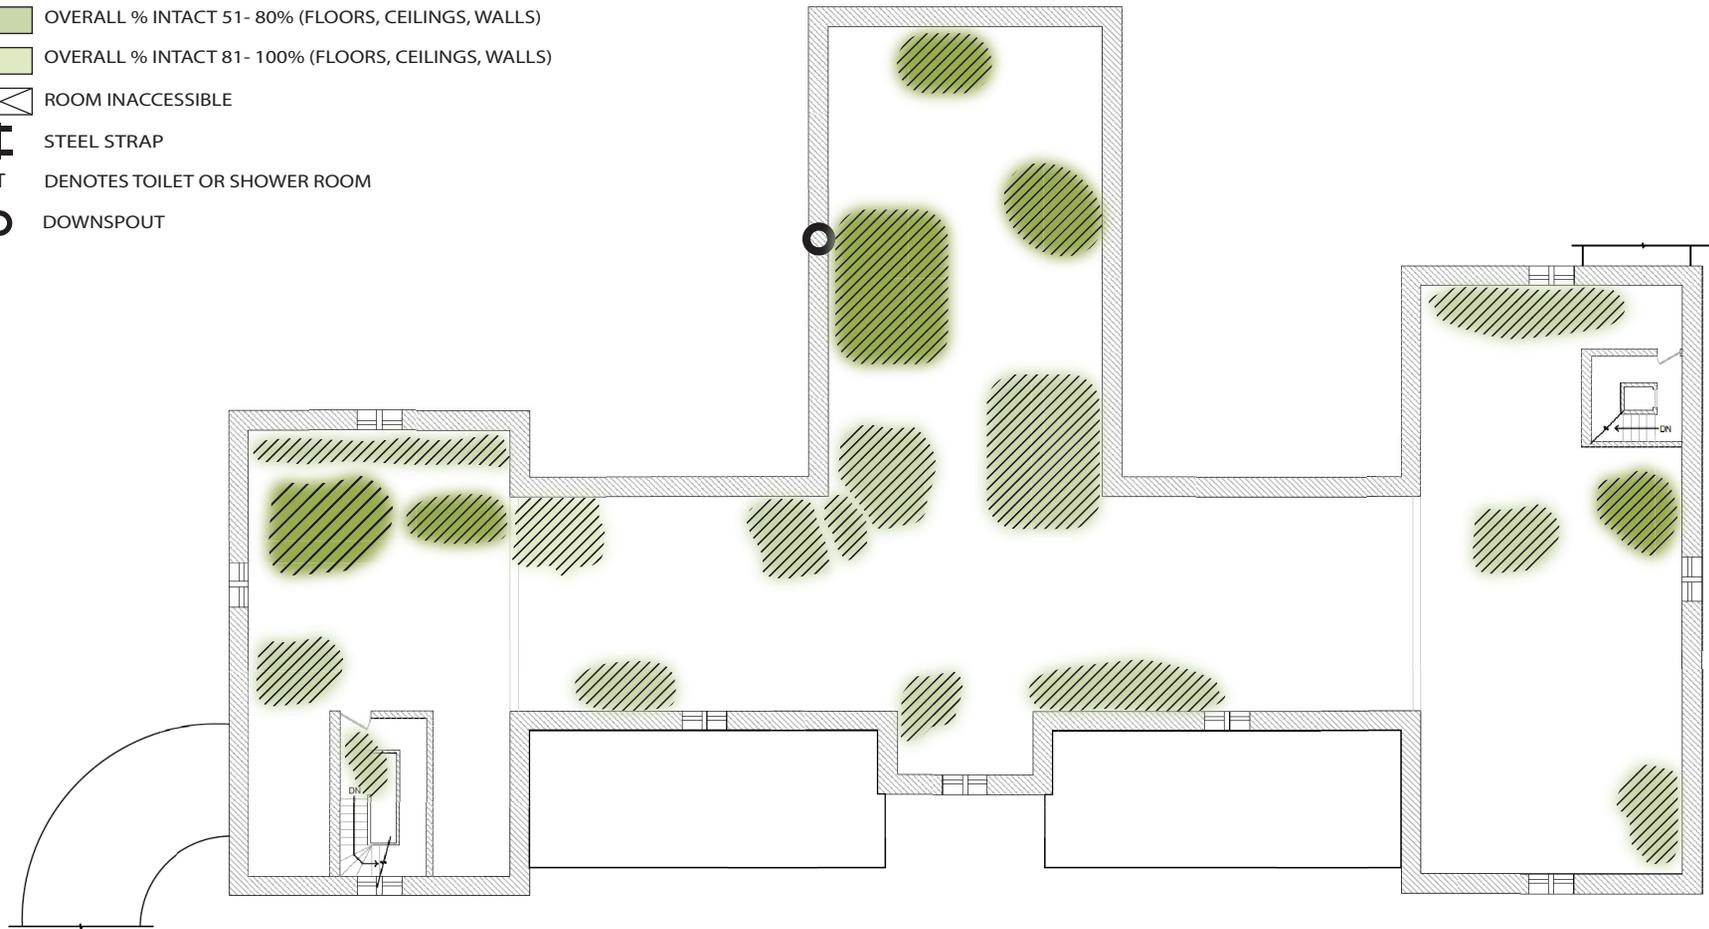
BUILDING 9 (MALE WARD B)
ATTIC FLOOR PLAN

In general the structure of the building is in fair condition. The exterior and interior bearing walls appear to be in good condition. The floor structure and ceiling structure have failed in locations where there is significant water infiltration due to holes in the roof and failing internal downspouts. The roof framing in the main block was repaired in early 2000s as noted in the 2008 HSR. Several holes were observed in the roof decking at the east, west, and central wings. Water continues to infiltrate the building at these locations. Infiltration was observed in the east, west, and central wings. Water damage was observed on the attic floors, and where the purlins bear in pockets, and at sheathing abutting gable end walls.

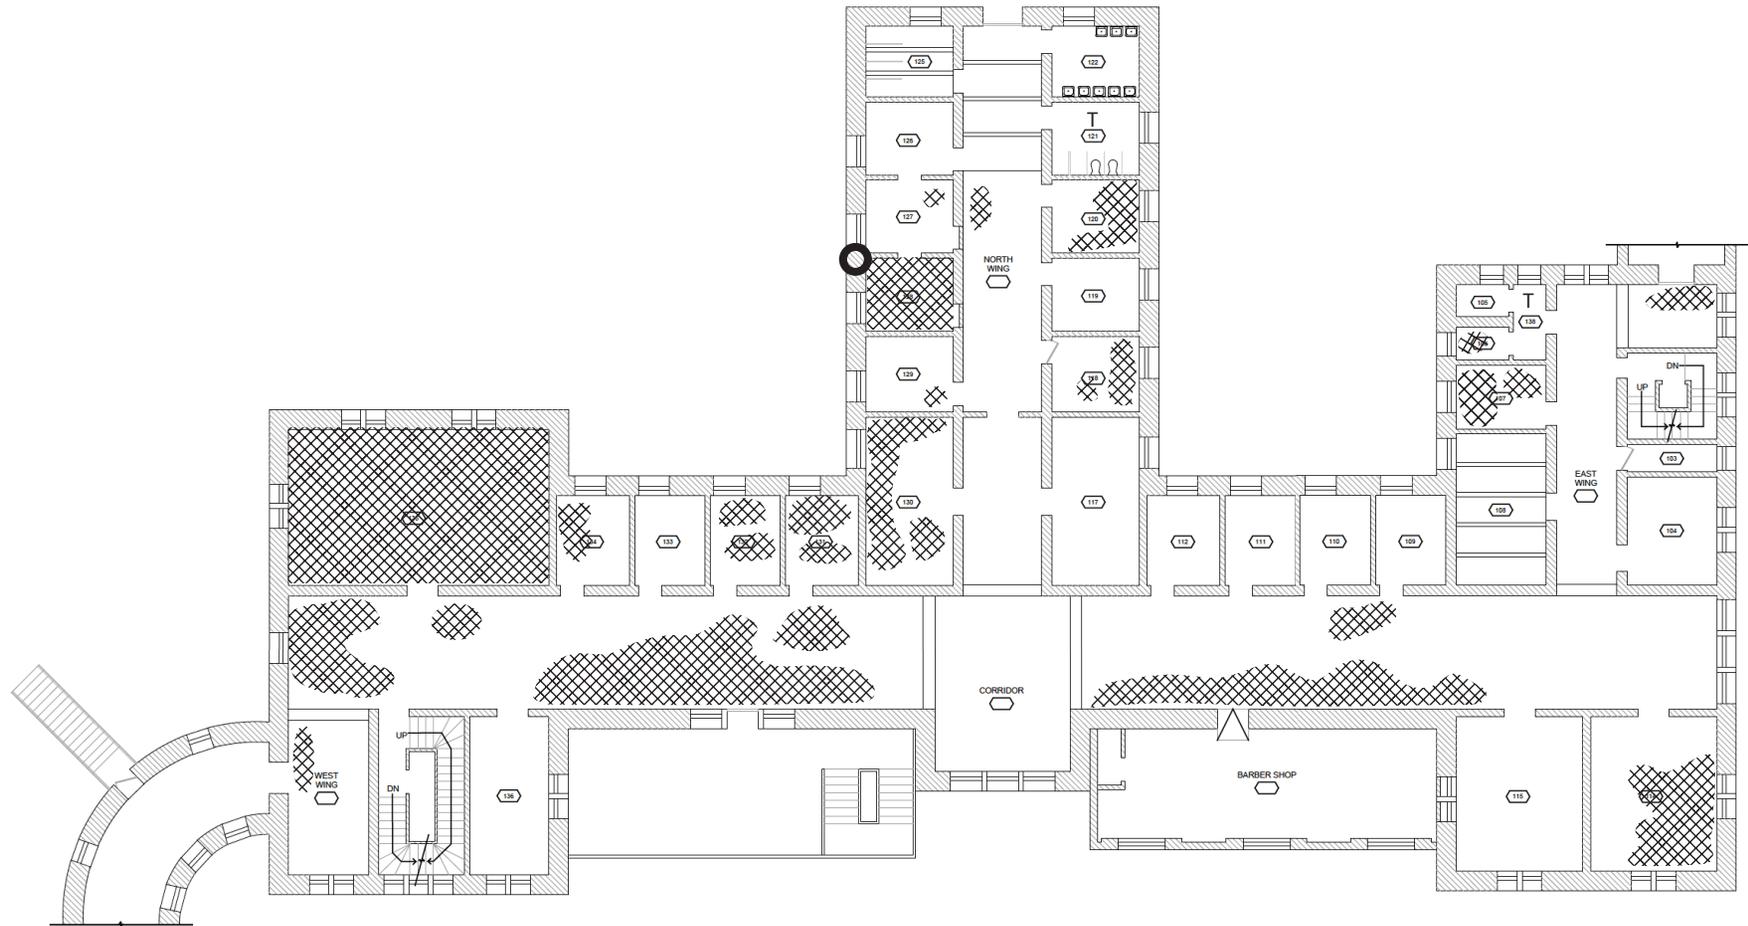
BUILDING 9 (MALE WARD B)
FIRST FLOOR REFLECTED CEILING PLAN

All areas of roof damage are R3

WATER INFILTRATION AT
PORCH-BUILDING CONNECTION

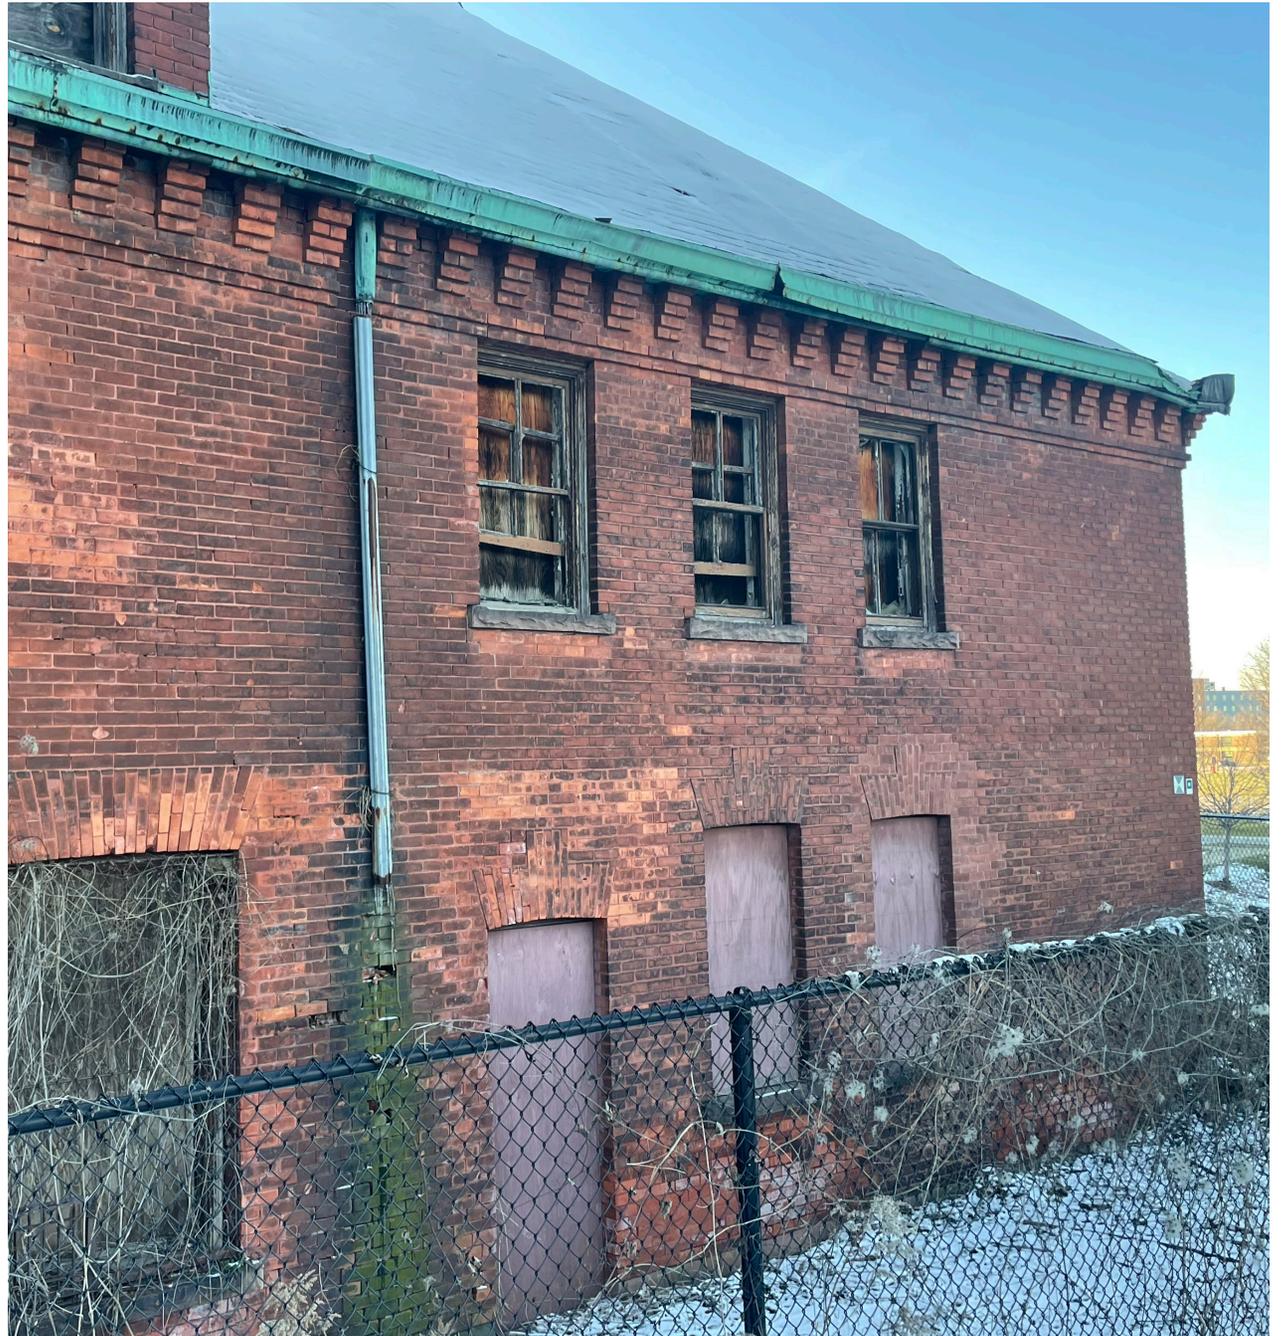
The structure of Building 43 is severely compromised. The roof and attic framing members are deteriorated and failing. Although not accessible, given the condition of the roof and continuous water infiltration it can be assumed that interior framing and structural members are also failing. Without immediate stabilization, including shoring/bracing to support the masonry walls and roof it is probable that the building will fail and collapse.

East Elevation Roof Damage and Deteriorated and Failing Masonry. Note Extant Four-Light Wood Sash.

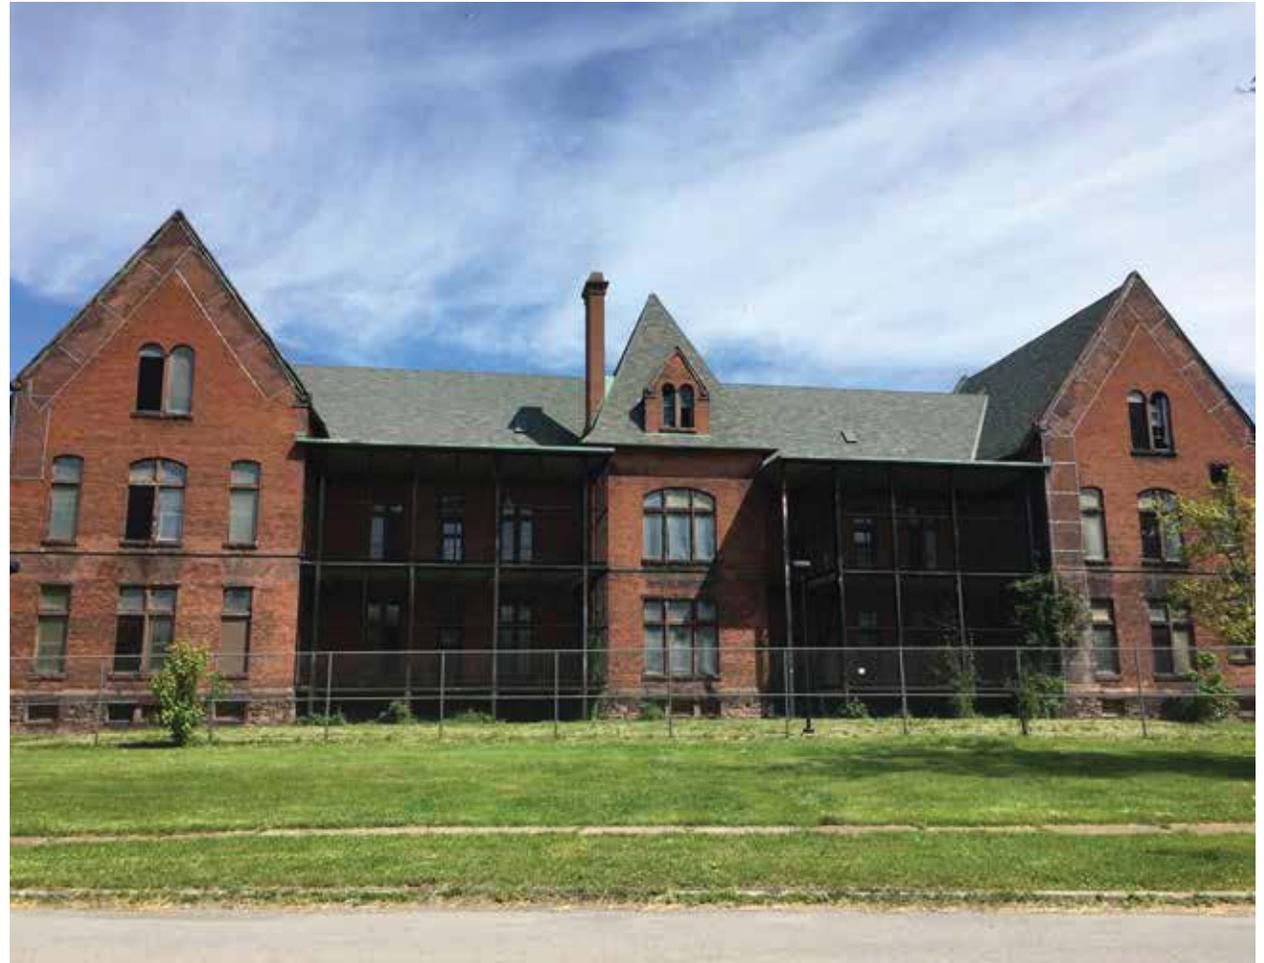
Fig. 3-8: South Elevation (CJSA 2019)

The Medina sandstone elements on the building are in fair condition. They exhibit minor spalling, staining, mortar loss, and some algae growth at the foundation walls. Some repairs and repointing are visible since the 2008 HSR.

The brick is in fair condition overall, with stabilization methods visible since the HSR.

Typically the brick behind the netting was not repointed before the metal netting was installed. The metal netting is present on all elevations of Ward H, on all of the upper gable walls just below the cap stones, and in various patches around the rest of the building. Areas that were repointed are visible to the eye because the mortar is a different color than the rest of the mortar on the building. New cracks through the brick and new areas of mortar loss since 2008 are visible.

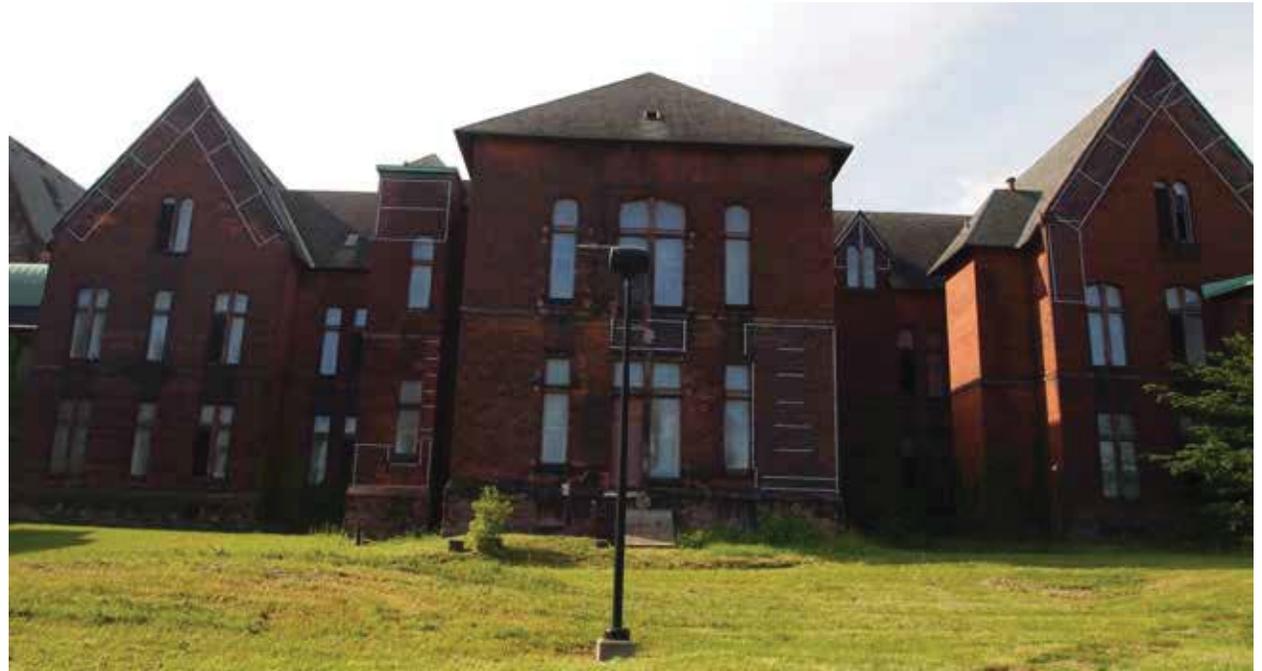
Fig. 3-9: North Elevation (CJSA 2019)

The roof is asphalt and projects over the walls with exposed rafter tails. Yankee gutters were not reinstalled and therefore water is shed directly onto the ground below. In some areas, the water is eroding the ground and exposing the stone foundation. Specific roof conditions were not reviewed as part of this report and are only noted in relation to other areas in the scope of work. For a full roof analysis, please see the contractor's report.

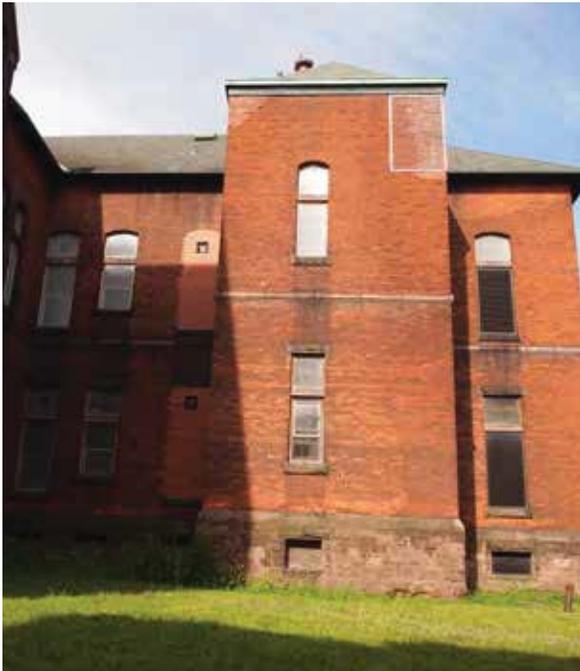
Fig. 3-10: East Elevation of Central Bay on North Elevation (CJSA 2019)

All of the basement windows have been covered with plywood. Most of the first, second, and attic floor windows have been protected with plastic attached to the exterior of the windows. The windows not covered with plastic have been replaced with louvers to ventilate the interior of the building, including some of the basement windows. Overall, fifteen percent of the windows on all floors of Ward H have been replaced with louvers. Most of the windows still have their iron bars under the plastic protection.

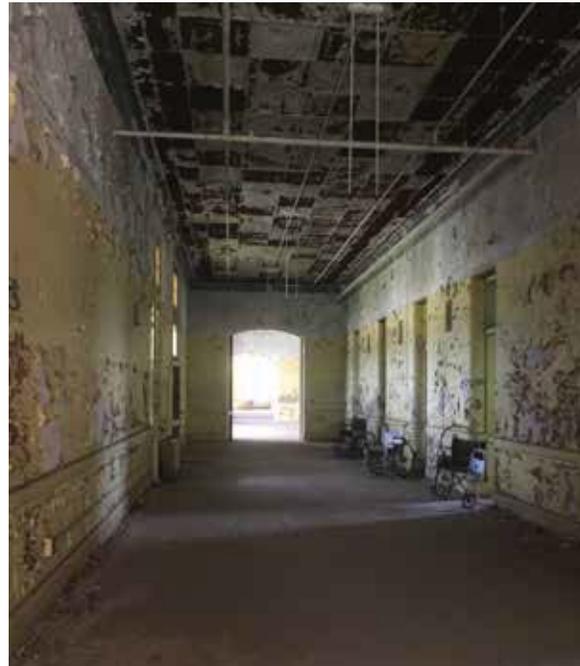
Fig. 3-11: Room 129, First Floor. Typical interior finish conditions in hallway (CJSA 2019)

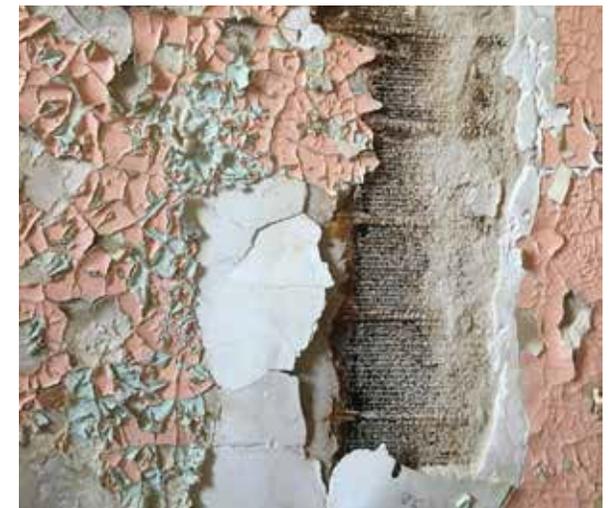
The majority of visible interior finish damage is limited to the paint or the finish plaster coat. The significant damage occurs around broken internal downspouts and areas of previous water infiltration.

Fig. 3-13: Detail of downspout damage (CJSA 2019)

However, the internal downspouts have since been disconnected and are no longer the primary cause of interior finish damage.

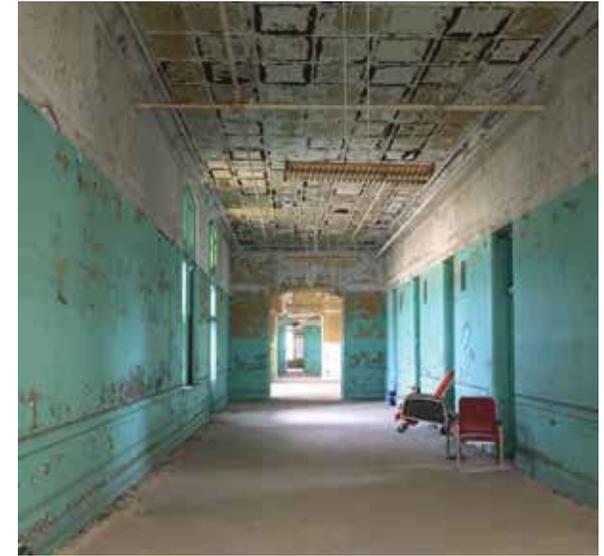
Fig. 3-17: Dayroom, Room 29, second floor. Paint finishes are primary concern (CJSA 2019).

Plaster on the walls will continue to deteriorate if the edges are exposed and external masonry is not repaired. Surface damage, including peeling paint and cracked plaster, is due to high levels of moisture in the unconditioned building.

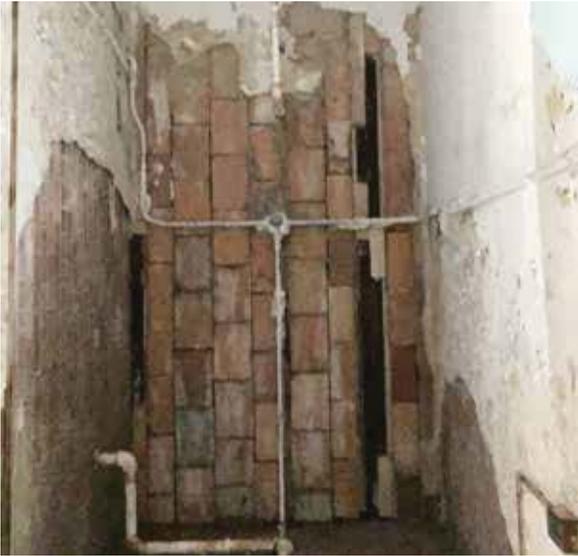
Fig. 3-18: Terra cotta ceiling exposed, second floor (CJSA 2019)

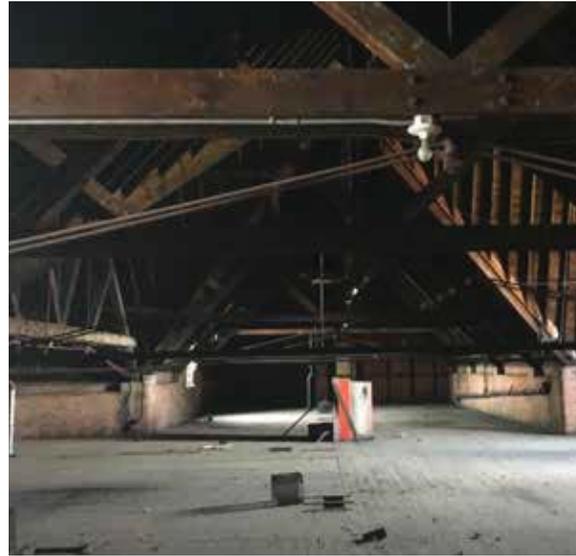
Fig. 3-19: Attic (CJSA 2019)

roof framing, including reinforcement of the purlin connections to the brick gable walls. However, we observed evidence of ongoing water infiltration and several valley members with water damage and potential reduction in bearing at the bottom of the valleys.

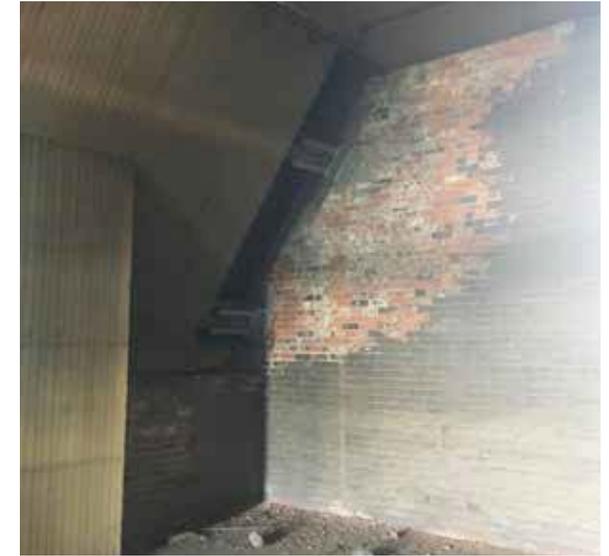
Fig. 3-20: Gable wall damage and stabilization in attic (CJSA 2019)

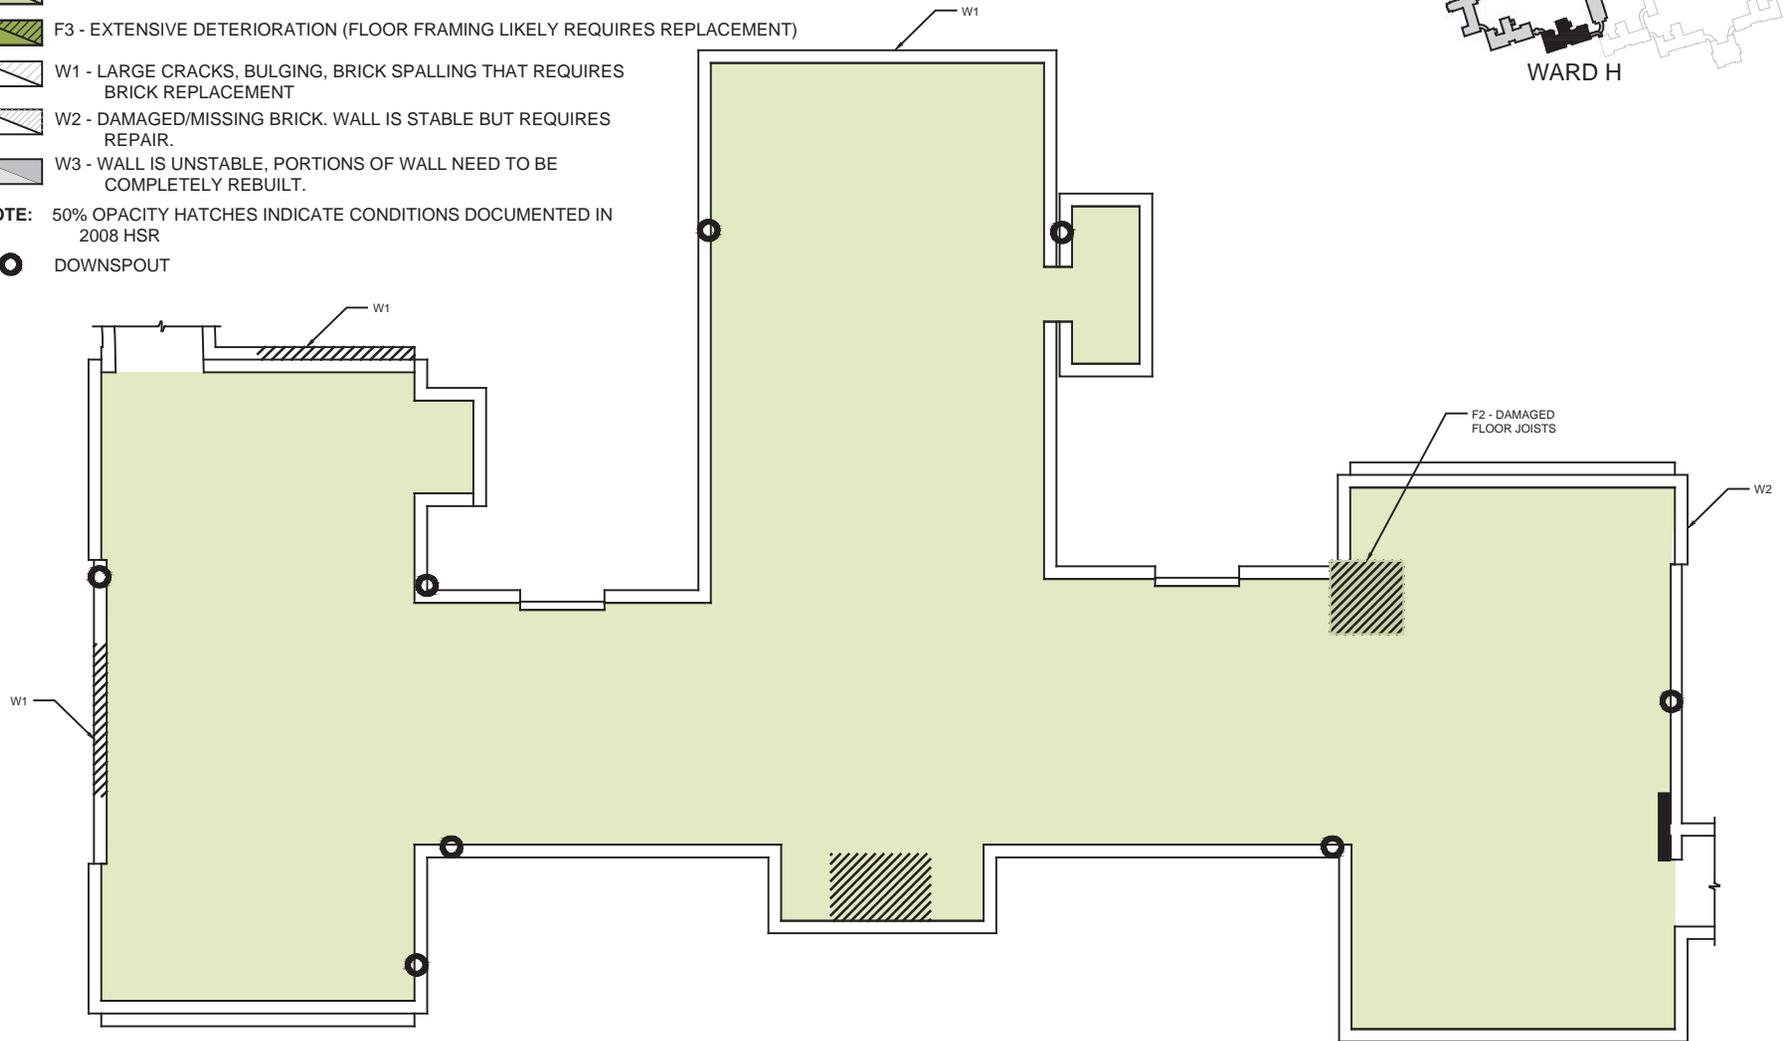
BUILDING 40 (FEMALE WARD H)
ATTIC FLOOR PLAN

R1 - MINOR CHECKING/CRACKING/WATER STAINING
-

R2 - ROOF FRAMING/SHEATHING REQUIRES LOCAL REPAIRS
-

R3 - ROOF FRAMING/SHEATHING REQUIRES REPLACEMENT

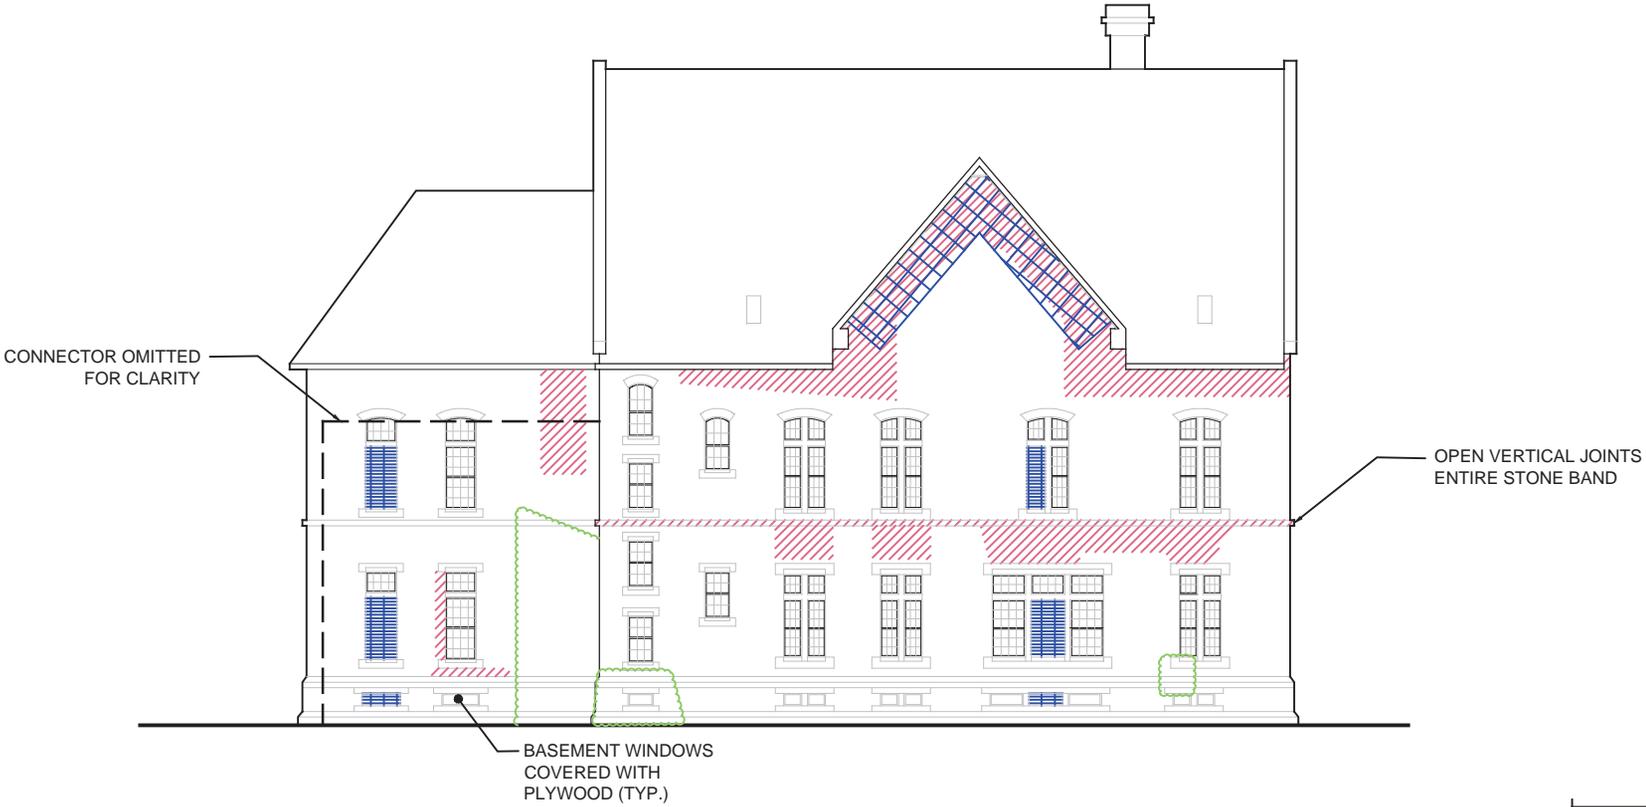
BUILDING 40 (FEMALE WARD H)
WEST ELEVATION

CRACKS	13% SPALLING

MASONRY COLLAPSE / MISSING MASONRY	80% STAINING

OPEN JOINTS / MASONRY DAMAGE	60% MORTAR EROSION
