**RICHARDSON OLMSTED CAMPUS
BUILDING CONDITIONS ASSESSMENT**

BUFFALO, NY

PREPARED FOR: RICHARDSON CENTER CORPORATION

JANUARY 2023

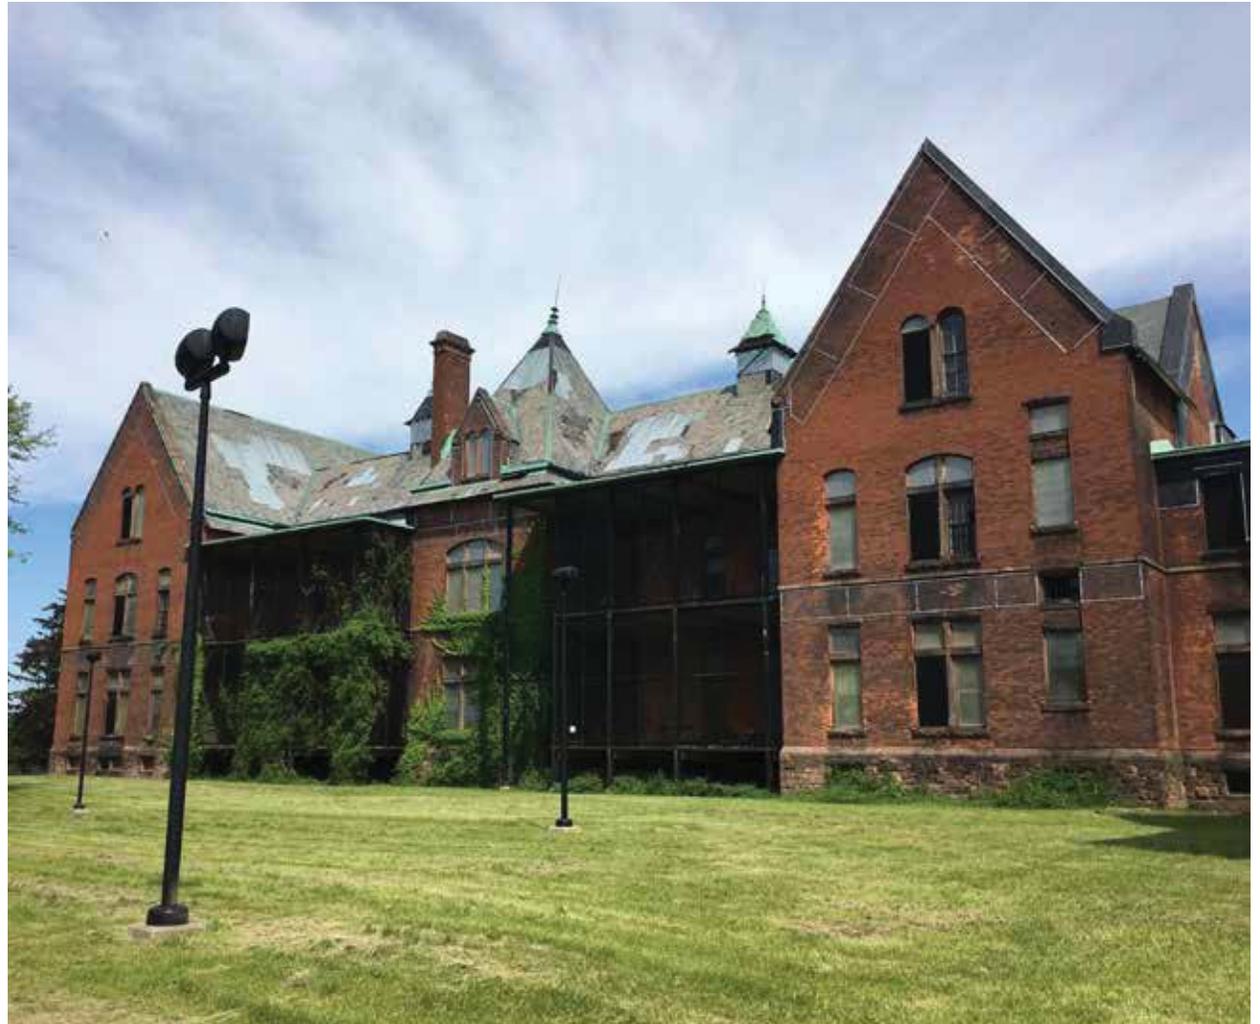
Fig. 3-21: South Elevation (CJSA 2019)

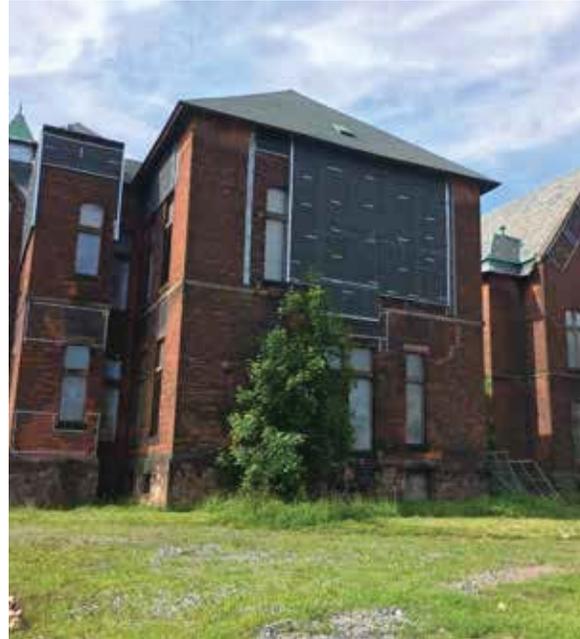
Fig. 3-26: Central bay of North Elevation with replacement roof(CJSA 2019)

The central portion of the roof facing the south was replaced with asphalt after 2008 and is in good condition.

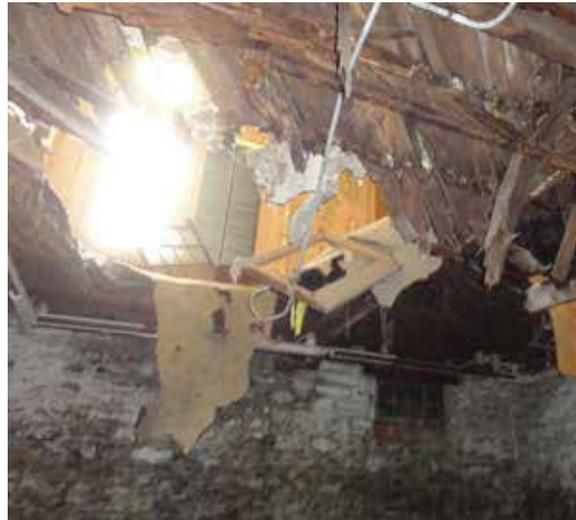
Fig. 3-31: Collapsed portion of first floor (SGH 2019)

The interior areas that were noted with the most concern in the HSR, including the west and east ends of the first and second floor, exhibit the most structural failure and areas of failure have expanded. Most of the patient rooms on the north side of the dayroom have collapsed or partially-collapsed floors. The dayroom from the west to east ends has suspect framing and floor sheathing throughout its entire length. The areas of floor collapse appear to have happened after 2008.

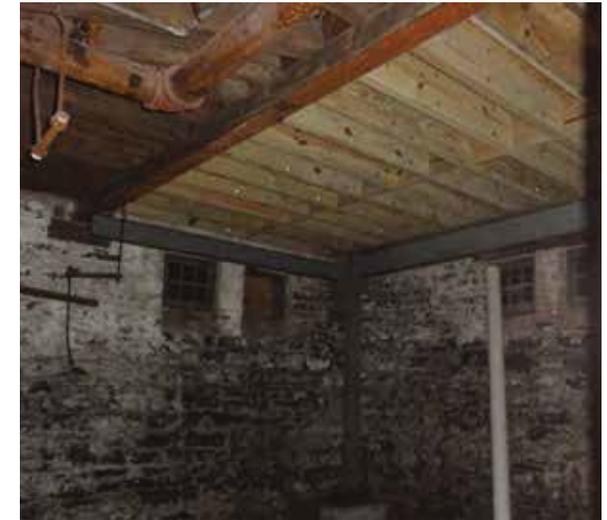
Fig. 3-32: Previous floor stabilization (SGH 2019)

however areas of water infiltration persist in these areas.

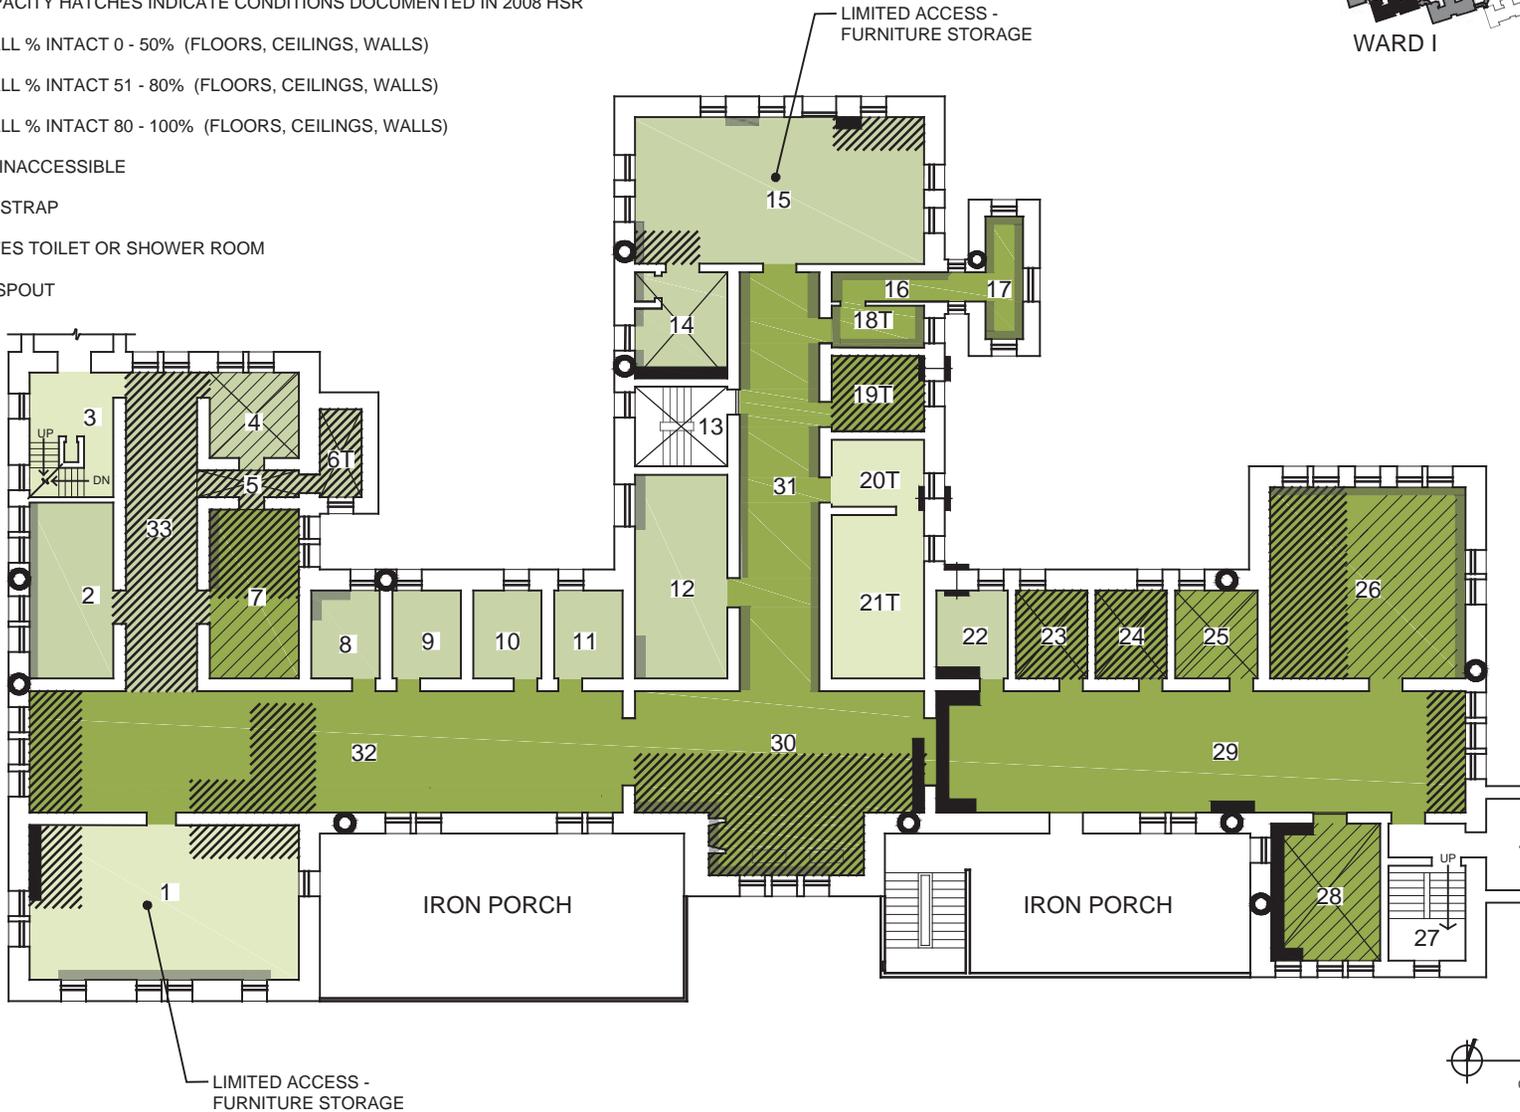
BUILDING 39 (FEMALE WARD I)
FIRST FLOOR PLAN

FLOOR - UNSOUND, PARTIALLY COLLAPSED, OR MISSING

WALLS - PLASTER AND/OR LATH DAMAGE

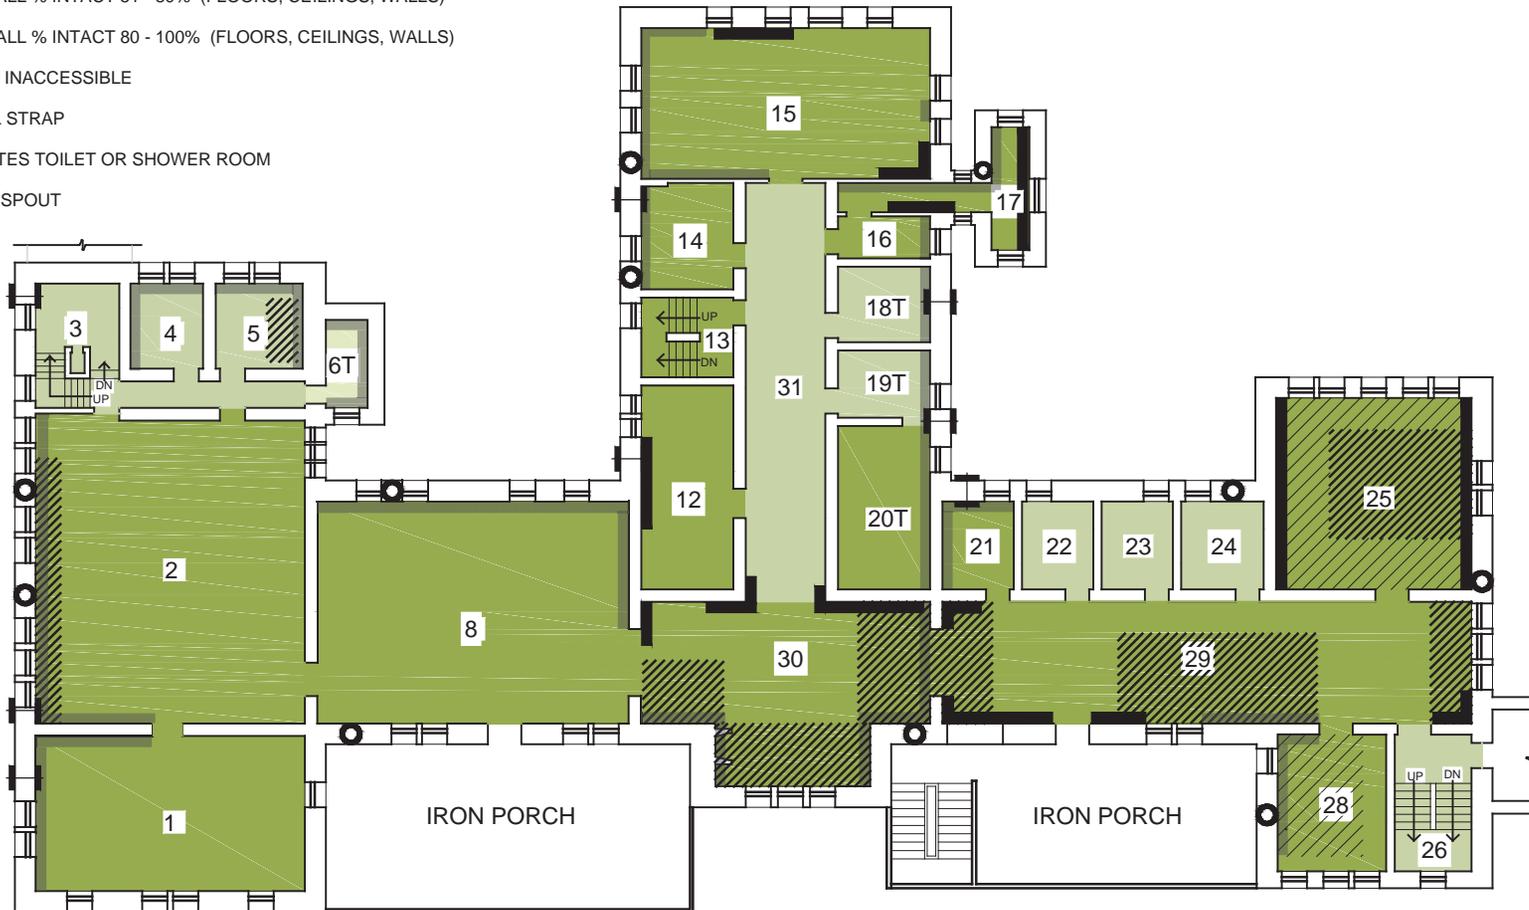
BUILDING 39 (FEMALE WARD I)
SECOND FLOOR PLAN

FLOOR - UNSOUND, PARTIALLY COLLAPSED, OR MISSING

WALLS - PLASTER AND/OR LATH DAMAGE

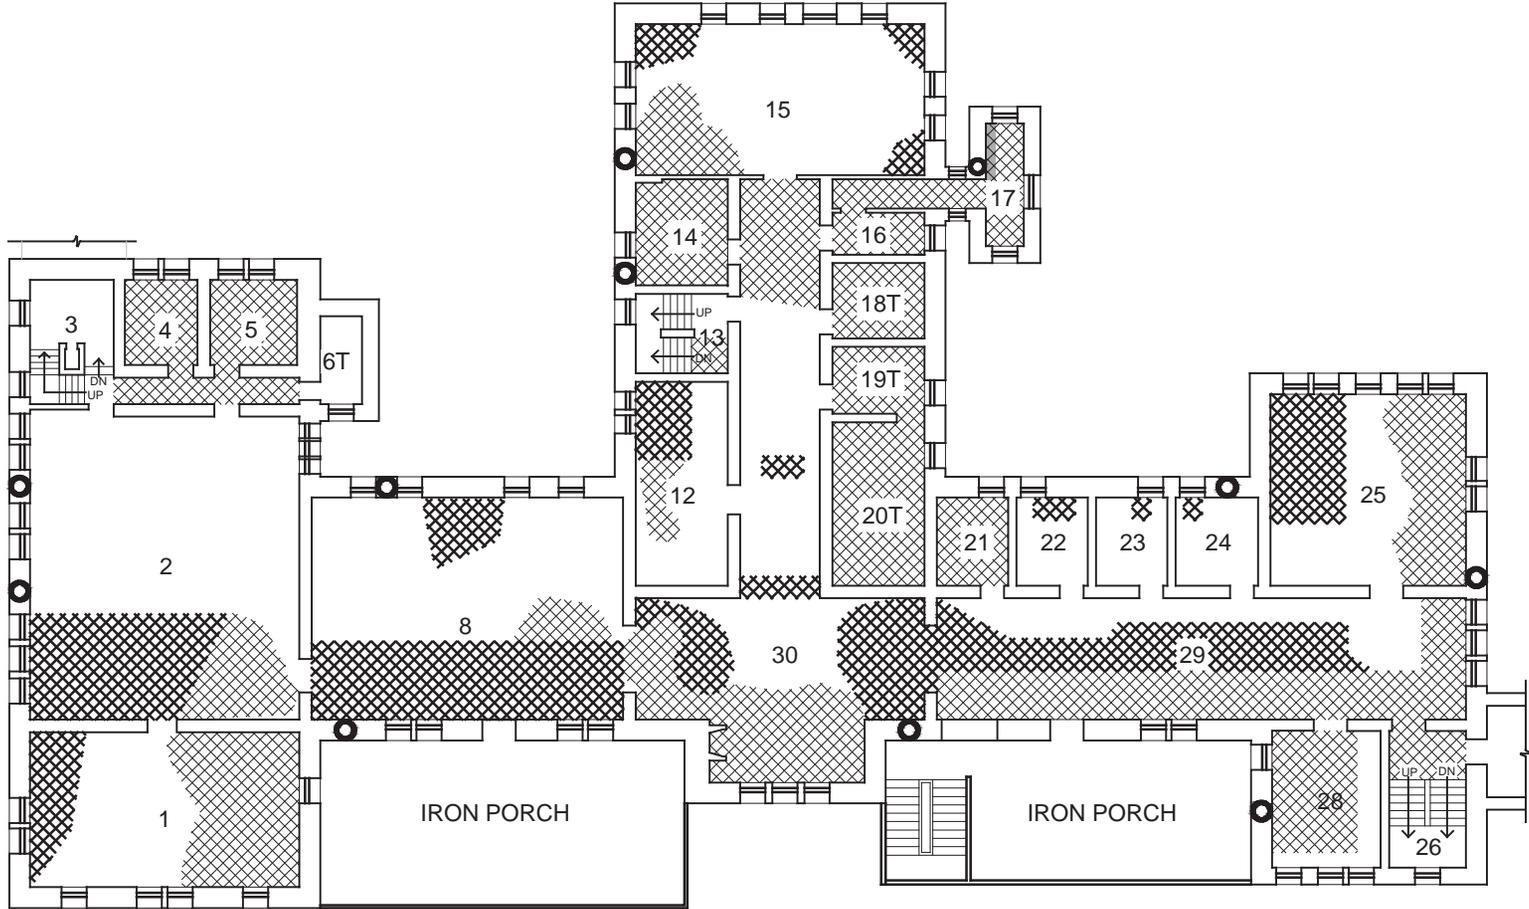
BUILDING 39 (FEMALE WARD I)
SECOND FLOOR REFLECTED CEILING PLAN

CEILING - PLASTER, LATH, OR TIN DAMAGE

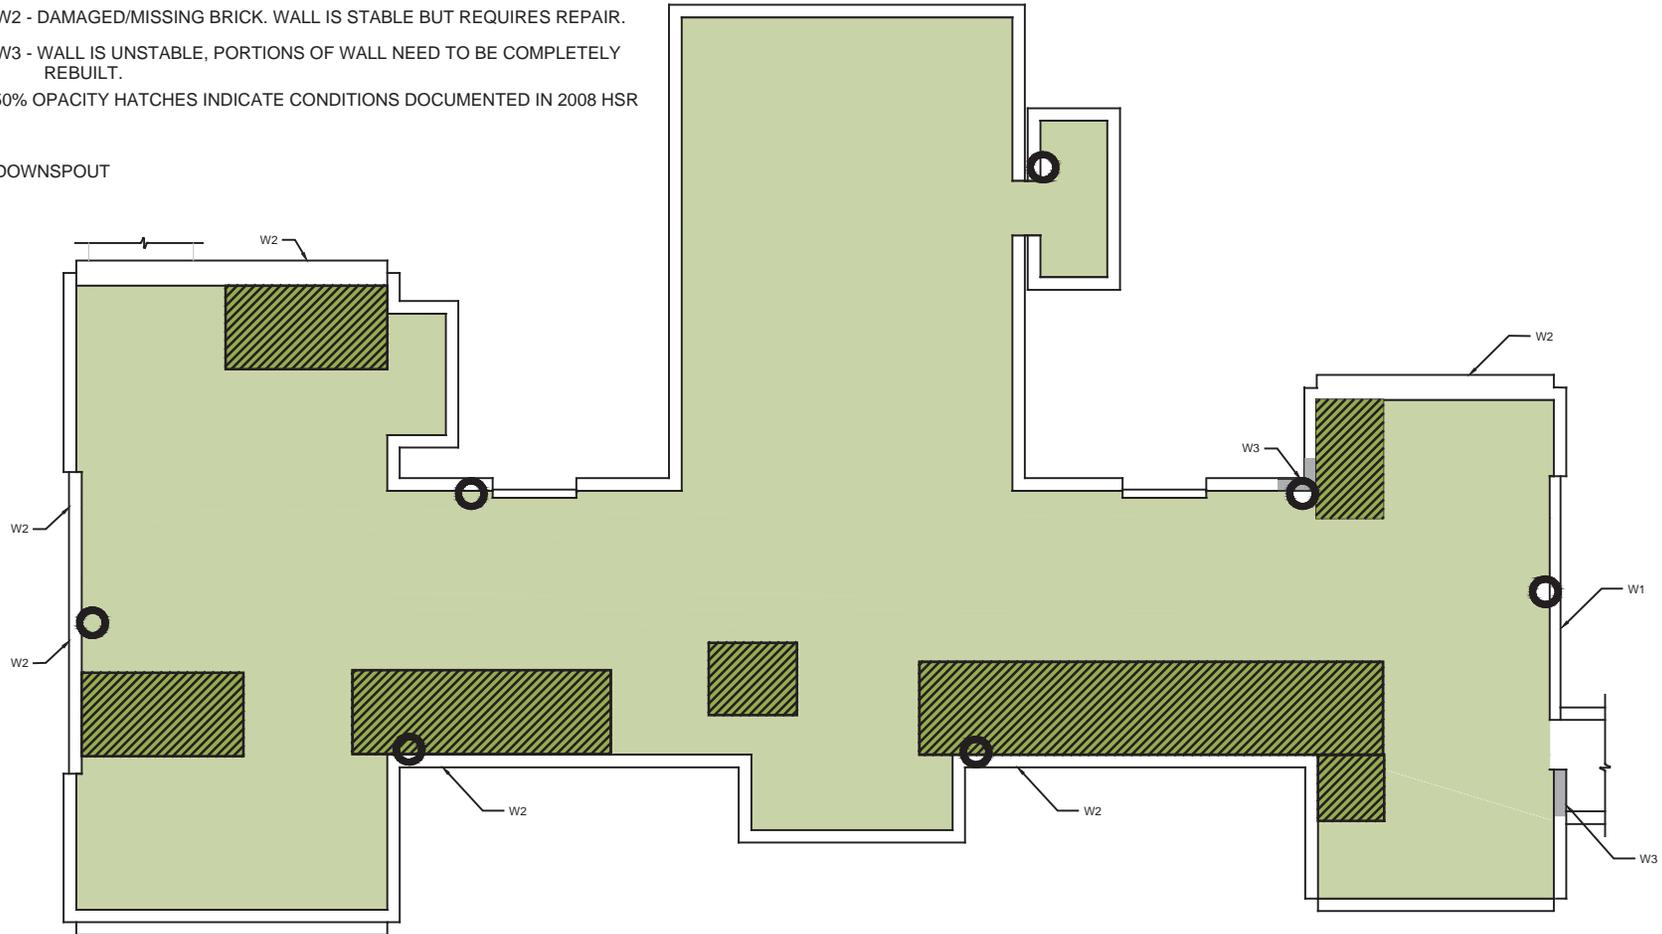
BUILDING 39 (FEMALE WARD I)
ATTIC FLOOR PLAN

F1 - MINOR DAMAGES
-

F2 - MEDIUM LEVEL OF DAMAGES (JOISTS MAY NEED TO BE REPLACED/SISTERED)
-

F3 - EXTENSIVE DETERIORATION (FLOOR FRAMING LIKELY REQUIRES REPLACEMENT)
-

W1 - LARGE CRACKS, BULGING, BRICK SPALLING THAT REQUIRES BRICK REPLACEMENT
-

W2 - DAMAGED/MISSING BRICK. WALL IS STABLE BUT REQUIRES REPAIR.
-

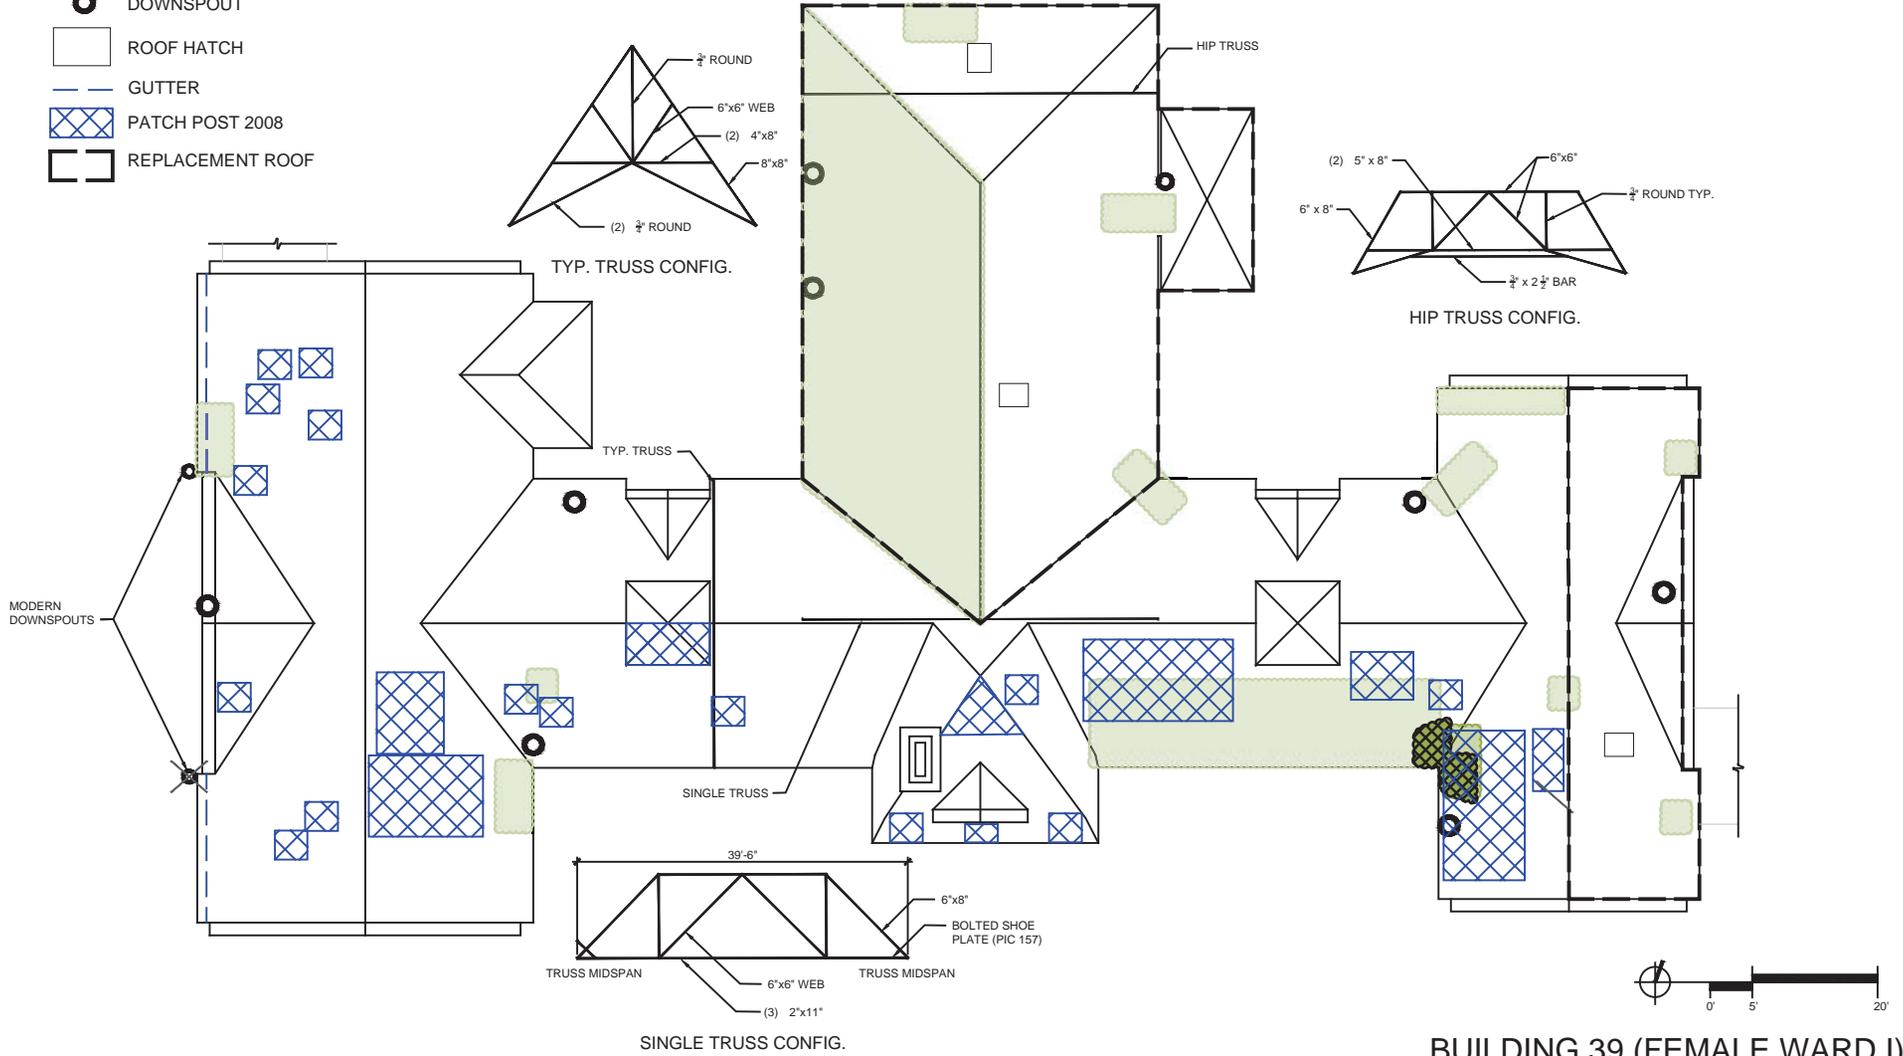
BUILDING 39 (FEMALE WARD I)
ROOF PLAN

R1 - MINOR CHECKING/CRACKING/WATER STAINING
-

R2 - ROOF FRAMING/SHEATHING REQUIRES LOCAL REPAIRS
-

R3 - ROOF FRAMING/SHEATHING REQUIRES REPLACEMENT

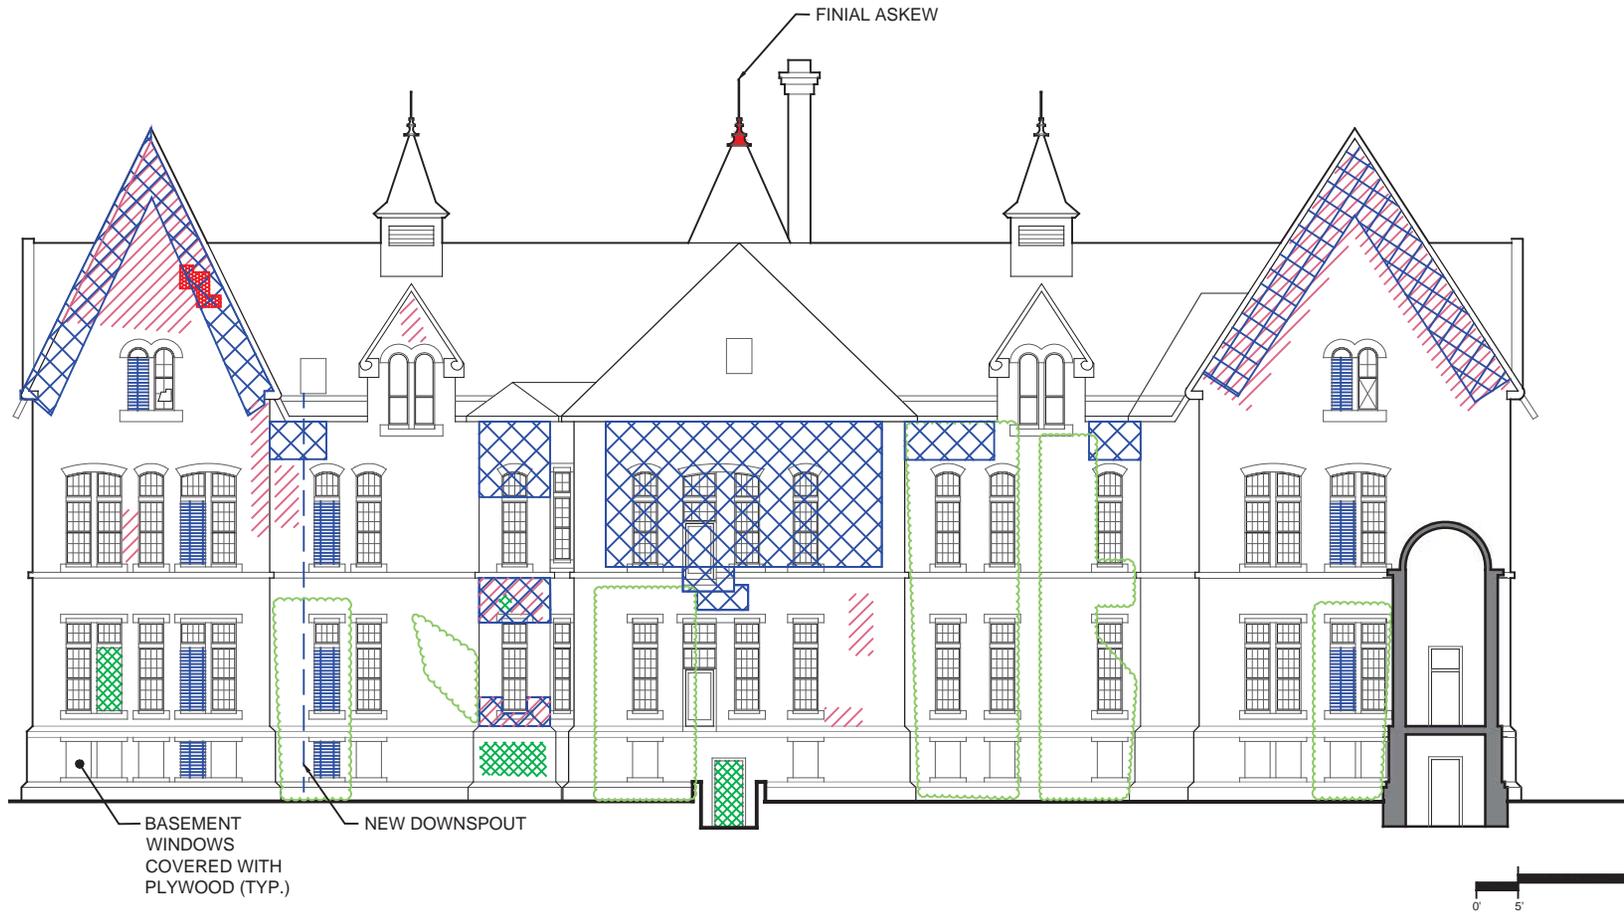
BUILDING 39 (FEMALE WARD I)
NORTH ELEVATION

CRACKS
-

MASONRY COLLAPSE / MISSING MASONRY
-

OPEN JOINTS / MASONRY DAMAGE
-

- 20% SPALLING
- 50% STAINING
- 35% MORTAR EROSION
- 5% MISSING WINDOW PROTECTION

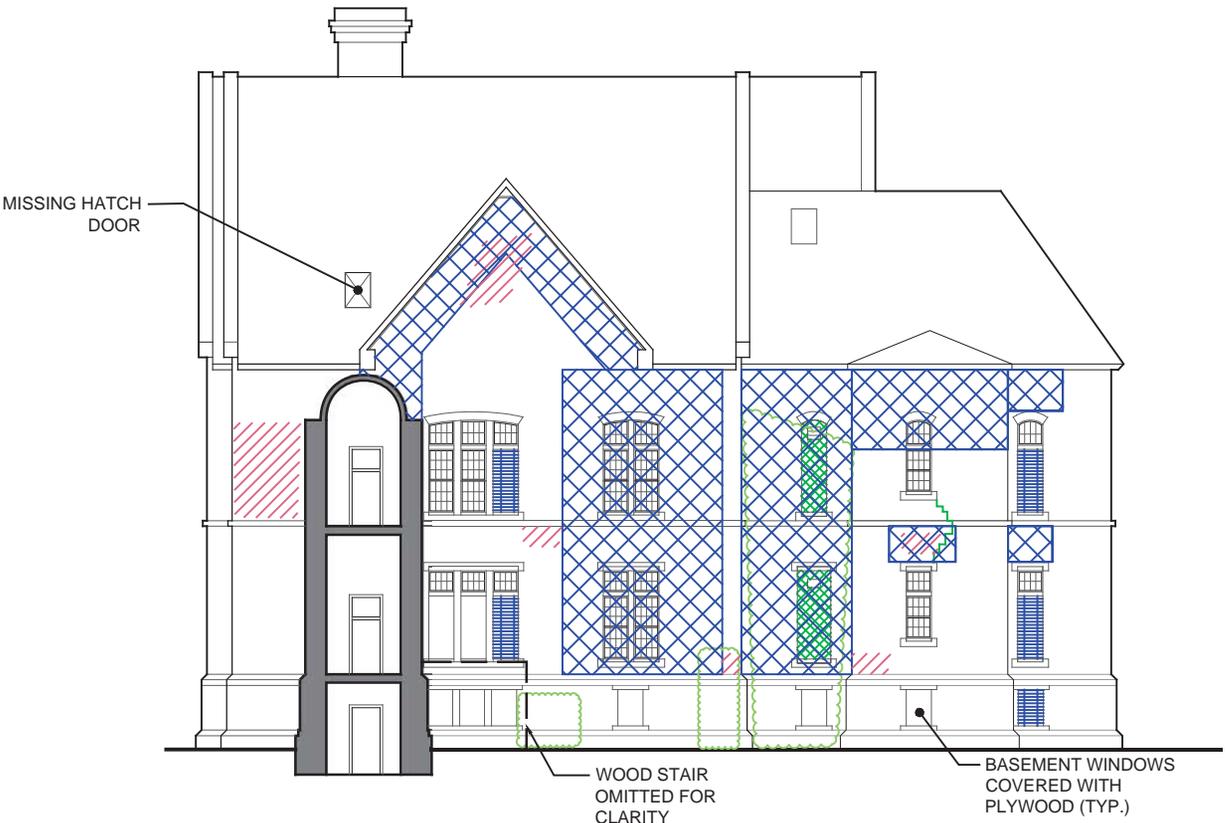
BUILDING 39 (FEMALE WARD I)
EAST ELEVATION

CRACKS
-

MASONRY COLLAPSE / MISSING MASONRY
-

OPEN JOINTS / MASONRY DAMAGE
-

- 45% SPALLING
- 55% STAINING
- 100% MORTAR EROSION
- 0% MISSING WINDOW PROTECTION

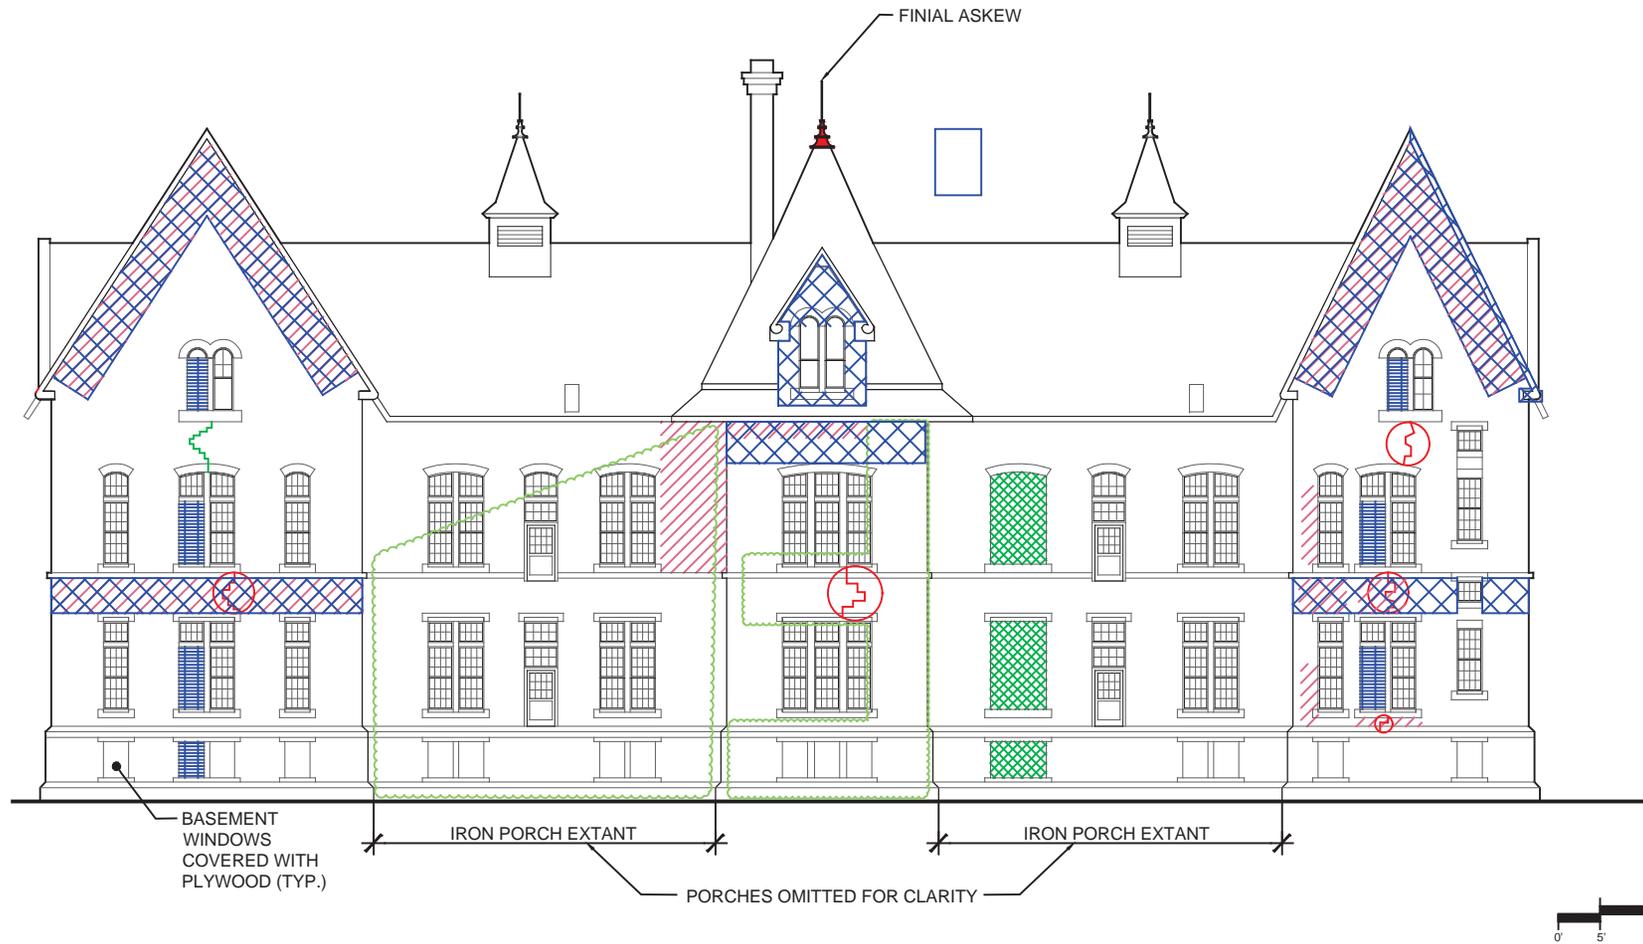
BUILDING 39 (FEMALE WARD I)
SOUTH ELEVATION

CRACKS
-

MASONRY COLLAPSE / MISSING MASONRY
-

OPEN JOINTS / MASONRY DAMAGE
-

- 10% SPALLING
- 20% STAINING
- 30% MORTAR EROSION
- 25% MISSING WINDOW PROTECTION

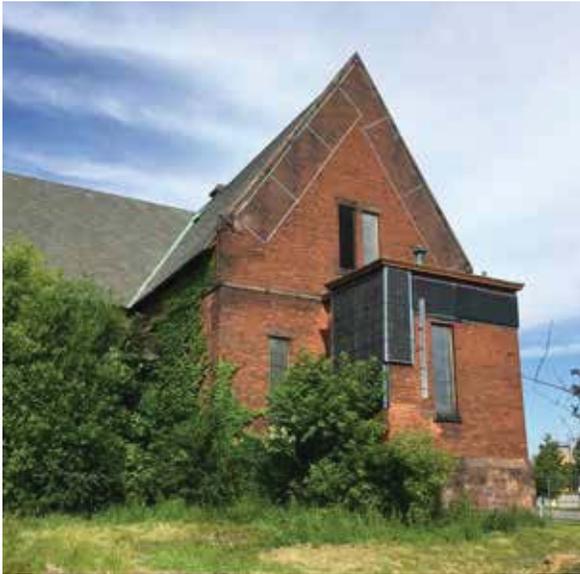
Fig. 3-34: Northeast corner with metal netting stabilization (CJSA 2019)

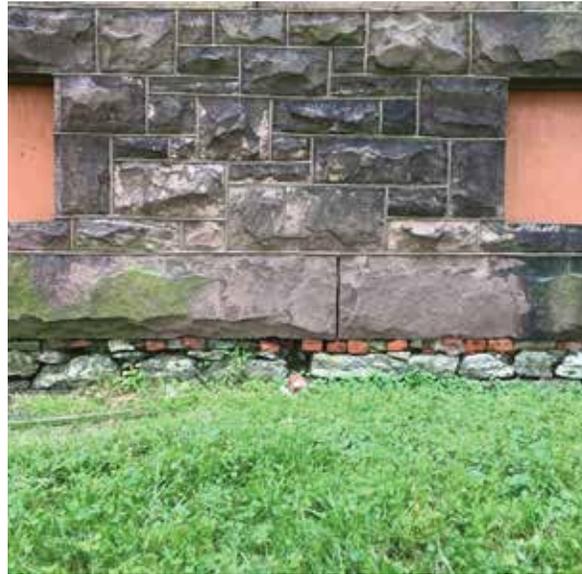
Fig. 3-35: Exposed foundation stones and brick on west elevation (CJSA 2019)

are missing mortar and exhibit open joints, especially on the west and south elevations. Over the majority of the west elevation and the north elevation of the southern wing, the ground has eroded and is exposing rubble foundation stone and brick coursing of the building. Some of these bricks are severely eroded and all exposed areas are missing pointing and bedding mortar.

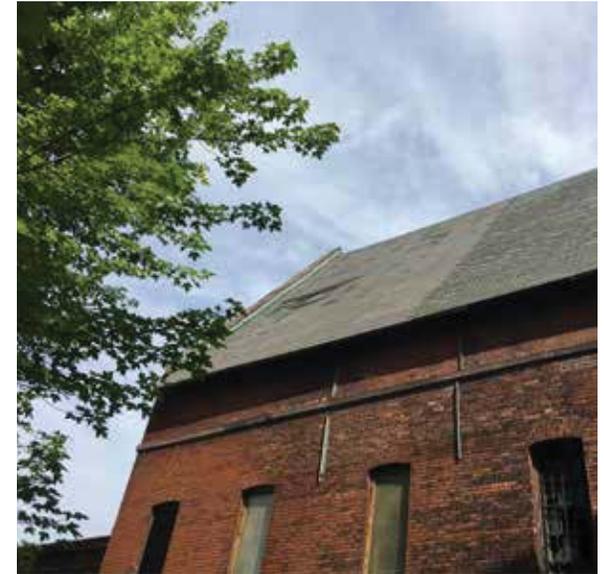
Fig. 3-36: Area of bowing wall, south side of west wing (CJSA 2019)

installed to stabilize the area. However, the south side of the bump-out is exhibiting severe masonry damage on the interior with a large portion of the brick missing in the southeast corner of Room 33. Steel scaffolding appears to have stabilized the roof, but the integrity of the wall is compromised from missing a large portion of bricks. The south facing elevation of the north wing continues to bow outward despite pre-2008 steel strapping installed.

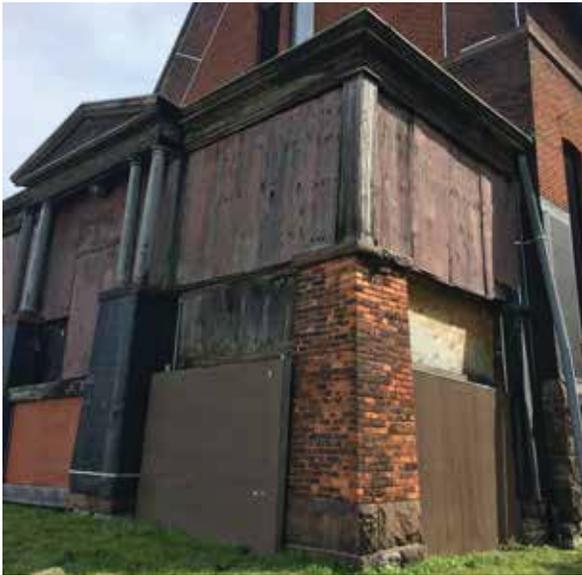
Fig. 3-37: Porch corner (CJSA 2019)

A large amount of the brick has spalled faces and is missing mortar. The porch itself is in poor condition, with most of its wood elements rotted.

Some of the piers have membrane protection, and the area under the porch has been protected with plywood, however the plywood is not conducive to ventilating the structure below and evaporating harmful moisture. Overall, the wood framing and enclosure should be rebuilt.

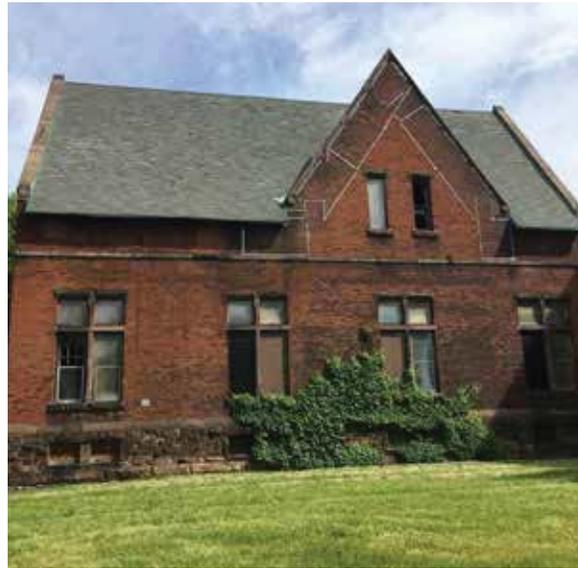
Fig. 3-38: South elevation showing replacement asphalt roof (CJSA 2019)

Ward J has an asphalt roof over the main portion of the building, its dormers, and the iron porch. The roof projects over the walls with exposed rafter tails. The bump-outs on the east and north elevation, and the wooden porch on the west elevation have flat seam copper roofs. There is a large asphalt patch on the southwest corner of the building that is different in color and pattern than the main roof. There are no gutters or downspouts on the building; this results in water shedding to

the ground and walls below, causing additional damage.

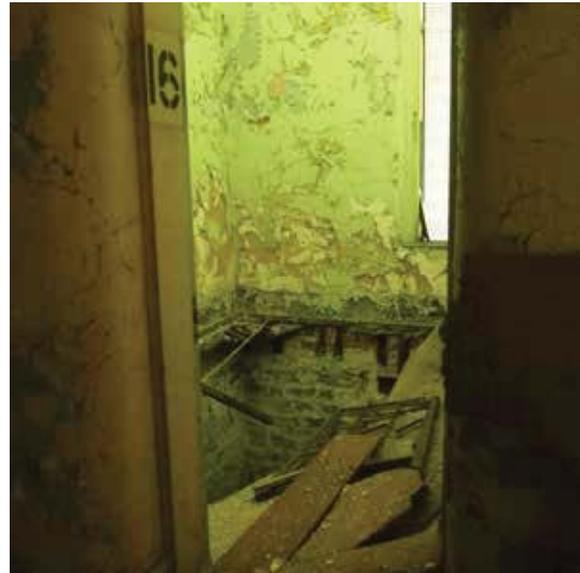
Fig. 3-41: Room 24 with collapsed floor (CJSA 2019)

wooden porch have collapsed floors, the same rooms noted in the 2008 HSR.

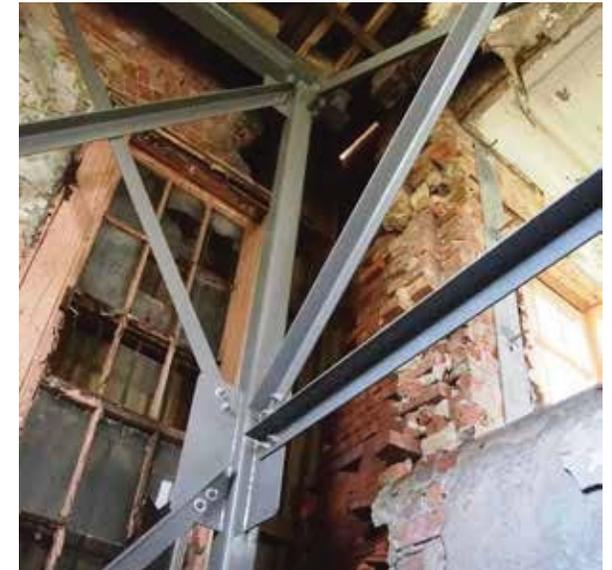
Fig. 3-42: Room 33, masonry damage and stabilization (CJSA 2019)

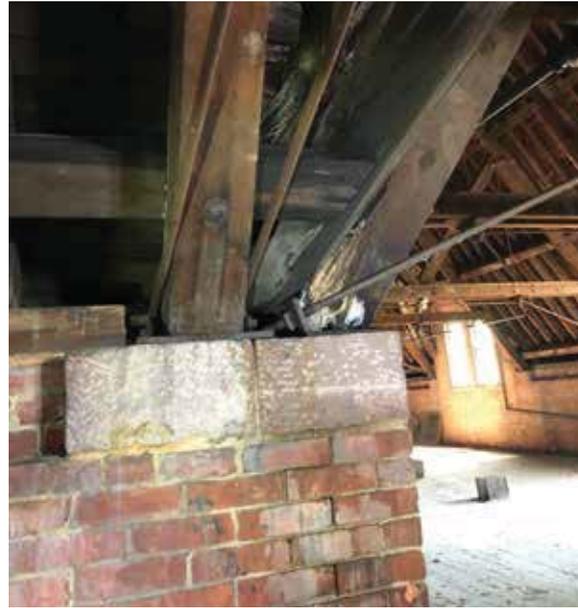
Fig. 3-44: Damaged roof structure (SGH 2019)

deteriorate over the past decade. There are several areas of floor framing that are severely deteriorated and will require replacement. At the roof level, we observed water damage at the ends of purlins where purlins bear in pockets in the gable end walls and at sheathing abutting gable end walls. We observed several holes through the roof sheathing, and that several valley members exhibit water damage and potential reduction in bearing at their bases.

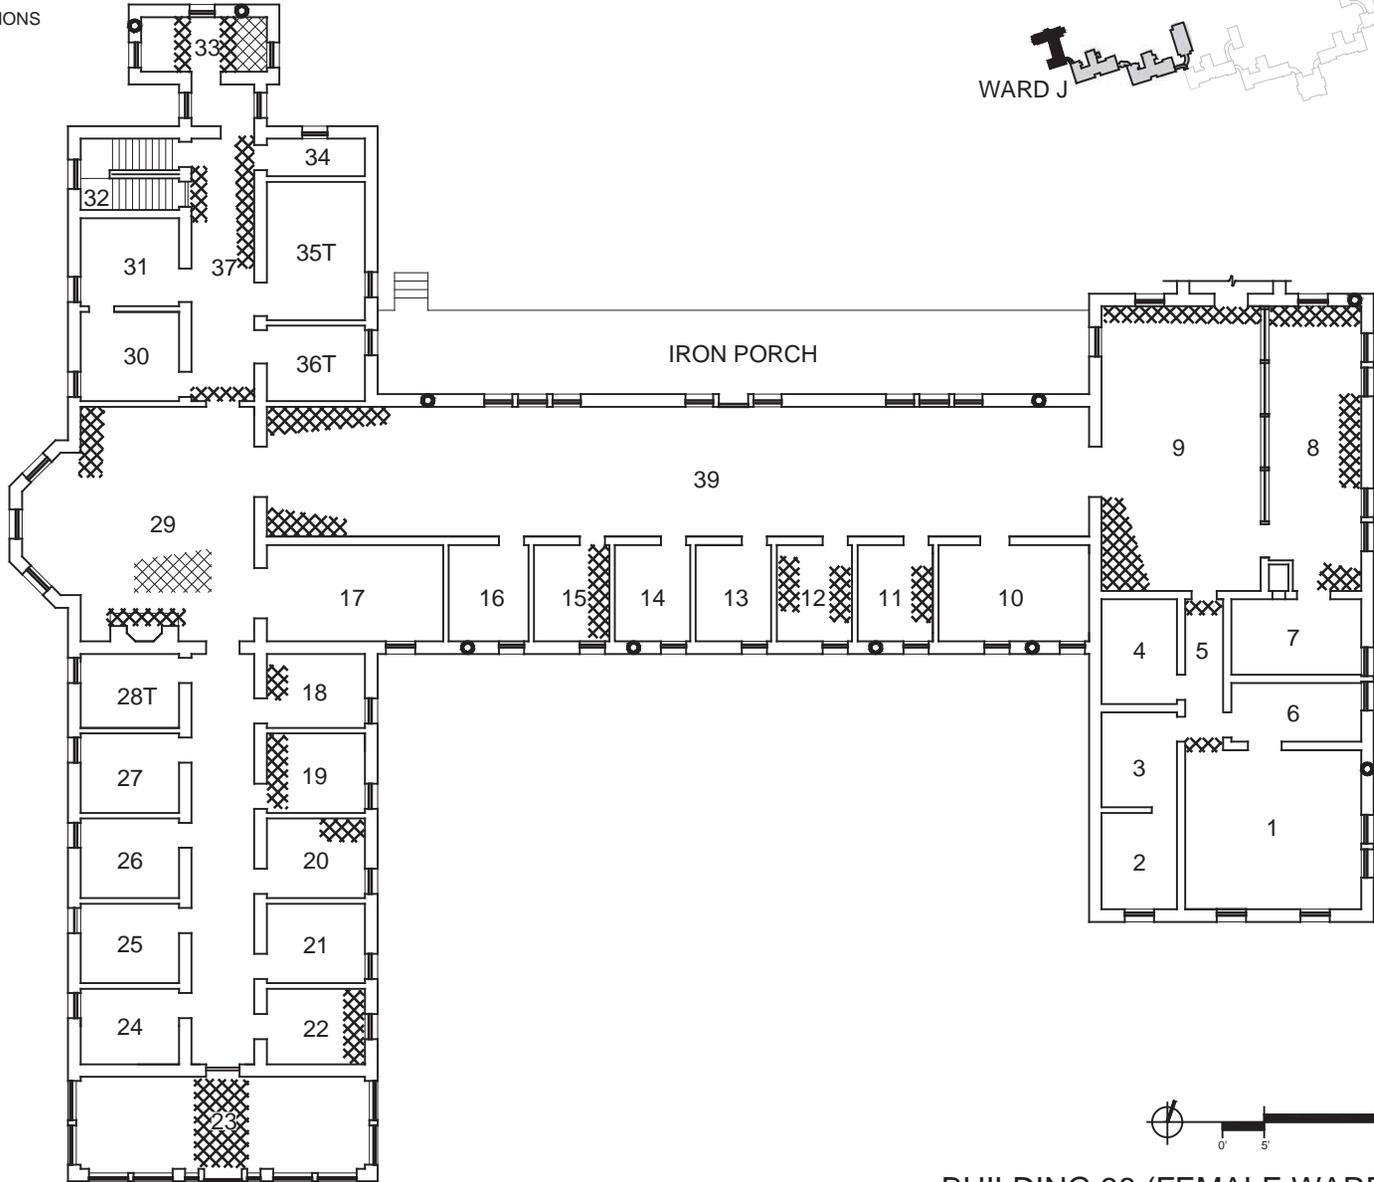
BUILDING 38 (FEMALE WARD J)
FIRST FLOOR REFLECTED CEILING PLAN

CEILING - PLASTER, LATH, OR TIN DAMAGE

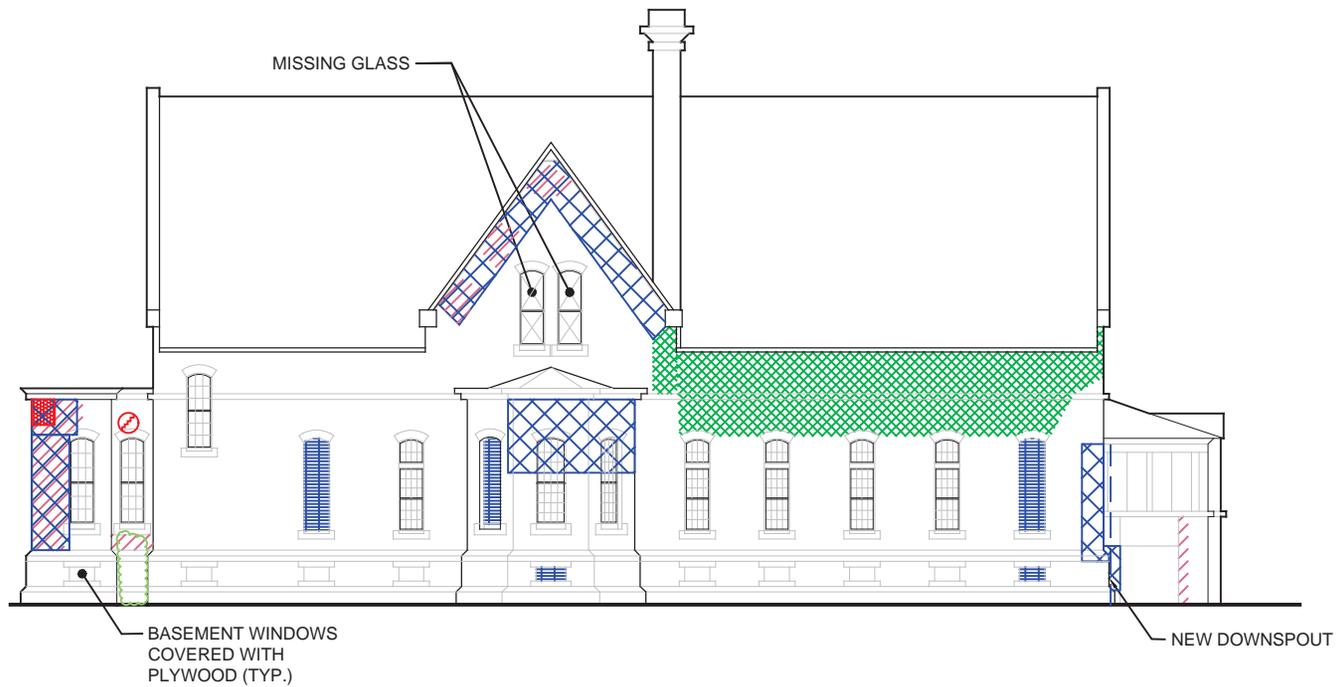
BUILDING 38 (FEMALE WARD J)
NORTH ELEVATION

- 30% SPALLING
- 85% STAINING
- 45% MORTAR EROSION
- 12% MISSING WINDOW PROTECTION

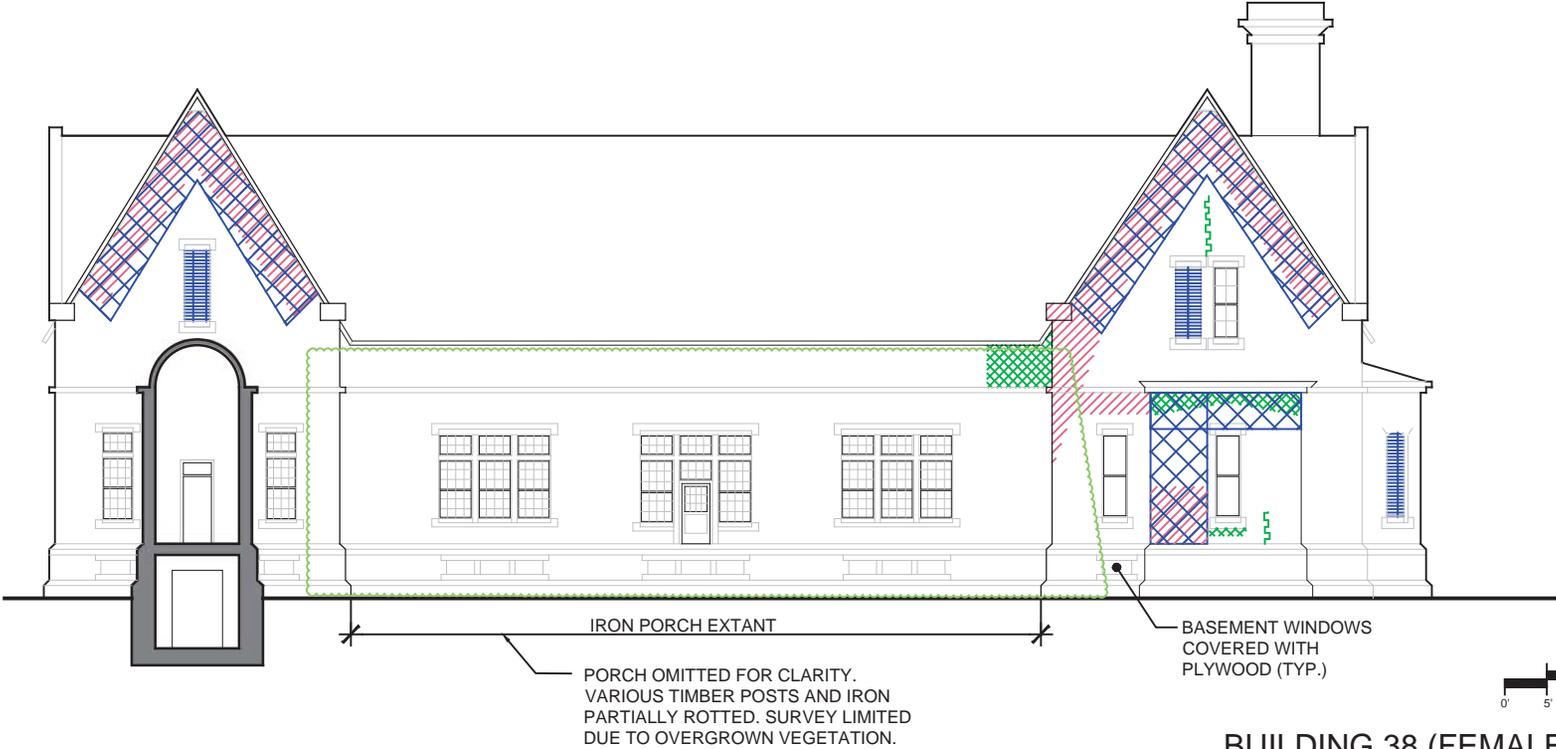
BUILDING 38 (FEMALE WARD J)
EAST ELEVATION

KEY	PERCENTAGES
	15% SPALLING
	30% STAINING
	30% MORTAR EROSION
	0% MISSING WINDOW PROTECTION
