**RICHARDSON OLMSTED CAMPUS
BUILDING CONDITIONS ASSESSMENT**

BUFFALO, NY

PREPARED FOR: RICHARDSON CENTER CORPORATION

JANUARY 2023

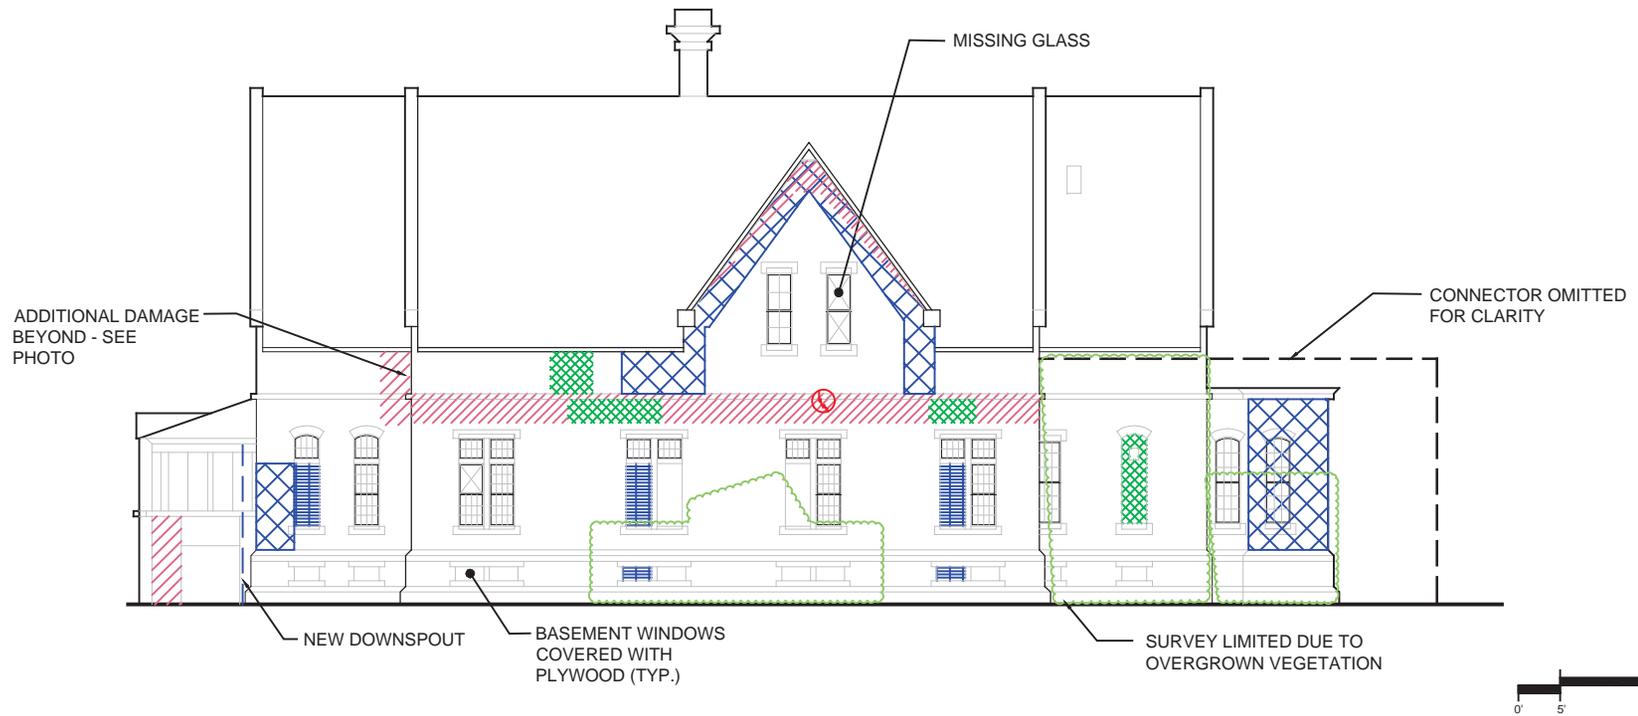
BUILDING 38 (FEMALE WARD J)
SOUTH ELEVATION

- 10% SPALLING
- 50% STAINING
- 60% MORTAR EROSION
- 12% MISSING WINDOW PROTECTION

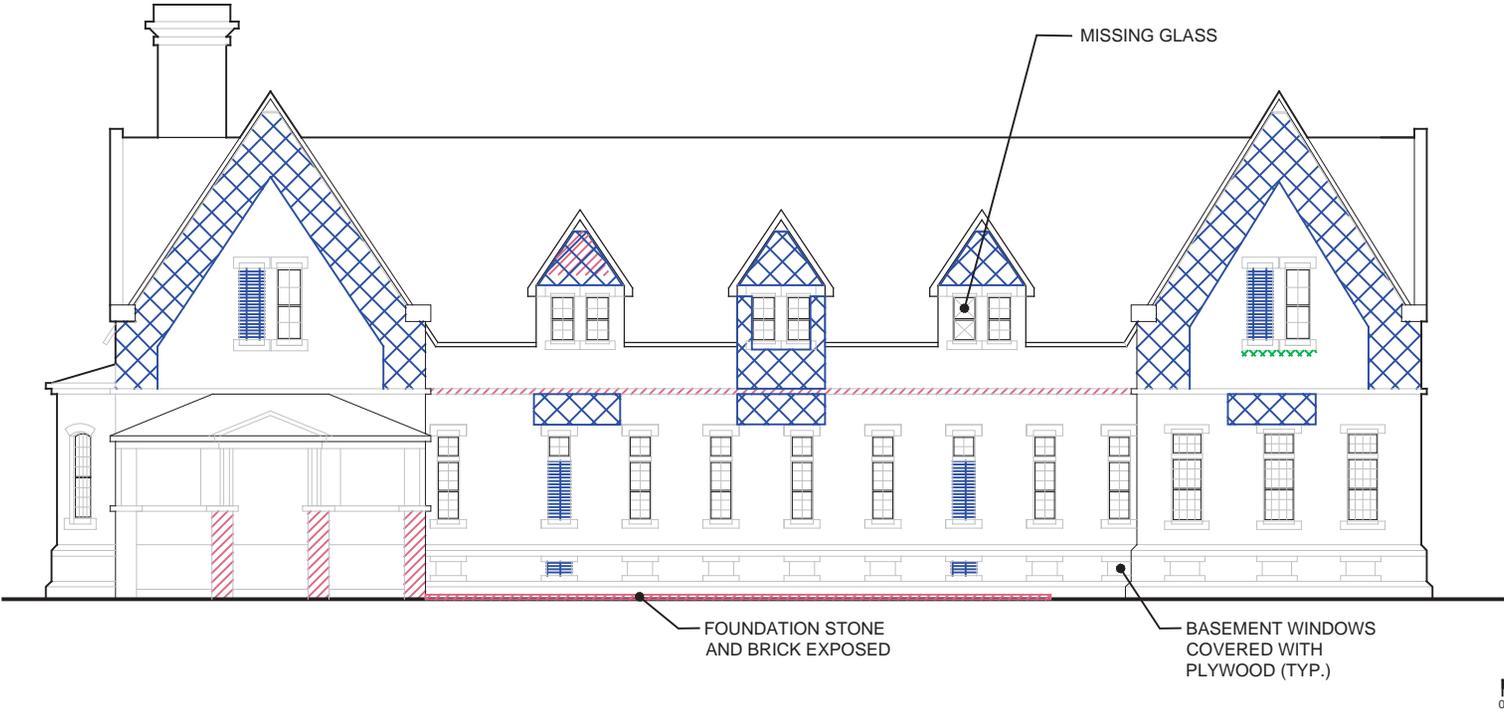
BUILDING 38 (FEMALE WARD J)
WEST ELEVATION

- 10% SPALLING
- 60% STAINING
- 50% MORTAR EROSION
- 7% MISSING WINDOW PROTECTION

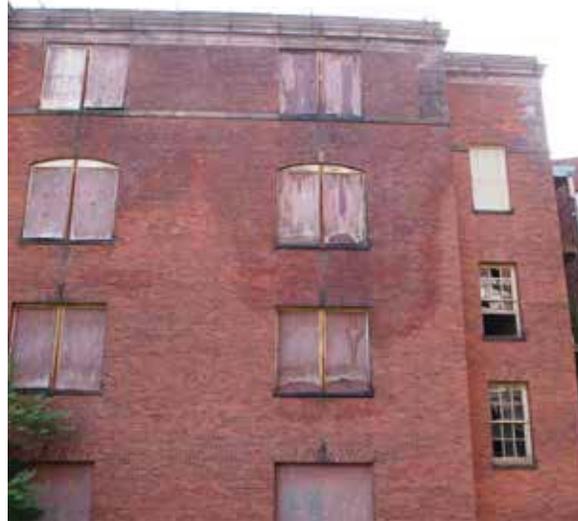
Fig. 3-47: Water infiltration on west elevation (CJSA 2019)

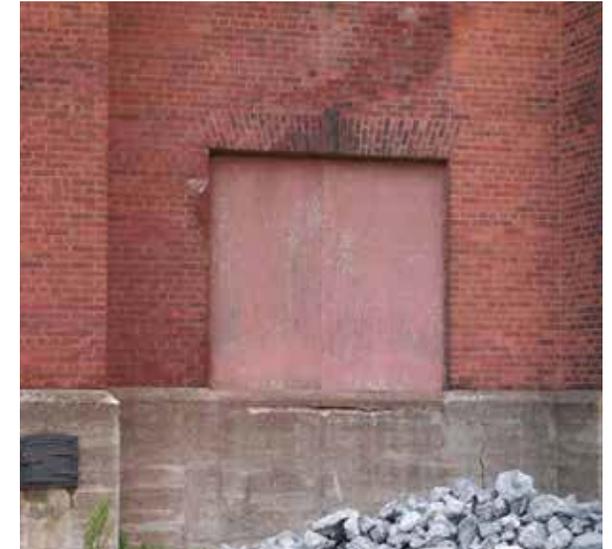
Fig. 3-48: West elevation, water infiltration and crack in concrete (CJSA 2019)

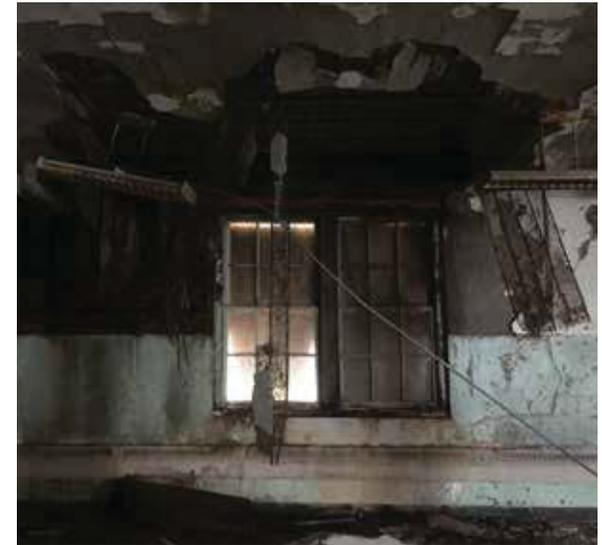
Fig. 3-50: Third floor ceiling and wall damage, looking west (CJSA 2019)

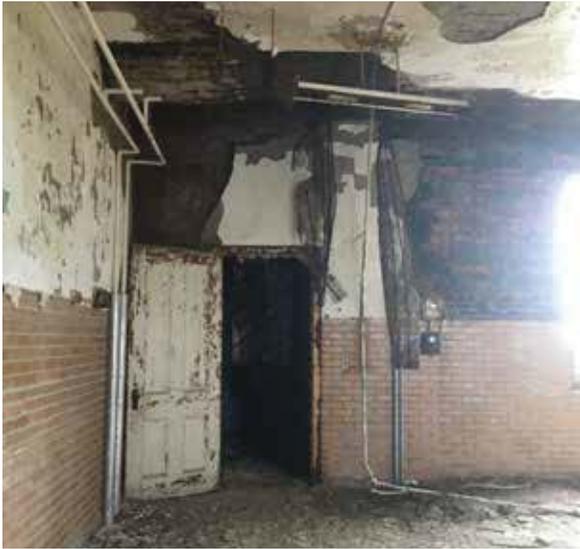
Plaster encases the steel columns and steel beams. In areas of poor condition and concern, the plaster has entirely failed to reveal the steel and the brick it bears on. The areas of highest concern are the east side of the first and third floors and the west side of the third floor. These areas typically have large amounts of ceiling and wall plaster damage radiating inward from the wall. In some cases, the plaster is completely gone from both the walls and ceiling and the lath is rusted, detached, and hanging down from bar joists above.

Fig. 3-51: Ceiling damage in Room 6, northwest corner of the third floor (CJSA 2019)

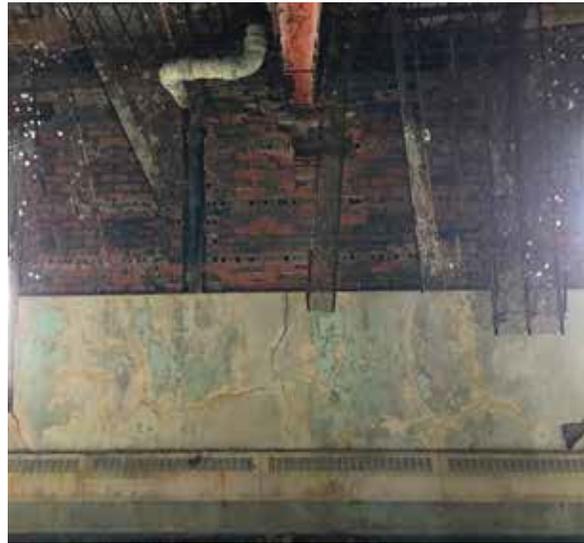
Fig. 3-52: Plaster and ceiling damage on third floor, note exposed structure (CJSA 2019)

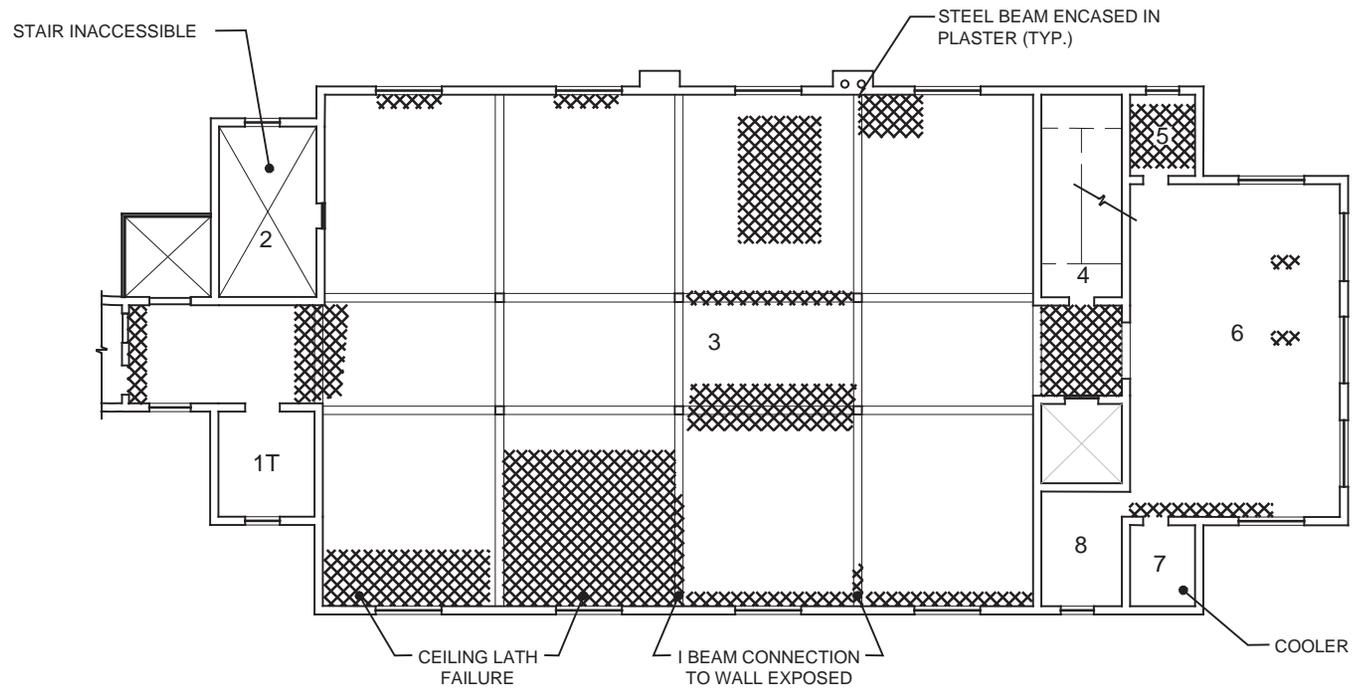
BUILDING 41 (FEMALE DINING HALL)
FIRST FLOOR REFLECTED CEILING PLAN

NOTE: BRICK WAINSCOT IN GOOD CONDITION.
TILE FLOOR GOOD CONDITION.

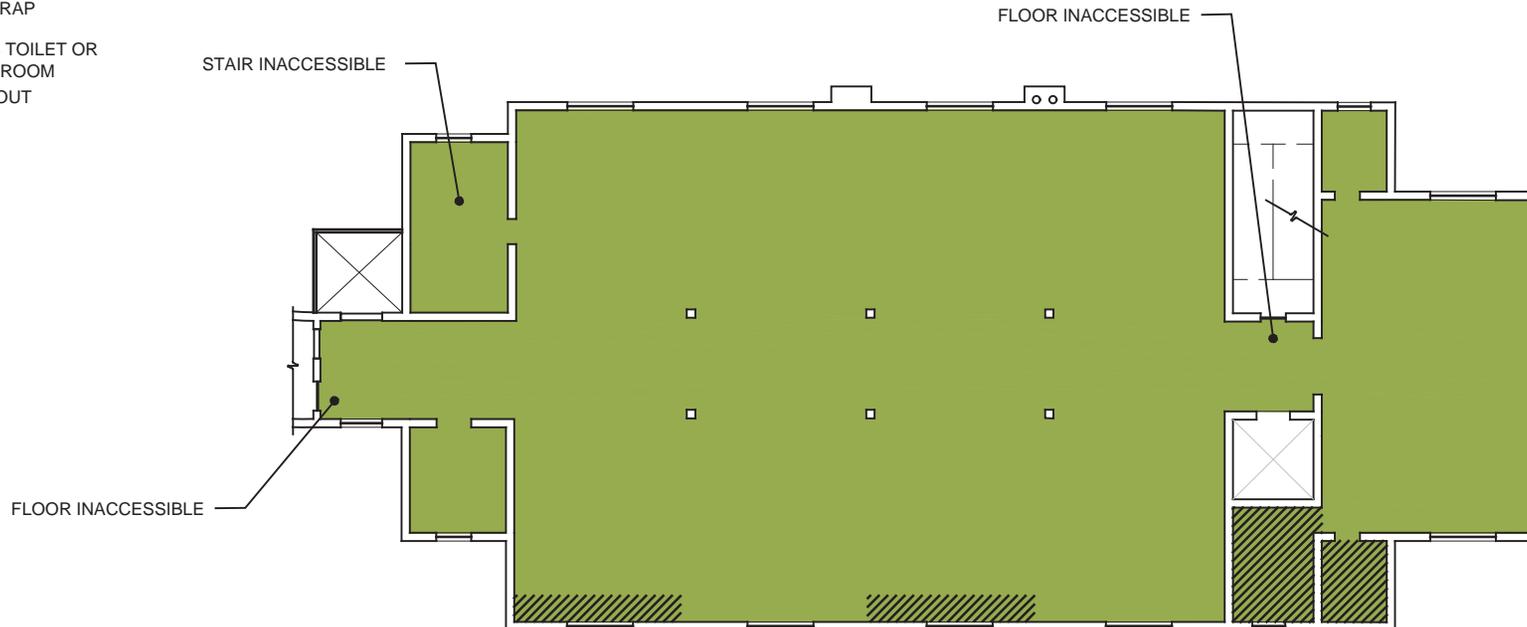
**BUILDING 41 (FEMALE DINING HALL)
SECOND FLOOR PLAN**

NOTE: THIS FLOOR WAS INACCESSIBLE AT THE TIME OF THE SURVEY. OBSERVATIONS WERE EXTRAPOLATED FROM THE EXTERIOR CONDITIONS OF THE BUILDING. A WINDOW AT THE CONNECTOR PROVIDED MINIMAL VIEWS INSIDE.

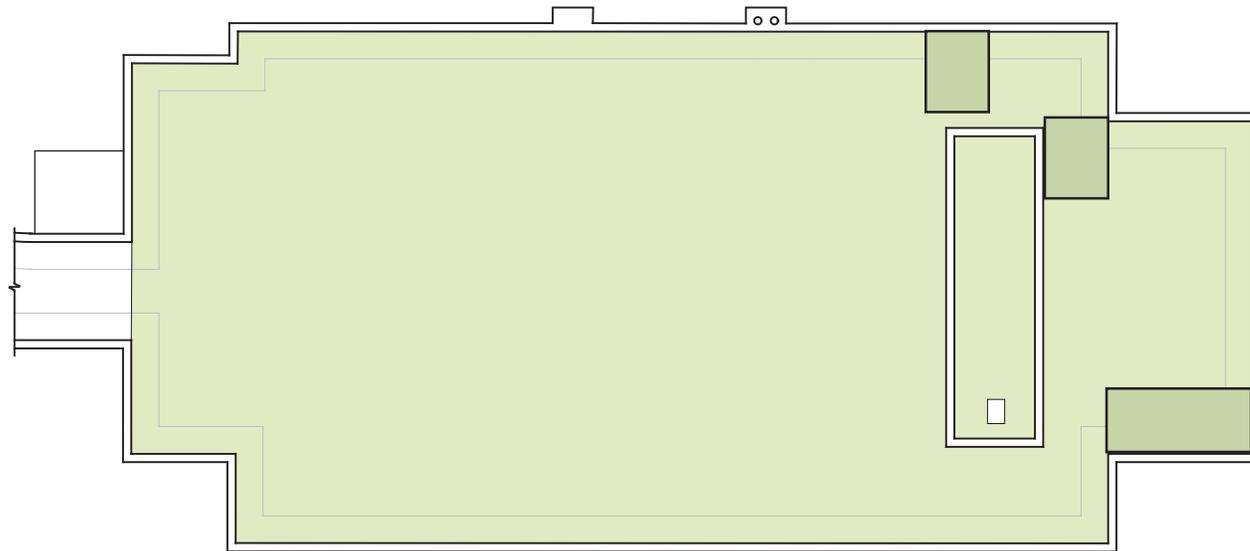
BUILDING 41 (FEMALE DINING HALL)
ROOF PLAN

The standing seam copper roofs on the two shed roofs are in fair to good condition. The main roof of the building is in poor condition. At the time of the survey, pools of water were observed on the southwest corner and the northwest corner. The south side of the west elevation had water actively dripping through and down the wall.

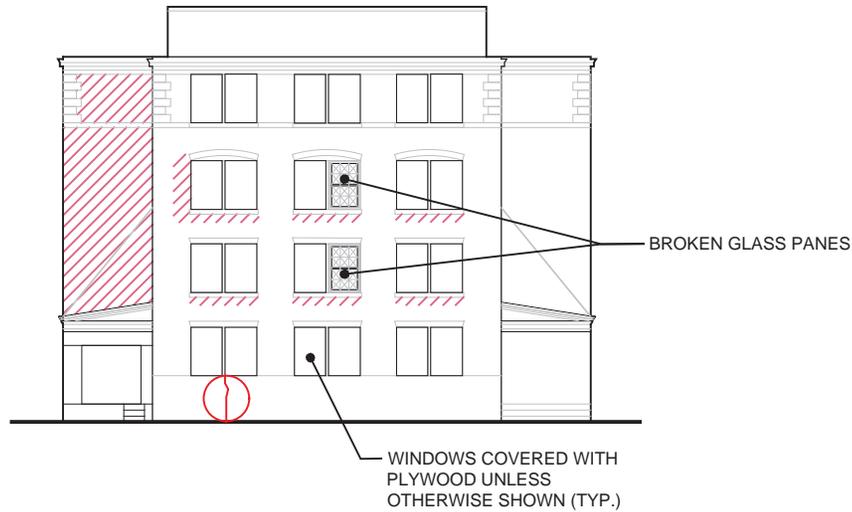
BUILDING 41 (FEMALE DINING HALL)
NORTH ELEVATION

- 15% SPALLING
- 35% STAINING
- 10% MORTAR EROSION
- 11% MISSING WINDOW PROTECTION

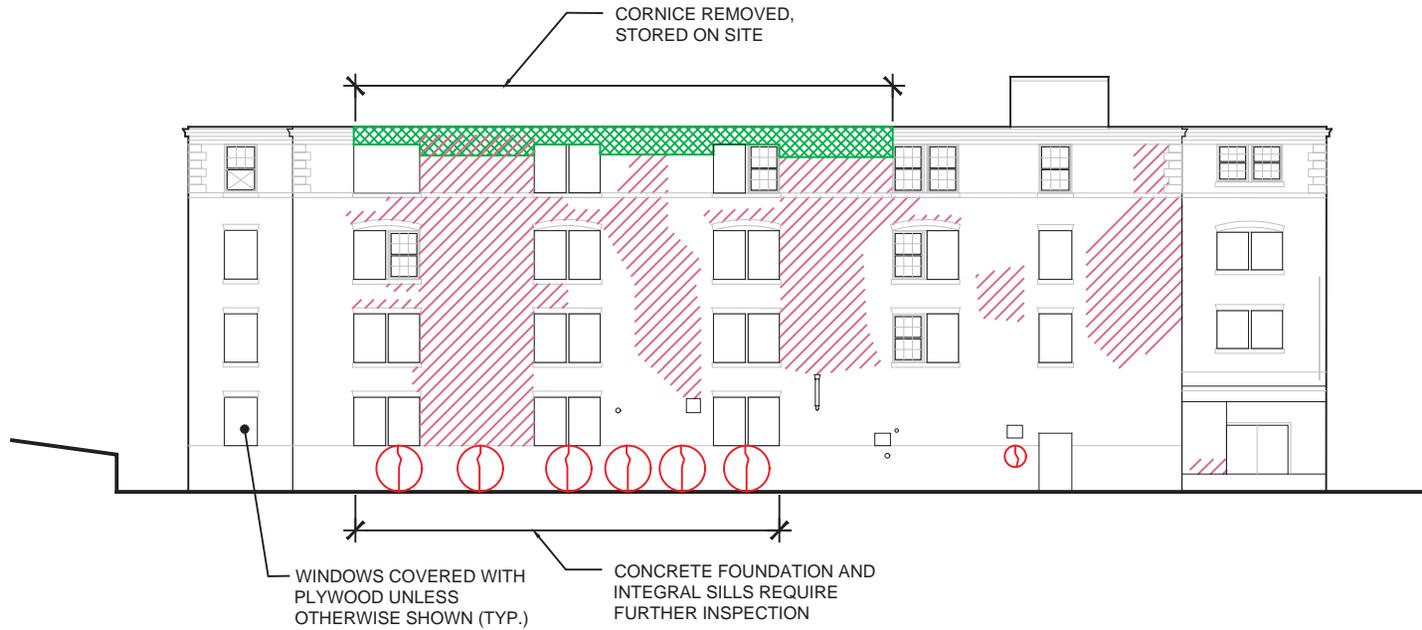
BUILDING 41 (FEMALE DINING HALL)
EAST ELEVATION

- 15% SPALLING
- 50% STAINING
- 40% MORTAR EROSION
- 20% MISSING WINDOW PROTECTION

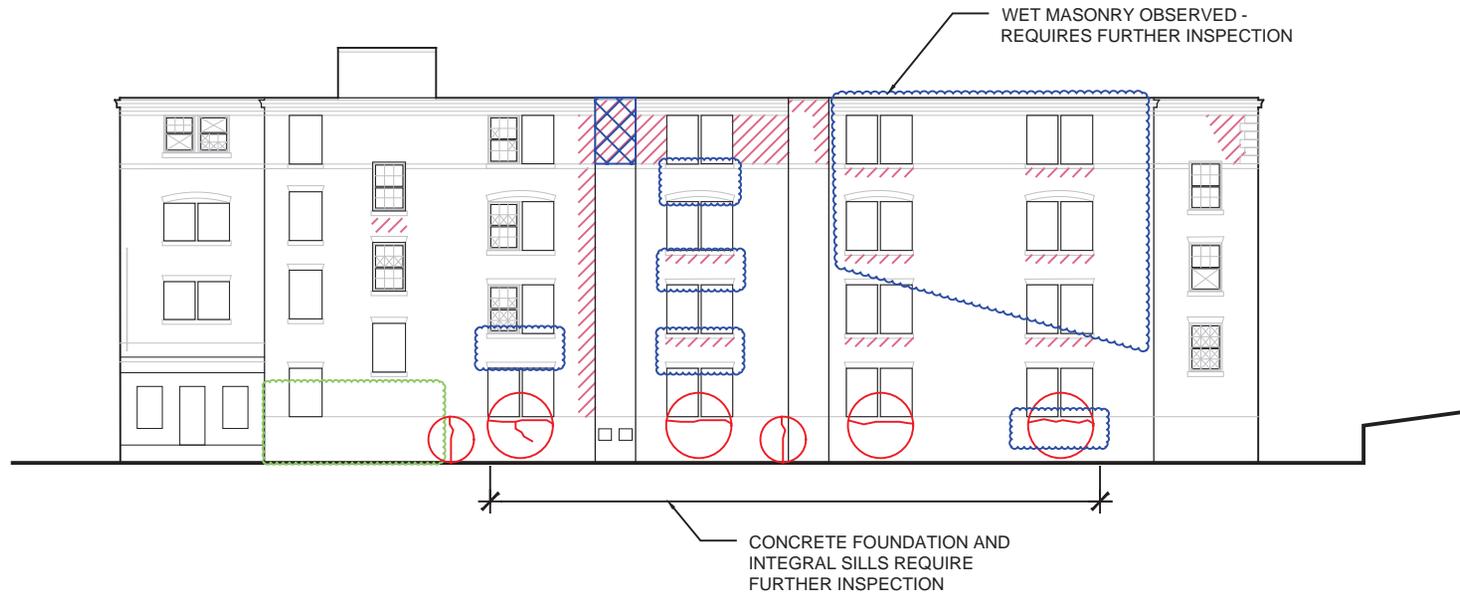
BUILDING 41 (FEMALE DINING HALL)
WEST ELEVATION

- 20% SPALLING
- 25% STAINING
- 40% MORTAR EROSION
- 25% MISSING WINDOW PROTECTION

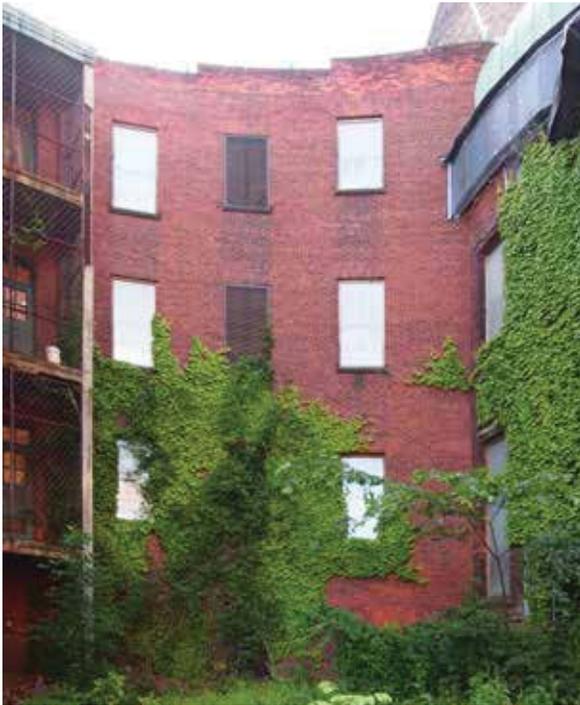
connectors with metal netting and membrane attached to the exterior walls. This was limited to the intersection of the roof and walls. A portion of the brick on west side of the first and second floors of the connector was replaced with CMU and membrane on the exterior. Ivy is partially covering the membrane on the south side of the connector. The parapet on the connector to the FDH has several courses of spalled bricks at the top of the walls of the

Fig. 3-55: Connector to FDH, West Elevation (CJSA 2019).

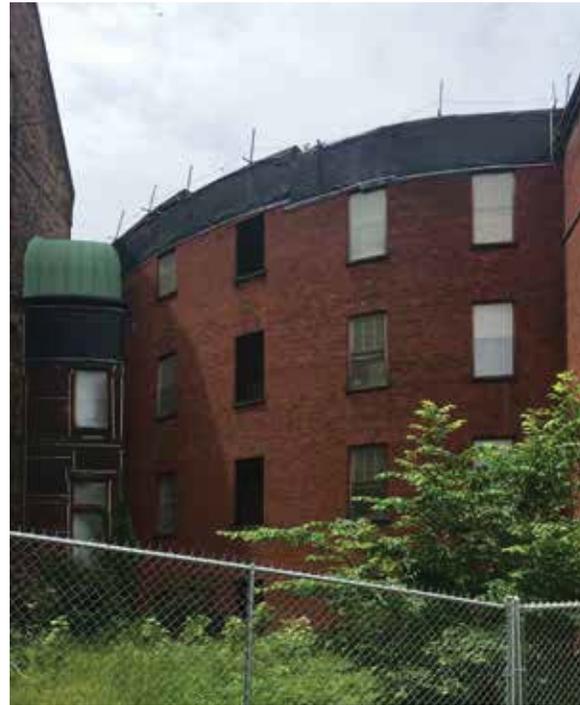
Fig. 3-56: East elevation of the Connector to the FDH (CJSA 2019).

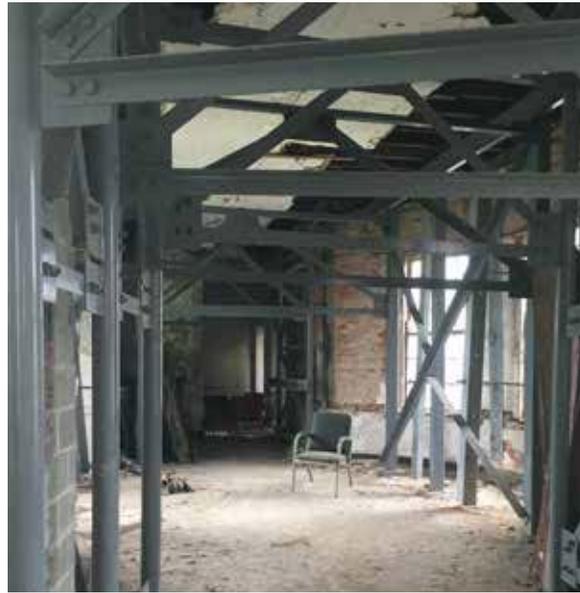
Fig. 3-59: Entrance to G, Second Floor (CJSA 2019).

place, but there is a large hole in the middle of the door. On the third floor, there is a metal door to the attic of Ward G that is pinned in place, making it completely inaccessible. The second floor of the Female Dining Hall is also inaccessible from the connector because the door is pinned in place. There is a small window in the door that allowed limited observation into the floor. There is steel scaffolding throughout the first and second floor.

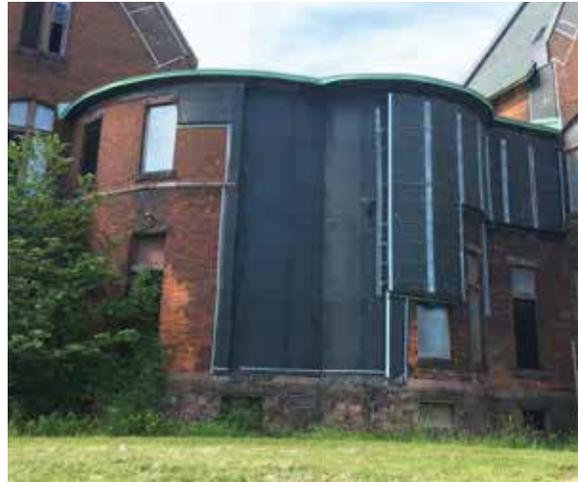
The brick is in fair condition with areas of spalling and soiling. Some of it was obscured from surveying by vegetation growth. Large areas of the brick adjacent to the semi-circular bay window have been rebuilt with concrete masonry units (CMUs); the CMU assembly is covered with wood framed membrane on the exterior. Similar to other areas, exact assembly was not verified at the time of the survey. It is unlikely that there is finish brick at the exterior

Fig. 3-60: Connector from Buildings H - I, North Elevation (CJSA 2019).

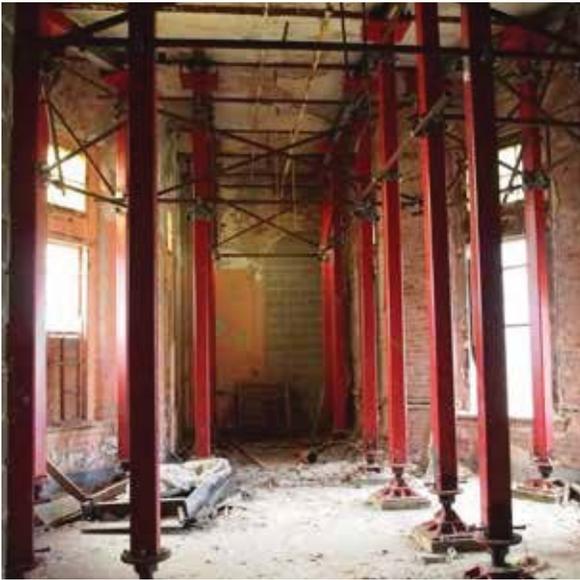
Fig. 3-62: Connector First Floor, infilled entrance to Building I (CJSA 2019).

a bridge on the second floor allow passage through the connector. However, the main arched opening into Ward I (39) on the first floor of the connector has been filled in with CMU.

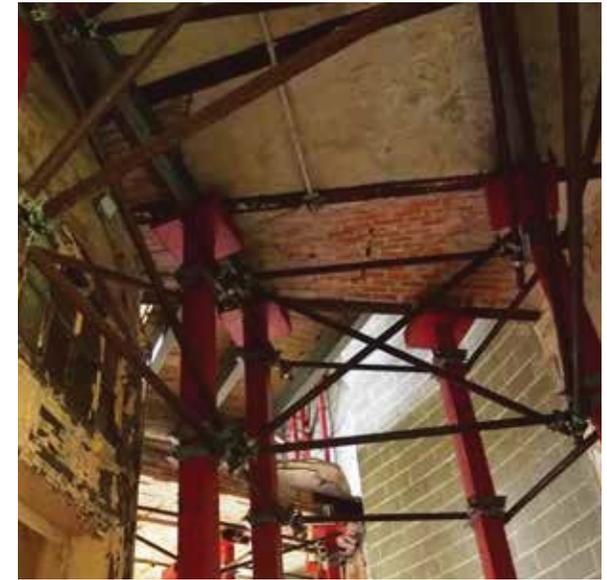
The interior of the connector is characterized by plaster walls, plaster ceiling over brick arches, and a mosaic tile floor. Areas that were rebuilt with CMU are missing their plaster entirely, leaving the bare CMU exposed. Most of the plaster ceilings on the first and second floor ceilings are compromised or missing. There is a large hole in the first floor ceiling/second floor where the structure has been completely cut away. Steel scaffolding throughout and

Fig. 3-64: Connector First Floor, hole in upper floor (CJSA 2019).

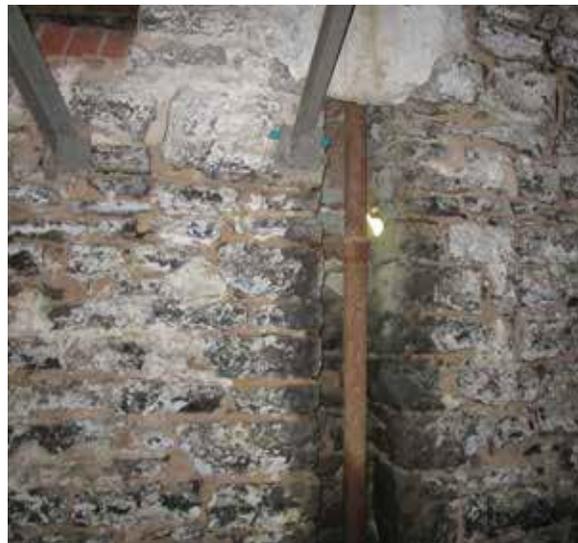
Fig. 3-66: Connector Ground Floor, exposed downspout (SGH 2019).

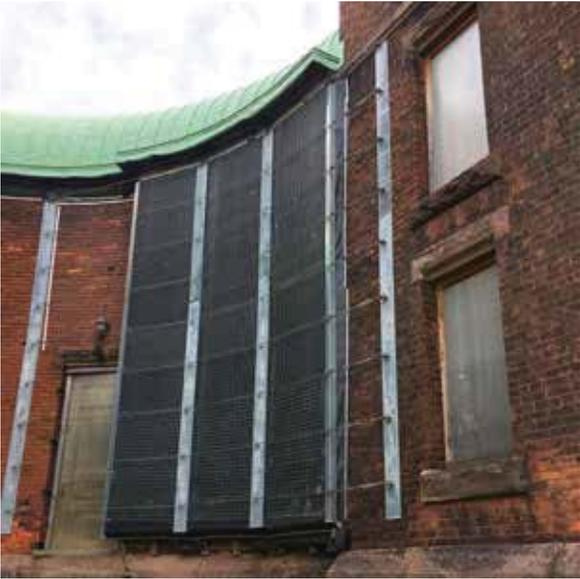
Fig. 3-69: Wall bracing, South Elevation (CJSA 2019).

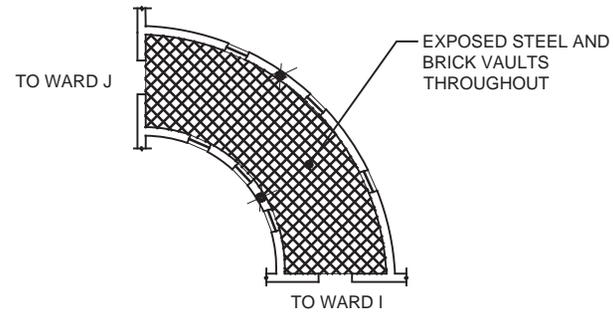
FIRST FLOOR REFLECTED CEILING PLAN

The interior of the connector is characterized by plaster walls, plaster ceiling over wood framing and a mosaic tile floor. Most of the plaster ceiling is damaged, with some areas exposing the steel and brick flat arch structure. There is scaffolding throughout the interior. This connector was the only one with internal downspouts exposed and, as expected, the damage was higher around them. Both exposed downspouts were broken and rusted, with the plaster around them completely gone, exposing the brick walls.
